No. 9

Trans Mediterranean Airways, DC-4 (C-54A), OD-AEB, accident in the Koh-i-Safid Mountains, Afghanistan on 12 December 1963. Report, dated November 1964, released by the Afghan Air Authority

ACCIDENT TO DC-4, OD-AEB, OF TRANS-MEDITERRANEAN AIRWAYS,
IN KOH-I-SAFID MOUNTAINS, AFGHANISTAN. 12 DECEMBER 1963

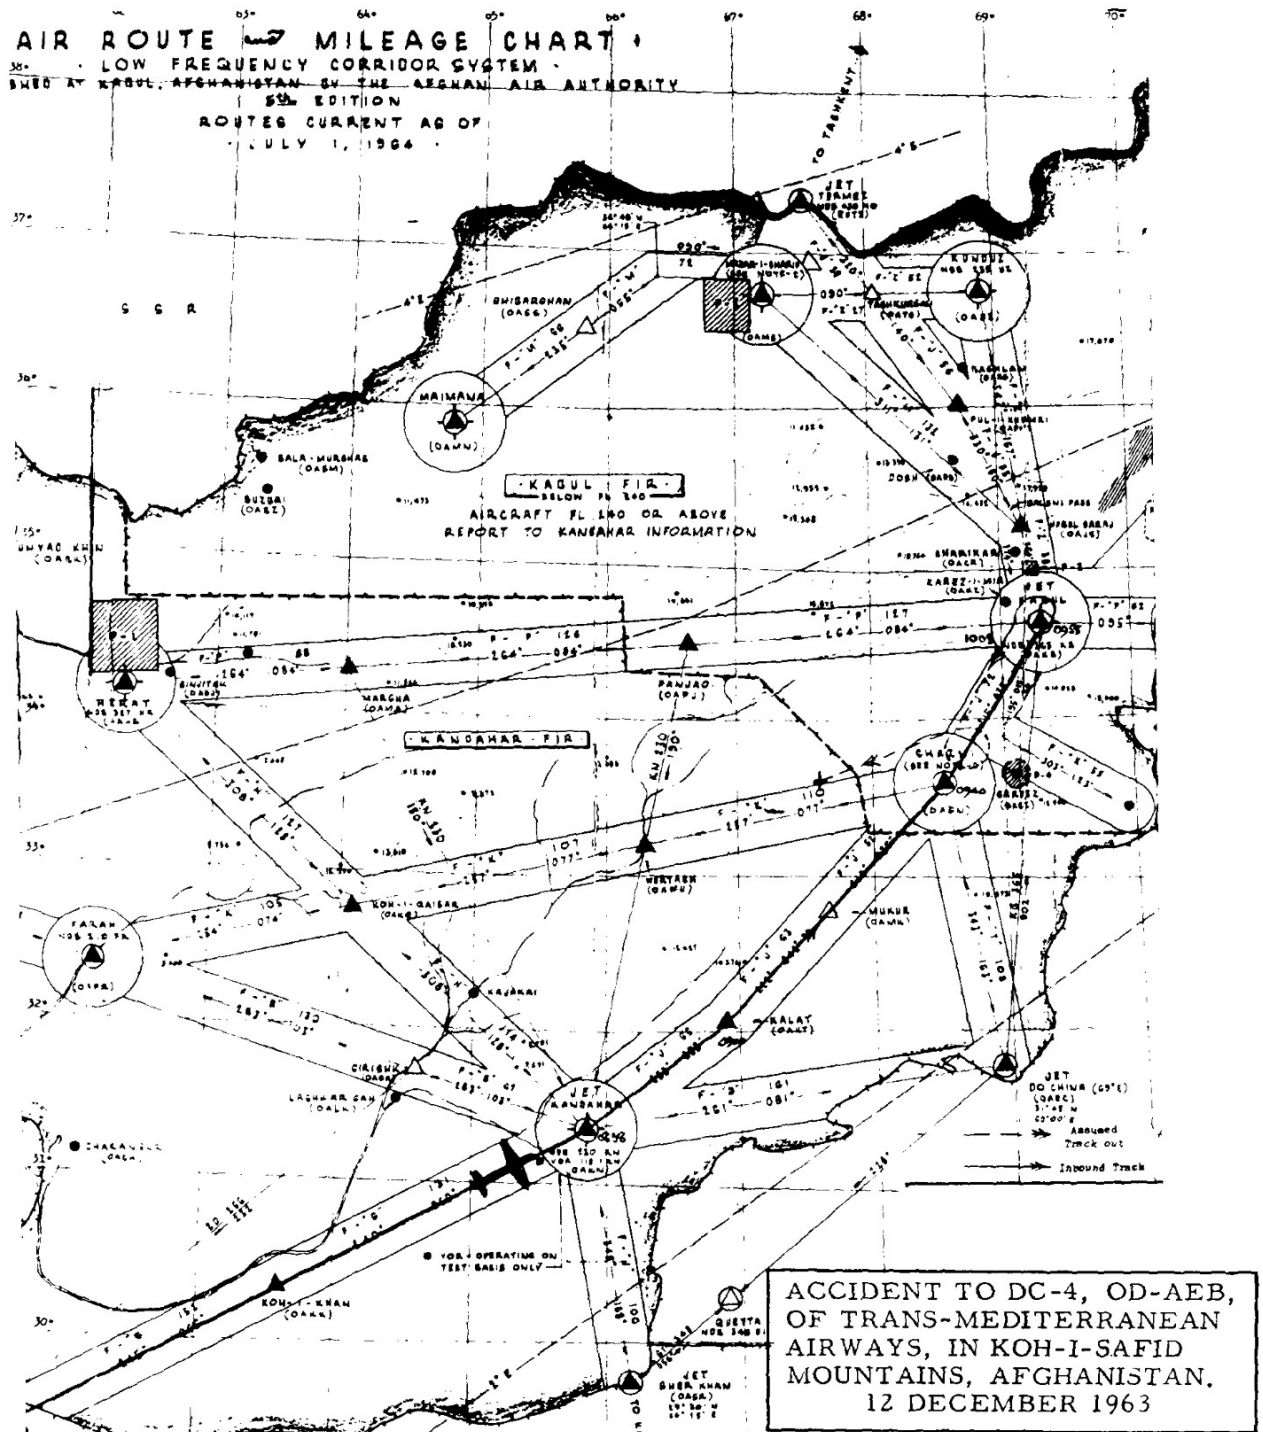
FIGURE 7

The aircraft was on a non-scheduled international cargo flight from Beirut, Lebanon to Kabul, Afghanistan via Kuwait, carrying a crew of three. The trip to Kuwait was uneventful, and it arrived there at 0036 hours GMT on 12 December. Departure from Kuwait for Kabul was at 0256 hours and the flight reported passing Kandahar at 0838 and Kalat at 0900 flying at flight level 110. While en route the aircraft was provided with the Kandahar and Kabul weather. At 0942 hours it reported passing Ghazni at 0940, flying at flight level 150 and estimated its arrival time at Kabul as 1010 hours. However, at 0958 (i. e. 12 minutes before ETA) it reported overhead Kabul and requested the latest weather situation which was provided. As the aircraft could not land at Kabul because of the weather conditions it reported at 0959 hours that it was diverting to Lahore. Shortly thereafter it reported it was proceeding to Zahedan via Ghazni (ETA 1025), Kandahar (ETA 1130) Zahedan (ETA 1315). It would maintain flight level 150 to Ghazni, 130 to Kandahar and 110 to Zahedan. At 1003 hours the Kabul tower passed the Kandahar weather to the flight and 5 minutes later the flight reported it was 25 miles out from Kabul, at flight level 150. The aircraft was then cleared by Kabul tower to route frequency and nothing further was heard from it. The wreckage of the aircraft was first sighted on 16 August 1964, after the snow had melted, at an elevation of 13 940 ft amsl in the Koh-i-Safid Mountains 50 NM west of Ghazni and 42 NM from the approved air route. The coordinates of the accident site were estimated to be 33° 37'N 67° 35'E (See Figure 7). The time of the accident was some time after 1015 hours GMT on 12 December 1963.

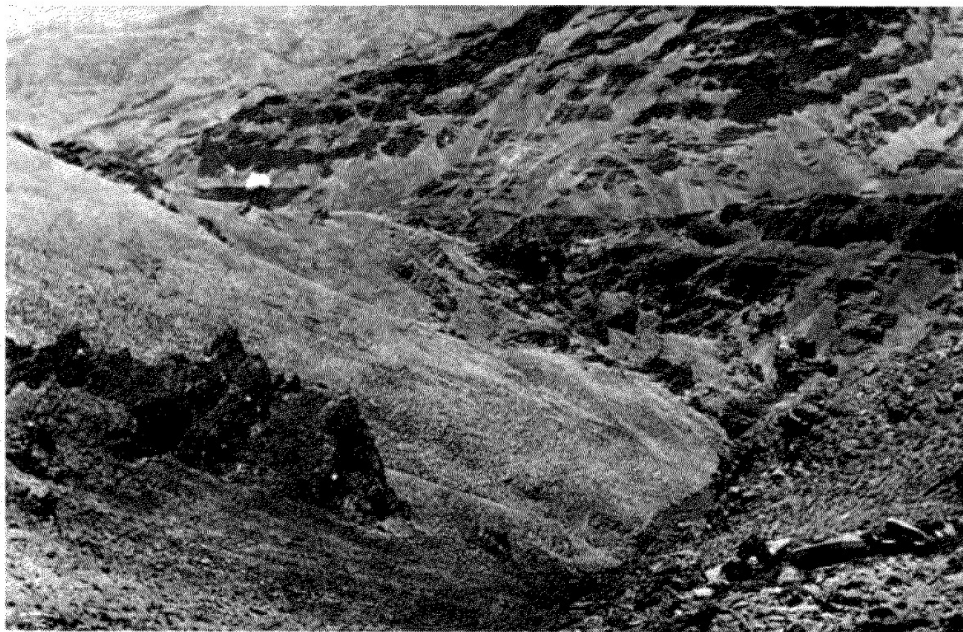
FIGURE 8

The aircraft wreckage was scattered over a wide area of mountainside (See Figures 8 and 9) at an elevation established by an altimeter as 13 940 ft amsl. The aircraft appeared to have struck the top of a ridge when flying in a southwesterly direction and to have disintegrated. It then fell down a steep slope on the other side of the ridge.

Aircraft struck ridge at 13940 feet (4250 metres) above sea level
and disintegrated.

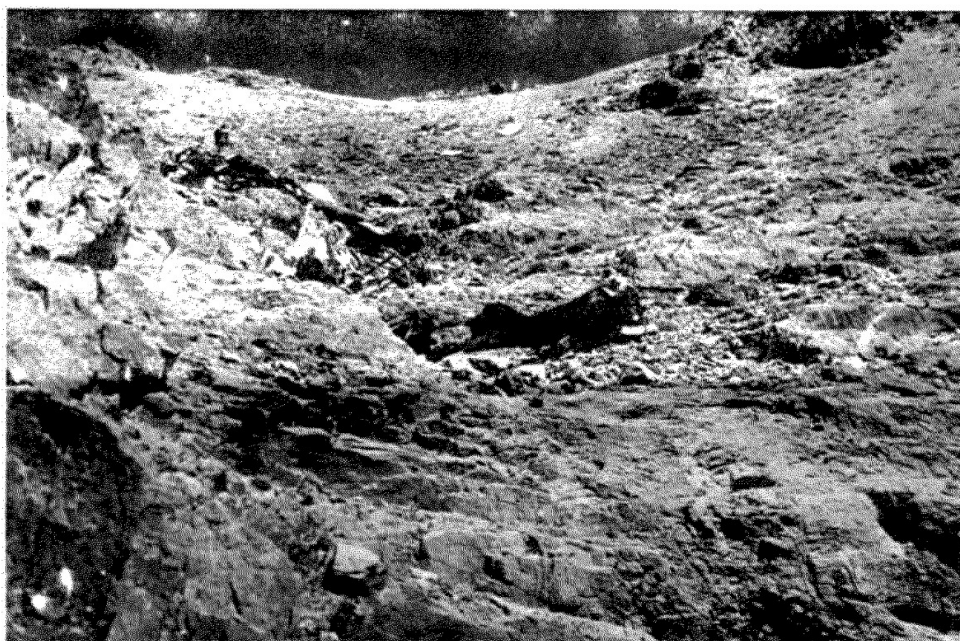
FIGURE 9

All four engines had broken away from the wings, and the propellers had broken away from the engines. The manner in which the propeller blades were bent by the impact indicated that the engines were developing power at the time of the accident. There were no signs that any one of the propellers had been feathered at impact. The fuselage had broken into many pieces.

Wreckage fell down steep slope on other side of ridge
