No. 22

Aer Lingus International Airlines Ltd., Vickers Viscount 808, EI-AKK,
accident at Bristol (Lulsgate) Airport, England, on 21 September
1967. Civil Accident Report No. EW/C/0187, released by the
Board of Trade, United Kingdom, on 20 December 1968.
C.A.P. 313

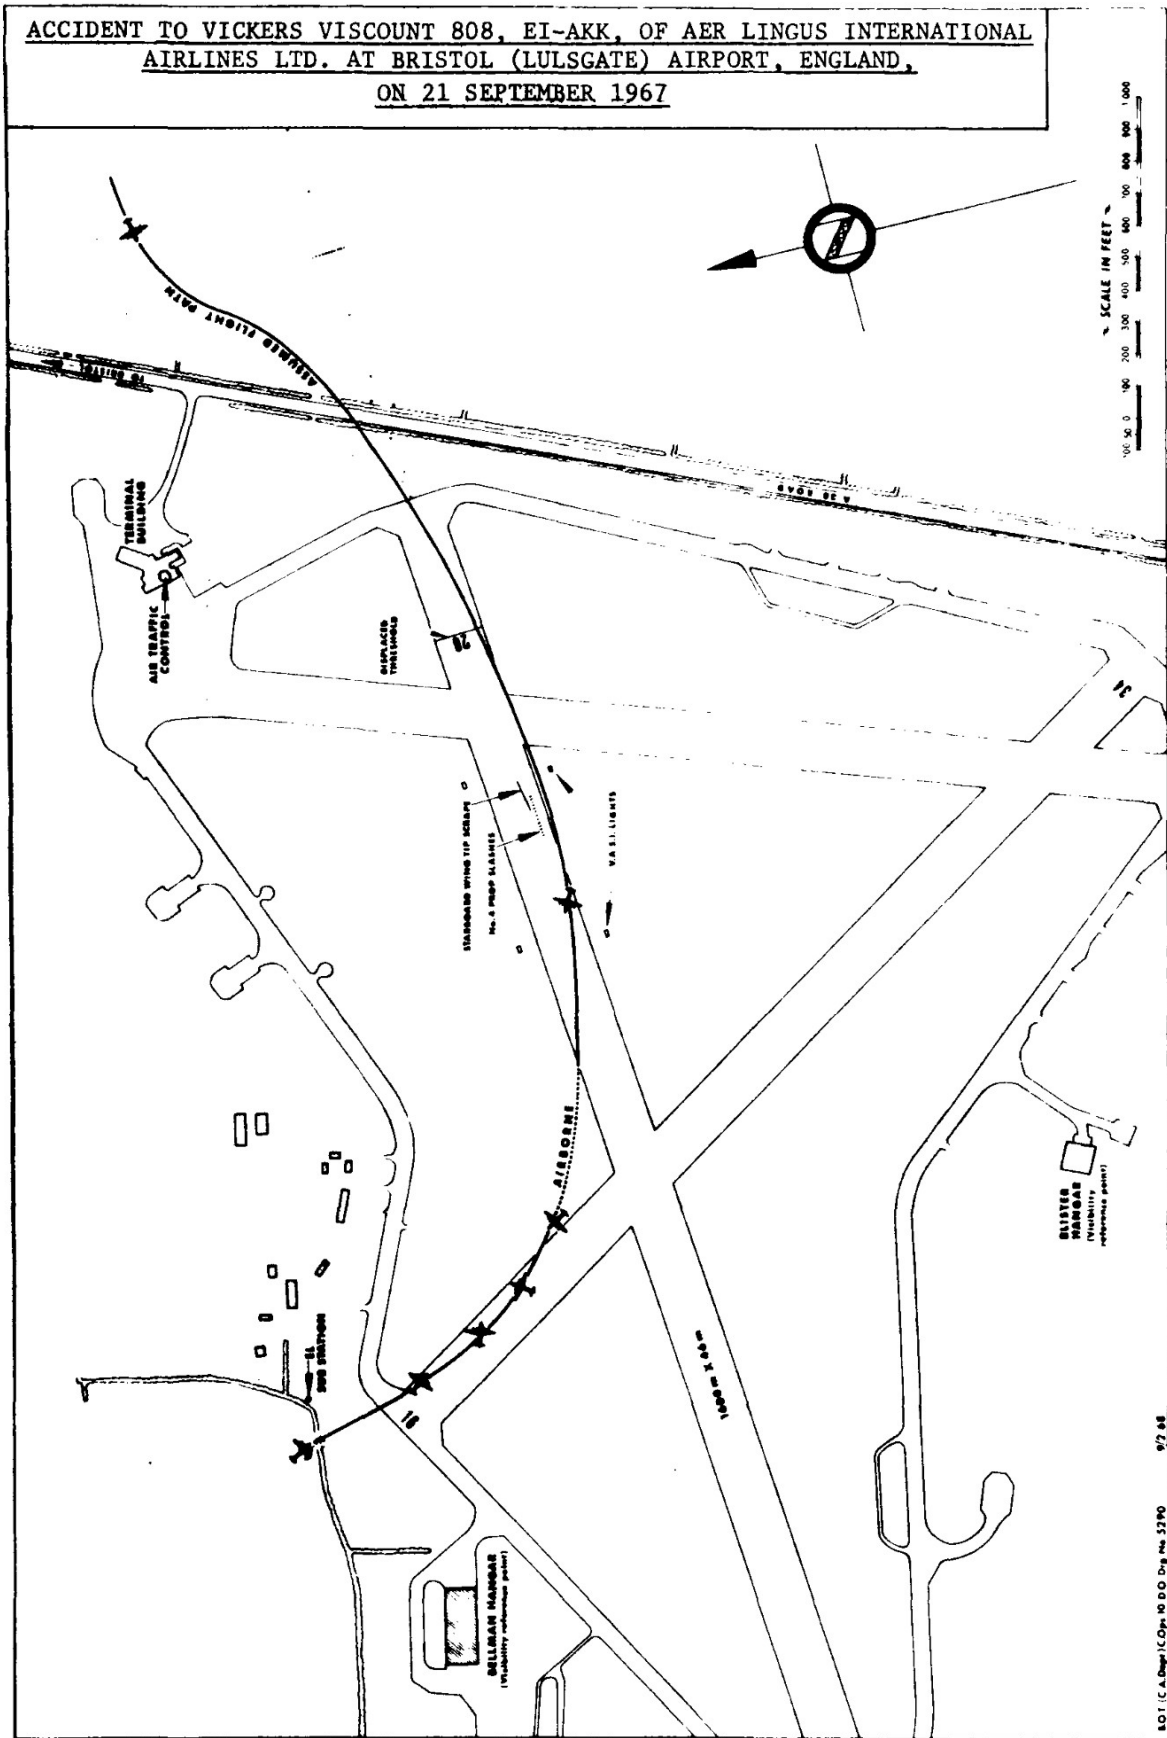
Fig. 22-1

ACCIDENT TO VICKERS VISCOUNT 808, EI-AKK, OF AER LINGUS INTERNATIONAL AIRLINES LTD. AT BRISTOL (LULSGATE) AIRPORT, ENGLAND, ON 21 SEPTEMBER 1967
