British Eagle International Airlines Ltd., Bristol Britannia 308,
G-ANCC, accident at Manston Aerodrome, Kent, United Kingdom, on
20 April 1967. Accident report No. EW/E/04, undated, released by
the Board of Trade, United Kingdom, C.A.P. 301

ACCIDENT TO BRISTOL BRITANNIA 308, G-ANGA, OF BRITISH EAGLE INTERNATIONAL AIRLINES LTD., AT MANSTON AERODROME, KENT, UNITED KINGDOM, ON 20 APRIL 1967.

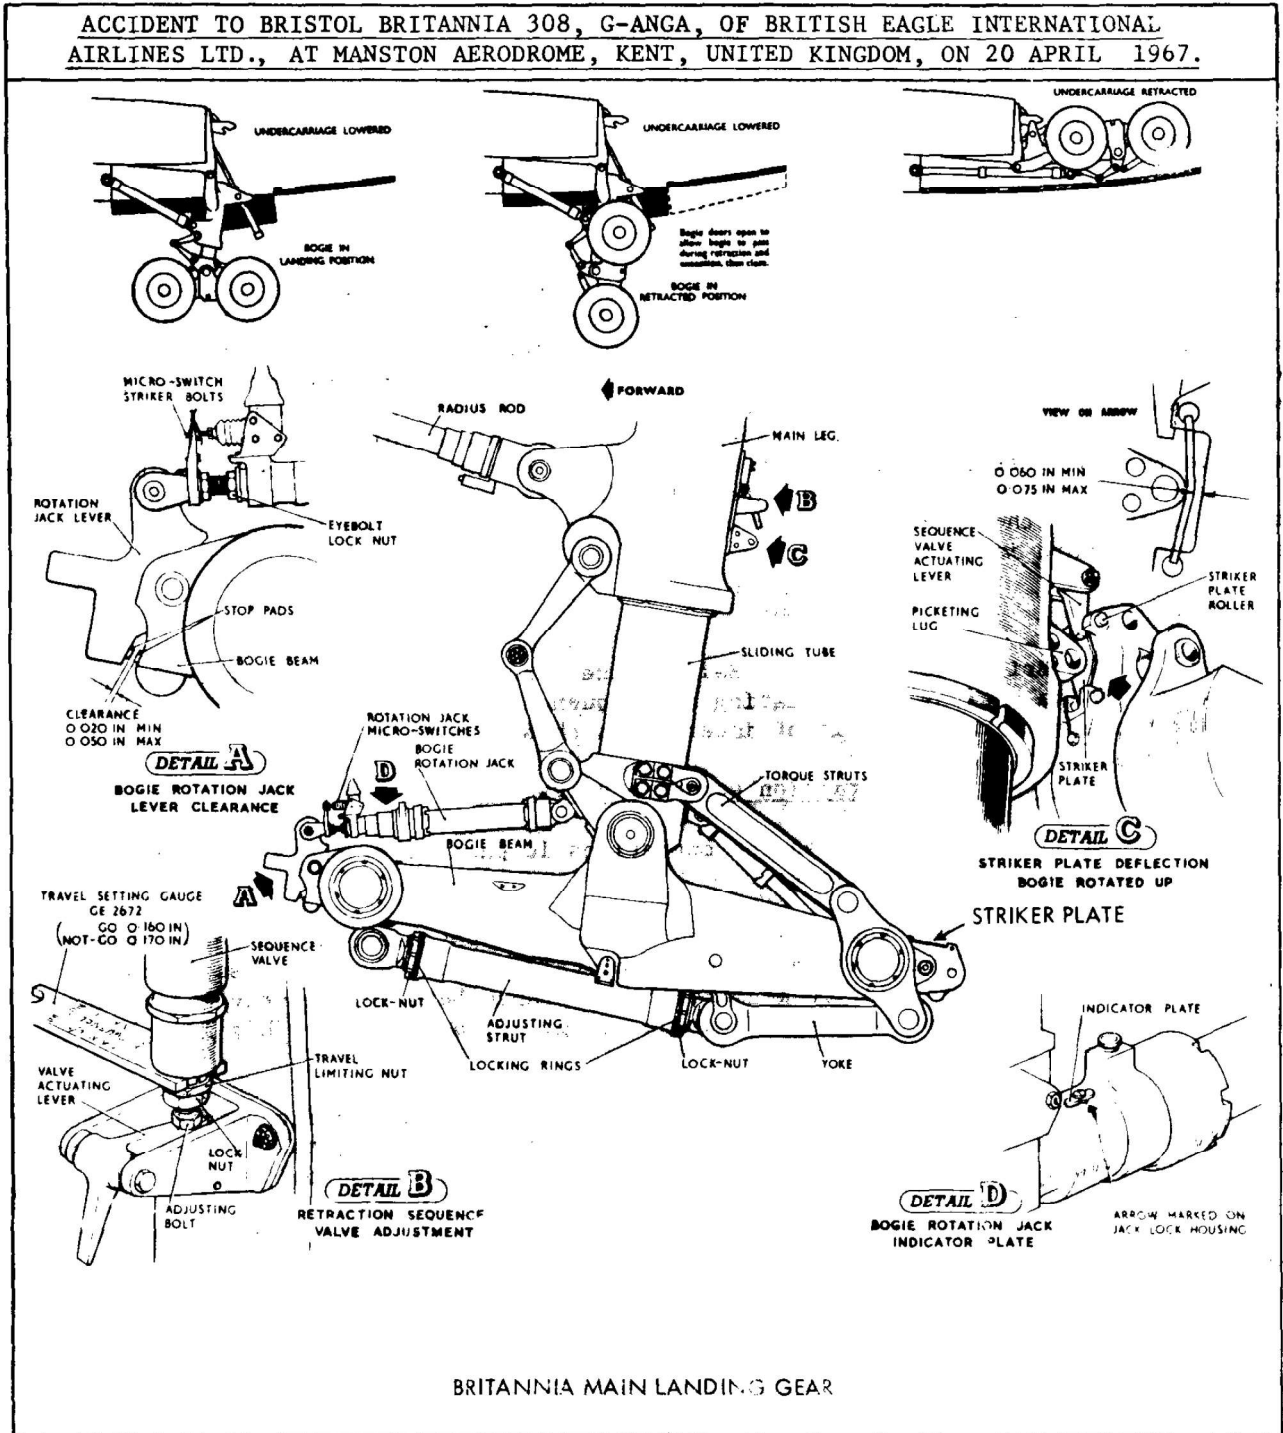
BRITANNIA MAIN LANDING GEAR

- (a) the bogie rotation jack being fully extended and locked;
- (b) the striker plate on the bogie being deflected by the picketing lug and producing a clearance between the plate and the adjacent face of the bogie beam of 0.060 to 0.075 in (see Appendix 2).

A check revealed that the clearance was in excess of 0.140 in; this resulted in the striker plate roller imparting insufficient movement to the sequence valve actuating lever, which in turn led to incorrect setting of the overtravel dimension of the sequence valve. This incorrect setting would have been detected if the sequence valve setting had been checked with the bogie horizontal as required by the Britannia Series 300 Maintenance Manual, Section 3, Chapter 5, paragraph 51 (3) and (4).

An excess clearance between the striker plate and the adjacent face of the bogie beam, as noted above, is corrected by increasing the length of the rotation jack by screwing the eye out of the piston rod. When this was attempted it was found that the eye end of the jack assembly could be moved easily without loosening the locknut, which was wire-locked; the eye could be screwed out $\frac{1}{4}$ turn without disturbing the locknut. This was done and the bogie was returned to 'tiptoe'; the striker plate clearance was now found to be 0.110 in and the resulting overtravel dimension of the sequence valve 0.153 in, that is, less than the minimum where previously it had been more than the maximum.
