AIRCRAFT ACCIDENT REPORT

**MOHAWK AIRLINES, INC.
FAIRCHILD HILLER FH-227B, N7811M
NEAR GLENS FALLS, NEW YORK
NOVEMBER 19, 1969**

Adopted: June 25, 1970

Report Number: NTSB-AAR-70-12

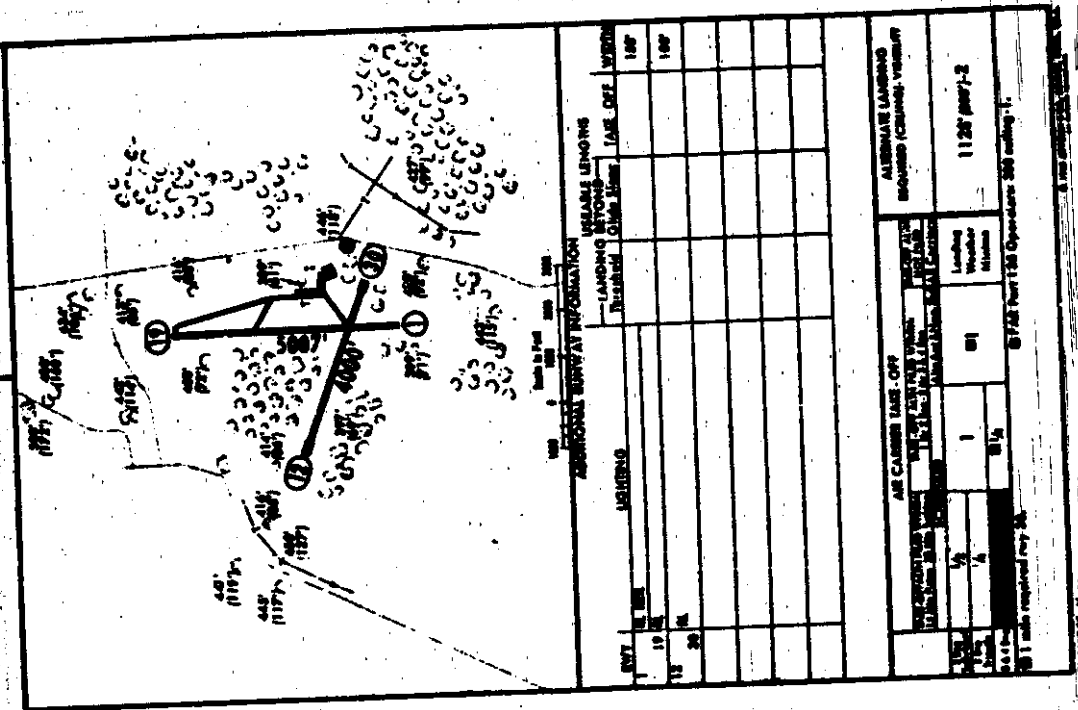
**APPROXIMATE FLIGHT TRACK
BASED ON FLIGHT RECORDER DATA**

MO-411 did not descend at Miller Intersection. The flight data recorder shows that MO-411 continued on to Glens Falls VORTAC at an altitude of 3,000 feet and on a 006° heading. Over the airport, the aircraft make a slight right followed by a slight left turn. During the left turn, the airspeed reduced from 164 knots to 152 knots. The aircraft then returned to and continued on the 006° heading for approximately 1 minute and 15 seconds (7 NM DME), at which time a reversal in course was initiated.
