**AIRCRAFT ACCIDENT REPORT
WESTERN AIR LINES, INC.
BOEING 720-047B, N3166
ONTARIO INTERNATIONAL AIRPORT
ONTARIO, CALIFORNIA
MARCH 31, 1971**

NATIONAL TRANSPORTATION SAFETY BOARD

REPORT NUMBER: NTSB-AAR-72-18

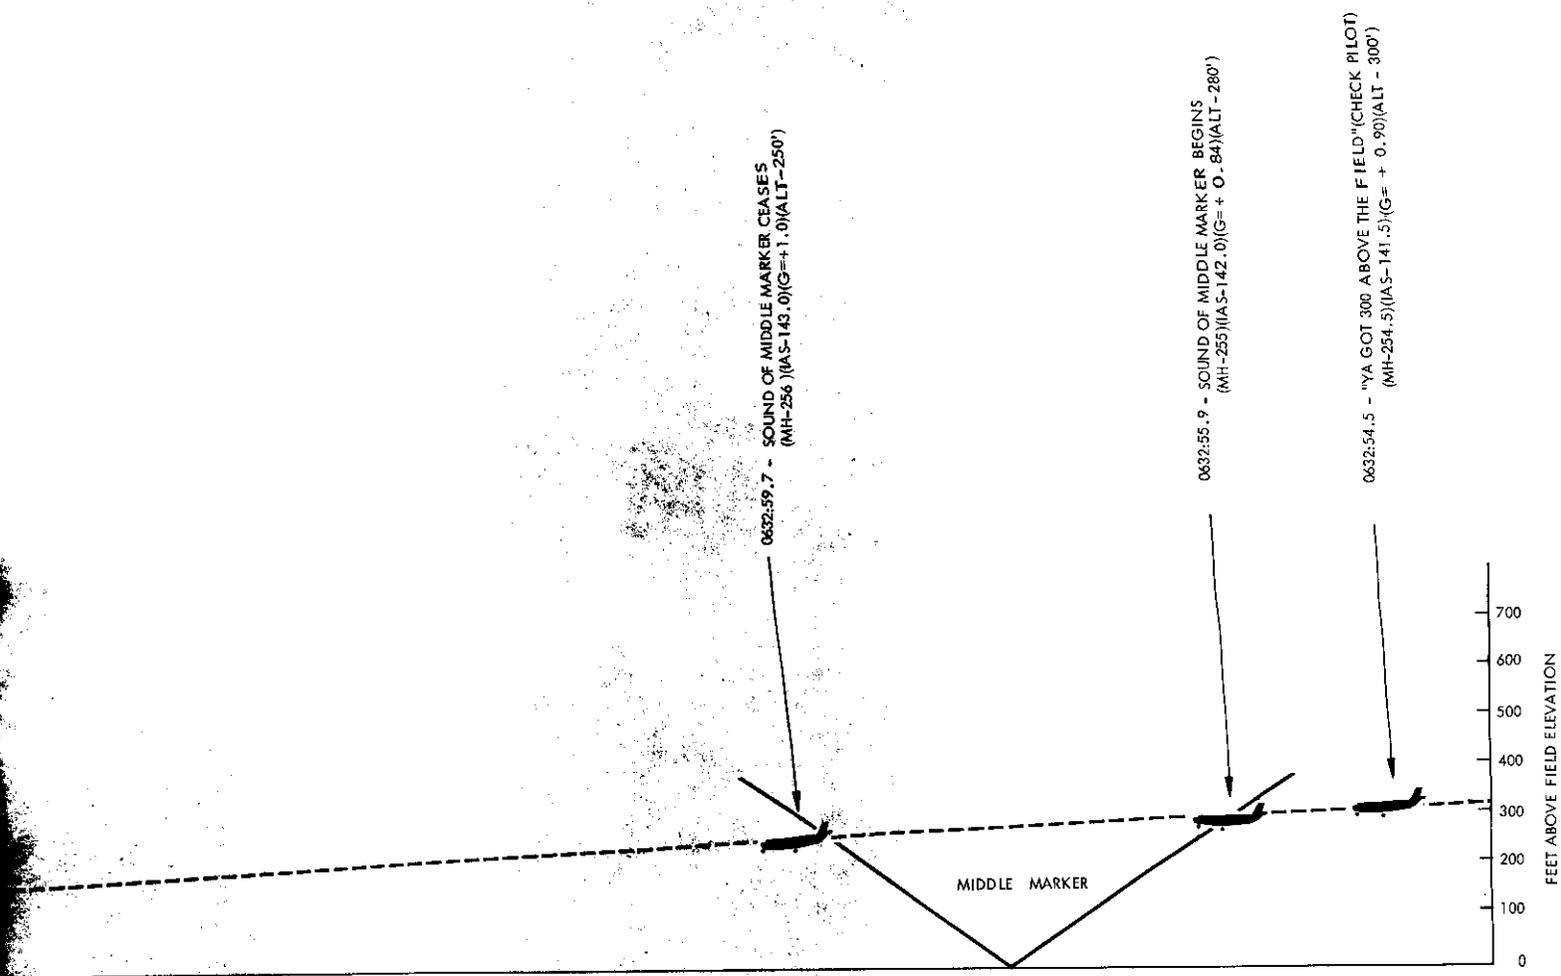
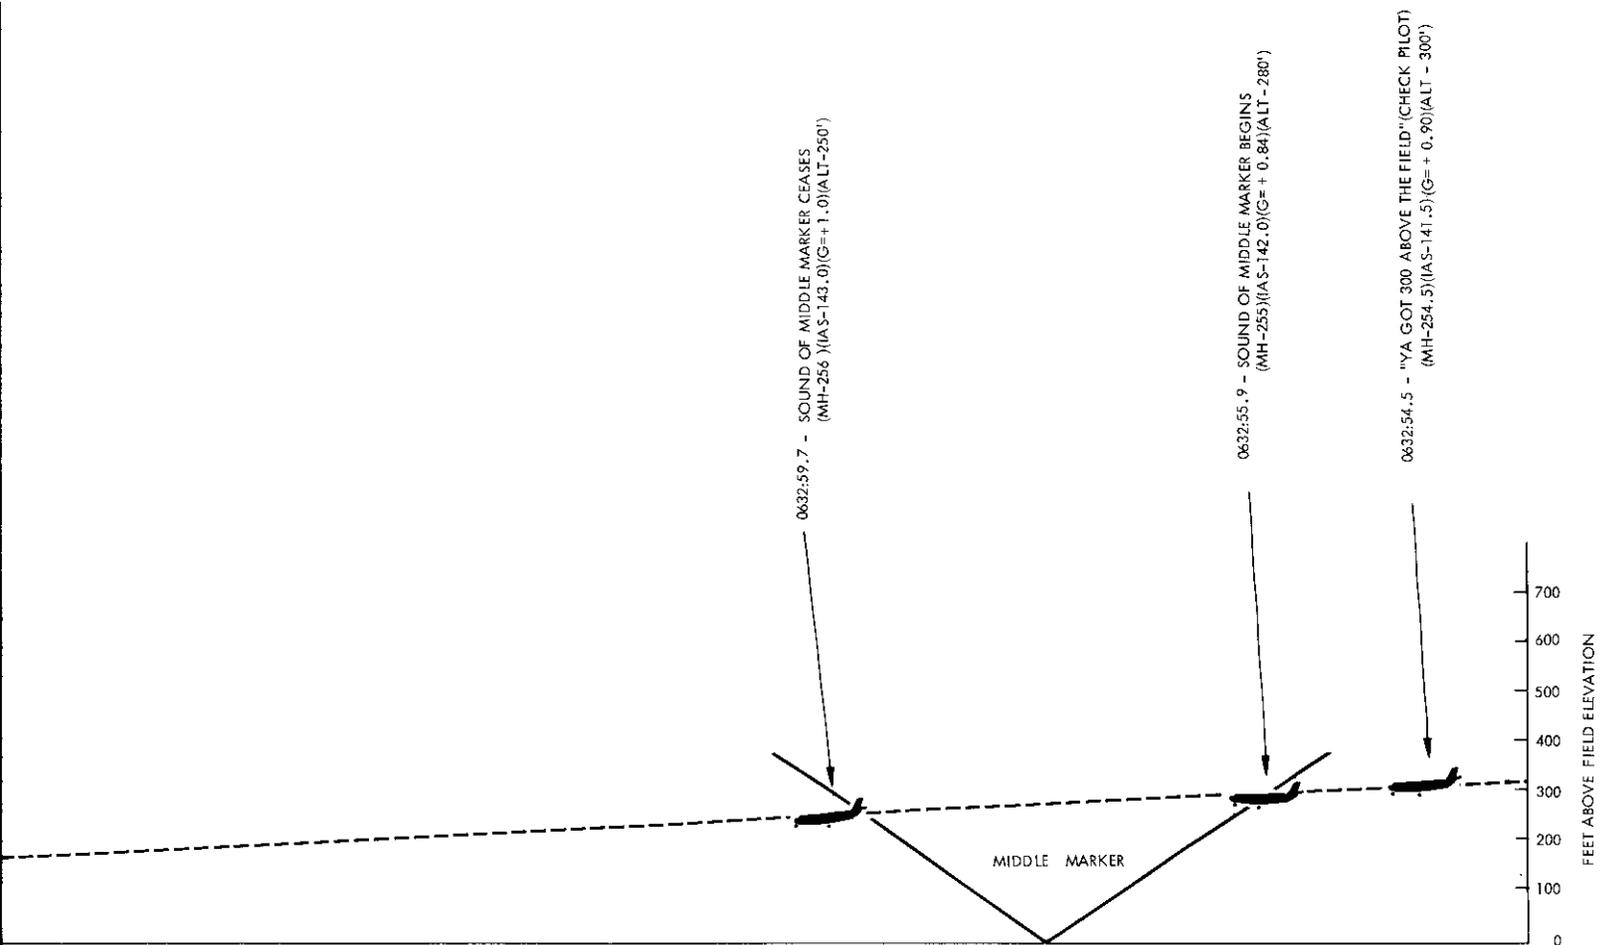
**PROBABLE FLIGHT PATH
WESTERN AIRLINES, INC.
BOEING 720-047B, N3166
ONTARIO, CALIFORNIA
March 31, 1971**

1. FLIGHT PATH IS PREDICATED ON THE CORRELATION OF WITNESS TESTIMONY, FLIGHT RECORDER TRACES AND THE VOICE RECORDER
2. DATA REFLECTING MAGNETIC HEADING, INDICATED AIR SPEED, ACCELERATION, AND ALTITUDE IS AS DEPICTED BY THE FLIGHT DATA RECORDER

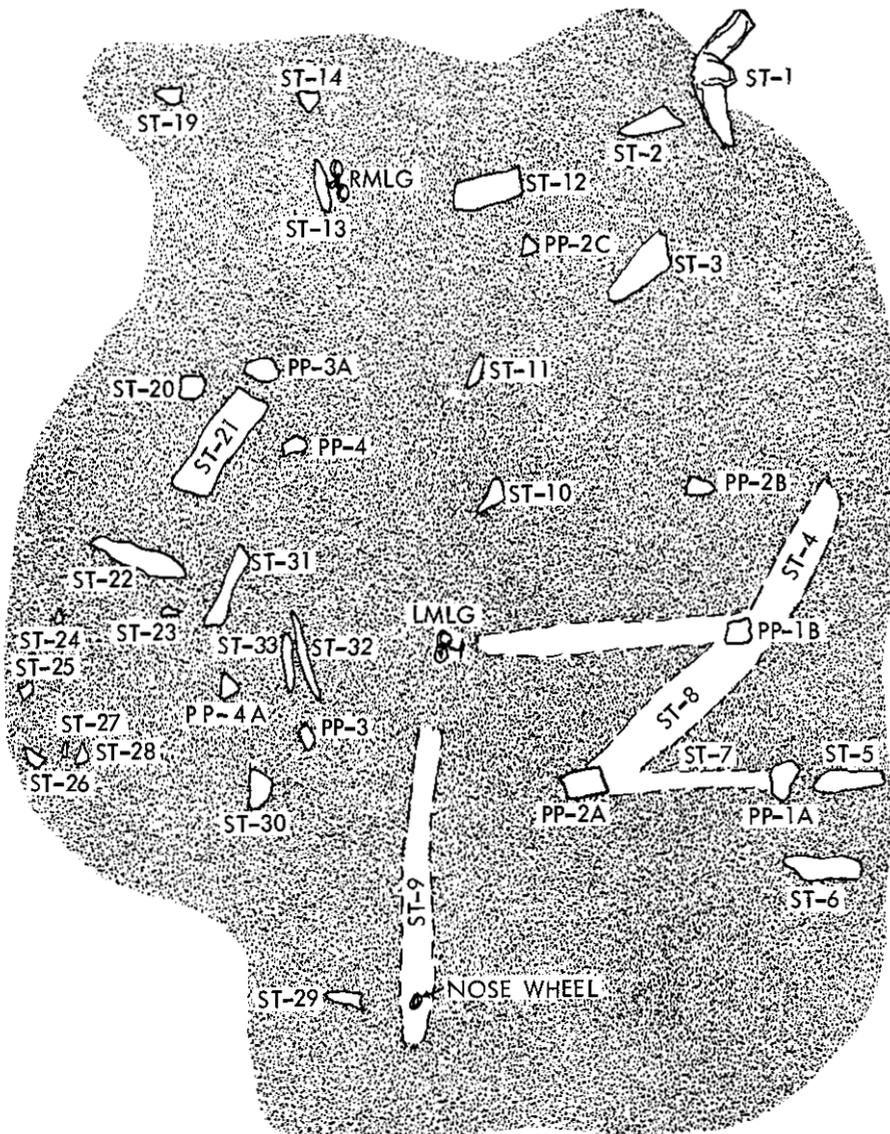
WRECKAGE SITE [Not to Scale]

- ST 28: Section of fuselage with Indian insignia
- ST 29: Section of fuselage
- ST 30: Service door assembly, No. 50-7910-9
- ST 31: Right outboard flap section

- ST 32: Section of leading edge and leading edge flap
- ST 33: Section of right wing leading edge flap
