**DELTA AIR LINES, INC. MCDONNELL DOUGLAS  
DC-9-32, N3323L, CHATTANOOGA MUNICIPAL  
AIRPORT, CHATTANOOGA, TENNESSEE**

**NATIONAL TRANSPORTATION SAFETY BOARD,  
WASHINGTON, D.C**

1. Report No. NTSB-AAR-74-13	2. Government Accession No.	3. Recipient's Catalog No.	
4. Title and Subtitle Aircraft Accident Report - Delta Air Lines, Inc., Douglas DC-9-32, N3323L, Chattanooga Municipal Airport, Chattanooga, Tennessee, November 27, 1973		5. Report Date November 8, 1974

# AIRCRAFT ACCIDENT REPORT

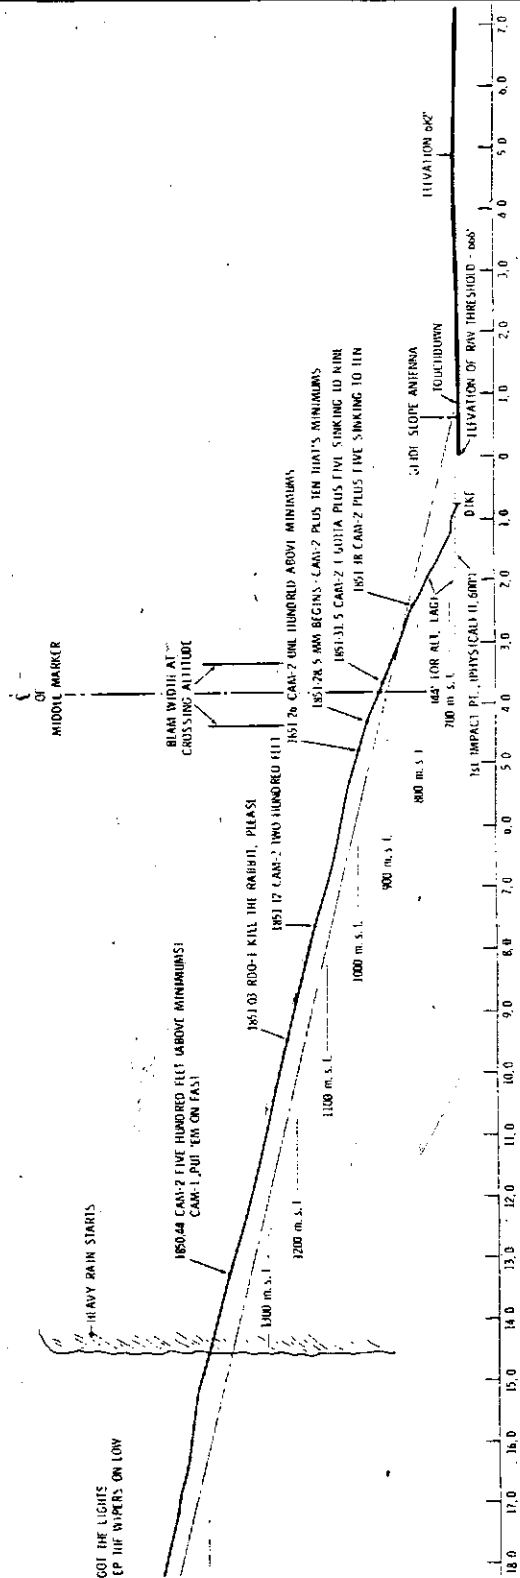
APPROACH PROFILE  
 DELTA AIR LINE, DOUGLAS DC-9, N3323L  
 FLT. 516, CHATTANOOGA, TENN.  
 NOVEMBER 27, 1973  
 (COMBINED F.D.R., C.Y.R., COMPUTER PLOT)

ELEVATION	WIND DIRECTION (DEG)	VELOCITY (KNOTS)
4,000 FT	195°	41
3,000 FT	185°	55*
2,000 FT	185°*	37.5
1,000 FT	180°	15.5
SURFACE	160°	1 TO 4
