# National Transportation Safety Board Aviation Accident Final Report

<b>Location:</b>	Camilla, GA	<b>Accident Number:</b>	ERA17FA066
<b>Date &amp; Time:</b>	12/05/2016, 2222 EST	<b>Registration:</b>	N765FA
<b>Aircraft:</b>	FAIRCHILD SA227	<b>Aircraft Damage:</b>	Destroyed
<b>Defining Event:</b>	Loss of control in flight	<b>Injuries:</b>	1 Fatal
<b>Flight Conducted Under:</b>	Part 135: Air Taxi & Commuter - Non-scheduled

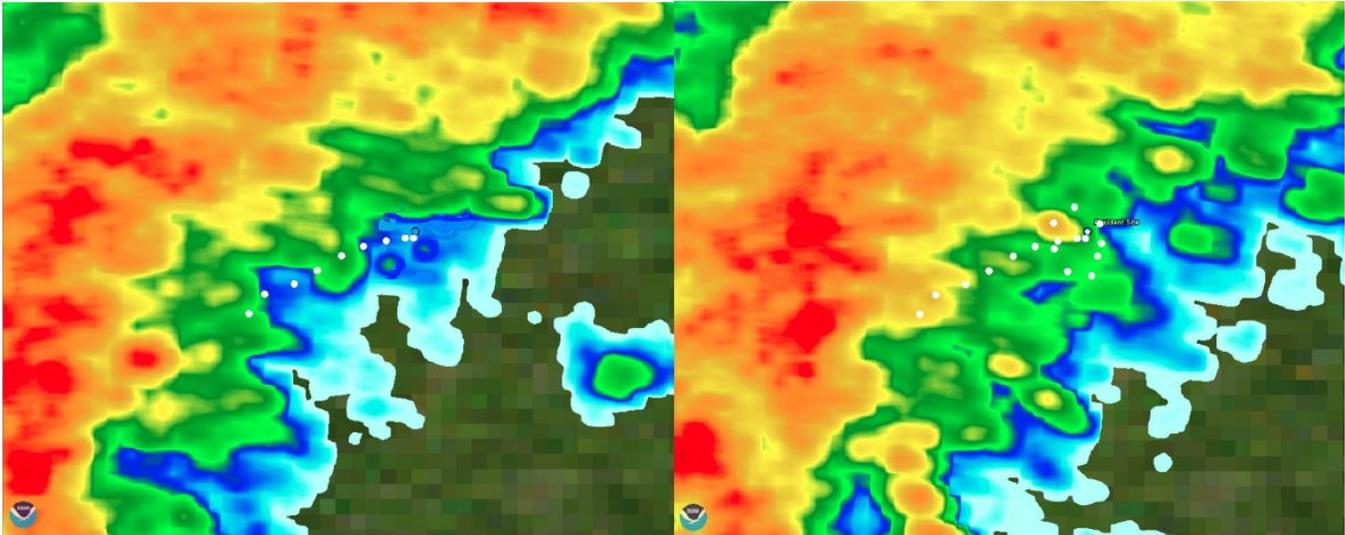
The KTLH WSR-88D base reflectivity image for the 0.5° elevation scan at 2221:47 (see Figure 1) showed the accident flight as it tracked along the leading edge of a line of heavy-intensity echoes, and operating in echoes of 5 to 20 dBZ, or light intensity precipitation. The next base reflectivity image for the 0.5° elevation scan at 2228:12 showed rapidly-developing echoes over the preceding flight track (which ended at 2222:24 in the vicinity of the accident site), with intensities of up to 43.5 dBZ or heavy-intensity precipitation.

Figure 1 - WSR-88D 0.5° base reflectivity image at 2221:47 (left) and 2228:12 (right) with radar-derived flight track overlaid (white dots).

The base reflectivity image for the 0.5° elevation scan at 2234:39 continued to show echoes increasing in intensity over the accident site with reflectivity values between 40 and 52 dBZ, or heavy to extreme intensity. Several small bowing segments were also indicated to the southwest.
