1. Report No. NTSB-AAR-76-9		2. Government Accession No.		3. Recipient's Catalog No.	
4. Title and Subtitle Aircraft Accident Report - Aerotransportes Entre Rios S.R.L. Canadair CL-44-6, LV-JSY, Miami International Airport, Miami, Florida, September 27, 1975		5. Report Date March 10, 1976		6. Performing Organization Code

AIRCRAFT ACCIDENT REPORT

AEROTRANSPORTES ENTRE RIOS S.R.L.
CANADAIR CL-44-6, LV-JSY
MIAMI INTERNATIONAL AIRPORT
MIAMI, FLORIDA
SEPTEMBER 27, 1975

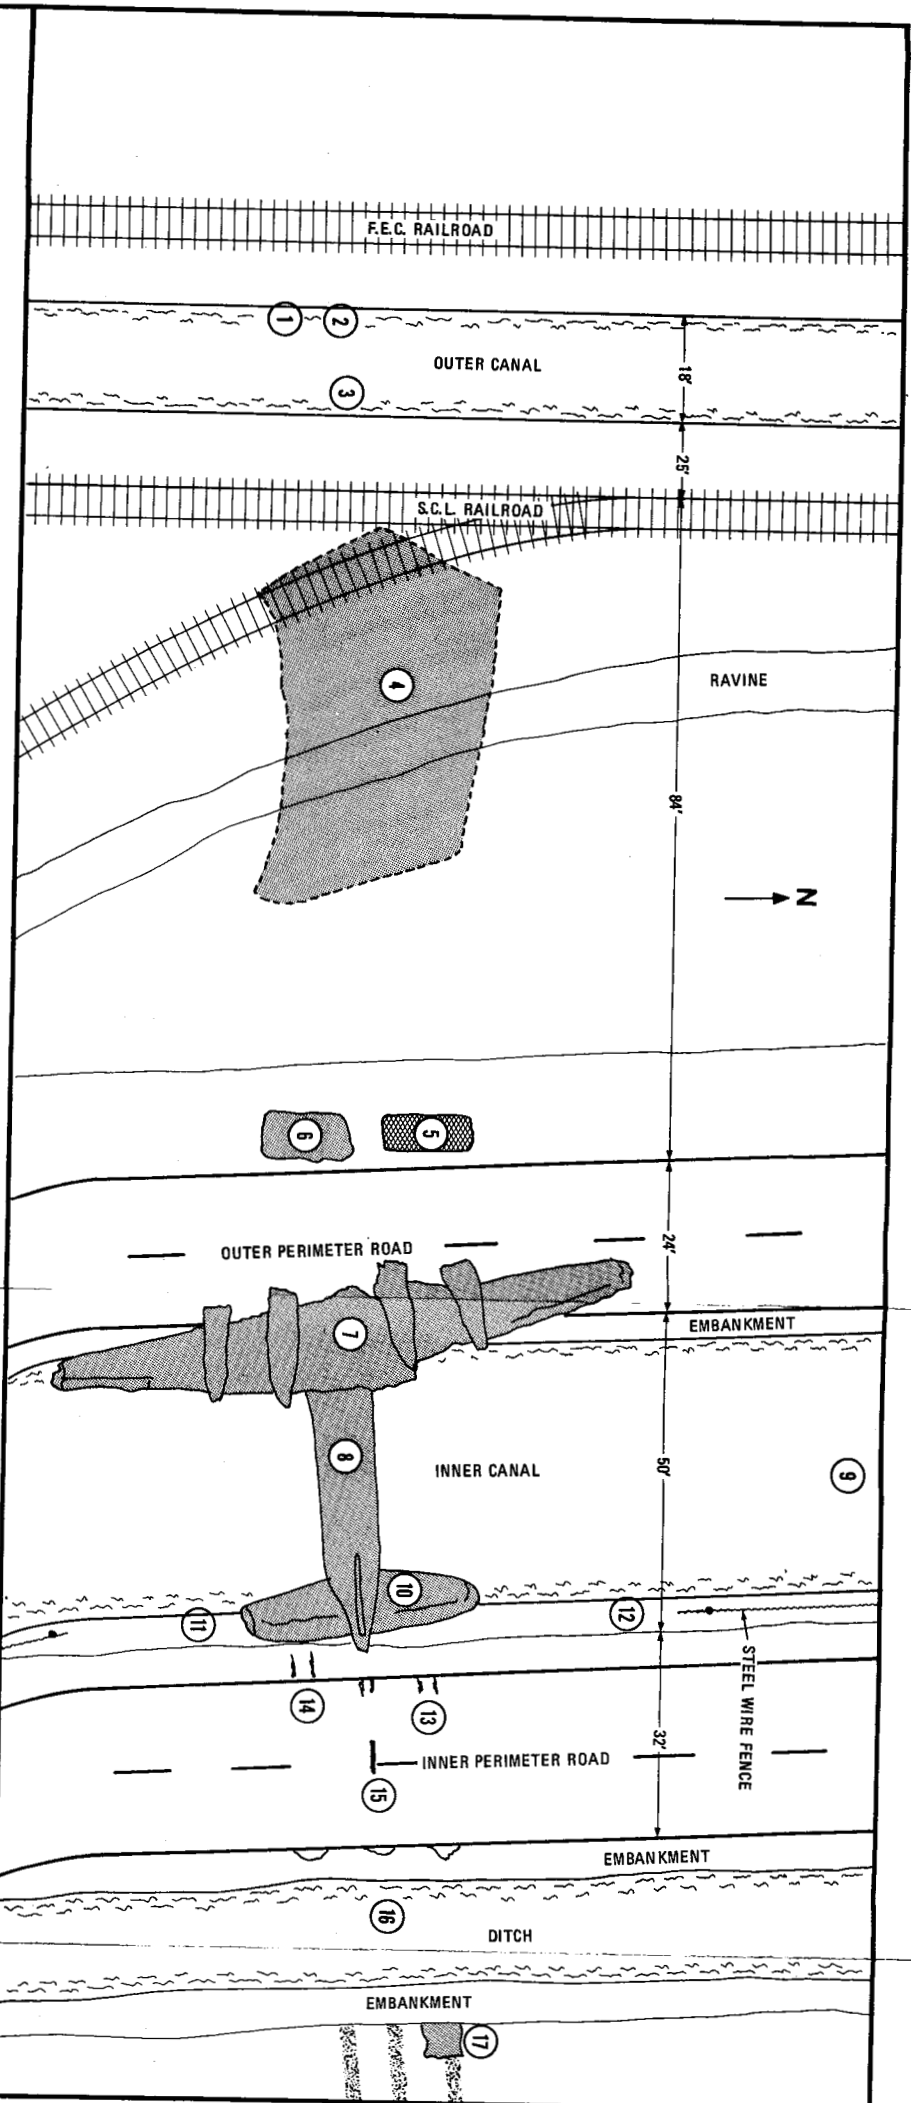
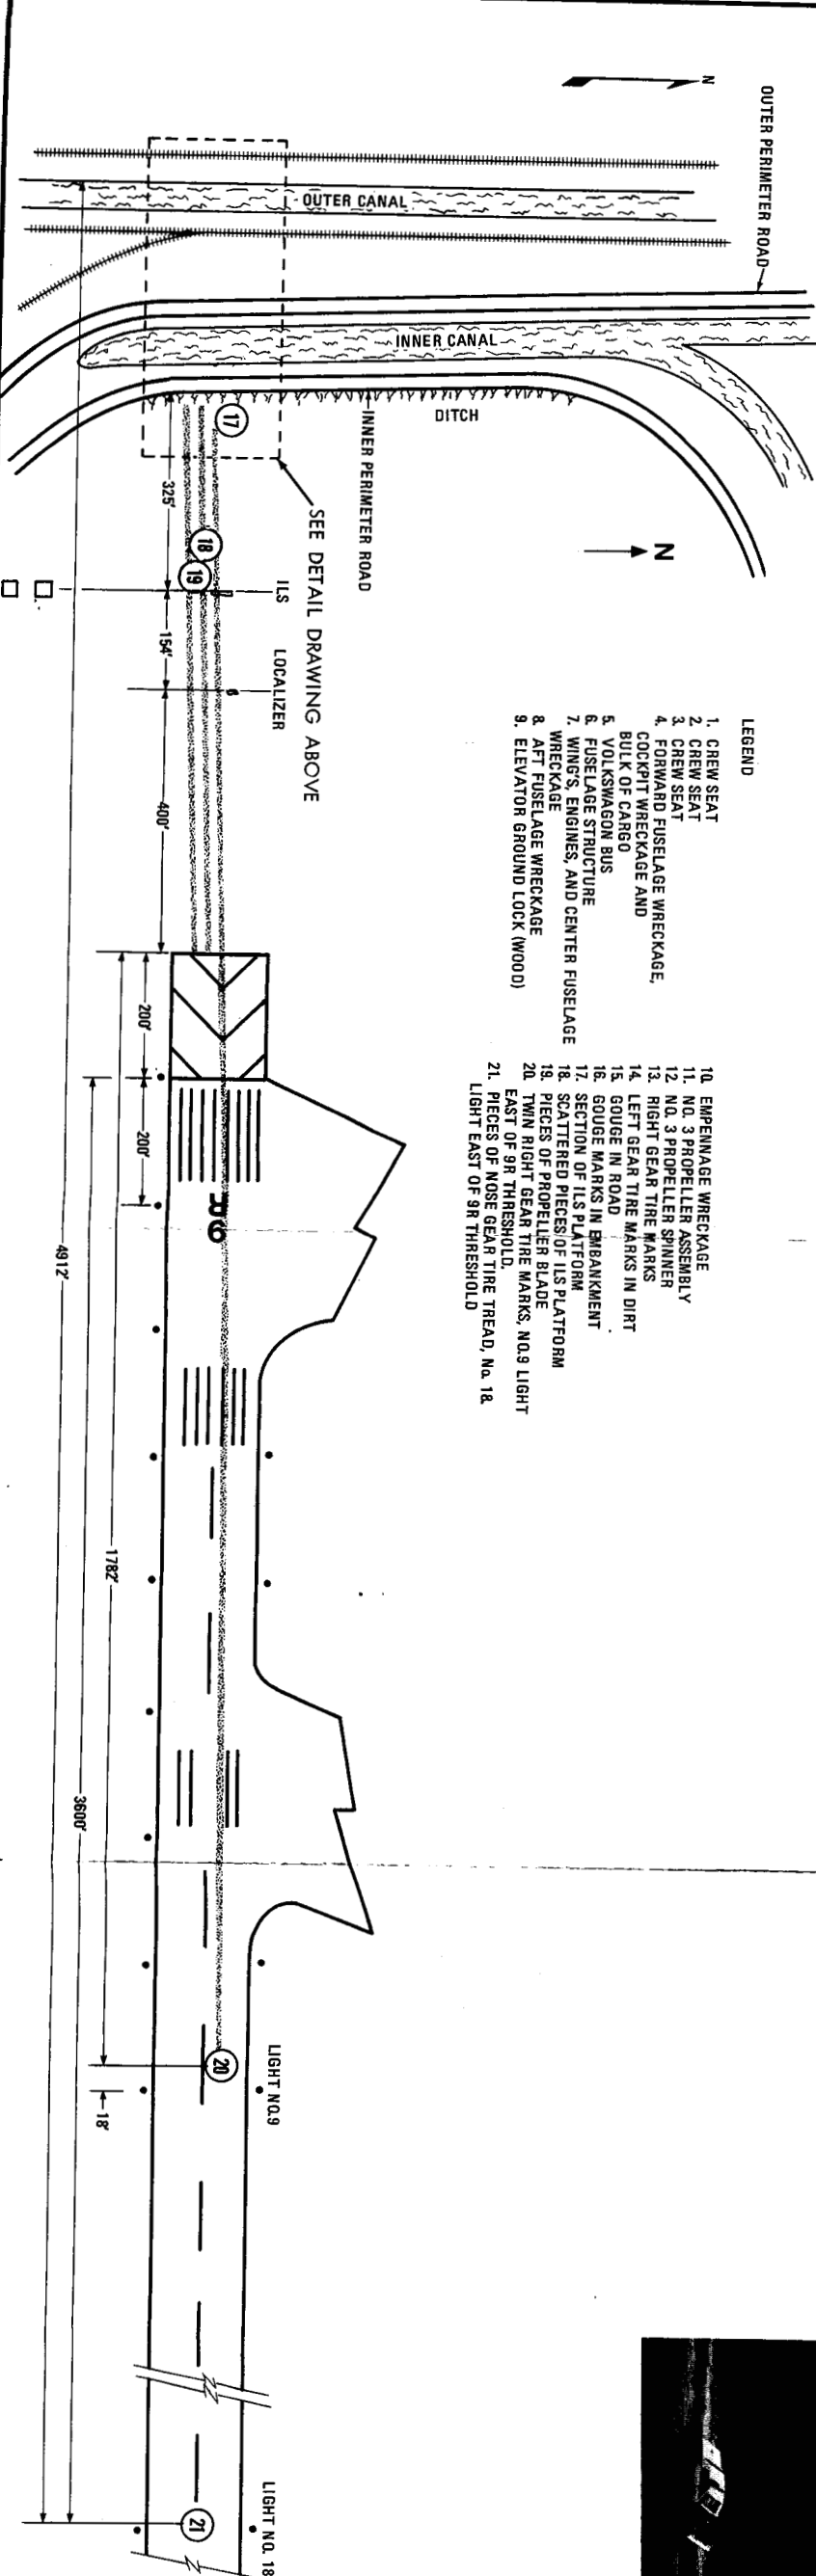
WRECKAGE DISTRIBUTION CHART
AEROTRANSPORTES ENTRE RIOS
CANADAI R CL-44-6, LV-JSY, S/N106925
MIAMI INTERNATIONAL AIRPORT
MIAMI, FLORIDA
SEPTEMBER 27, 1975
DCA 76-AZ-005

The empennage came to rest on the east bank of a canal 961 ft. from the departure end of the runway. The fuselage was across the canal and the center section, wings and engines were on its west bank. The fuselage forward of the wing, the cargo in the cabin, and the occupants were found west of the canal. (See Appendix D.)
