ACCIDENT INVESTIGATION REPORT

**DH114 2E/A1 Aircraft VH-CLS,
near Cairns Airport,
Queensland,
on 23 October 1975**

Special Investigation Report 76-1

**Connair Pty Ltd
Heron DH114 2E/A1 Aircraft VH-CLS
near Cairns Airport, Queensland
on 23 October 1975**

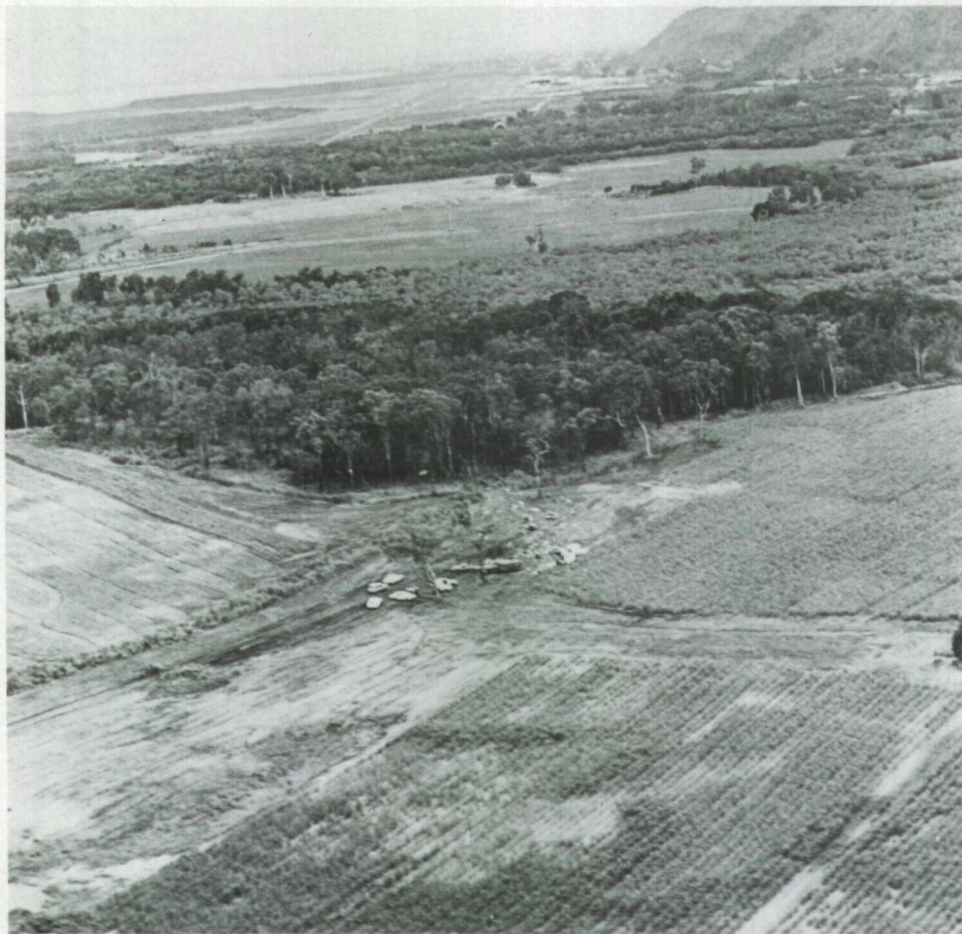
Accident Site (Airport in background)

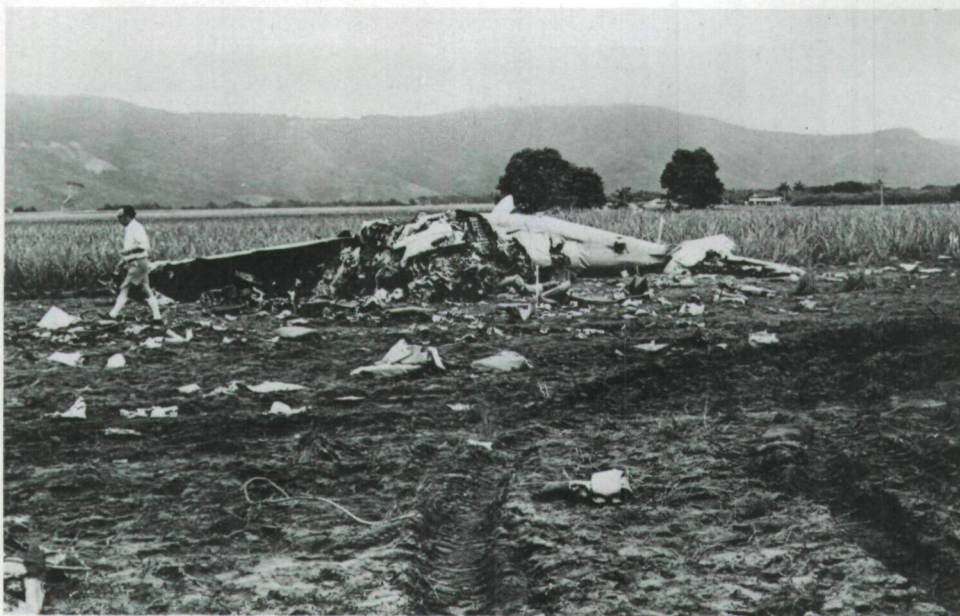
General view of main wreckage

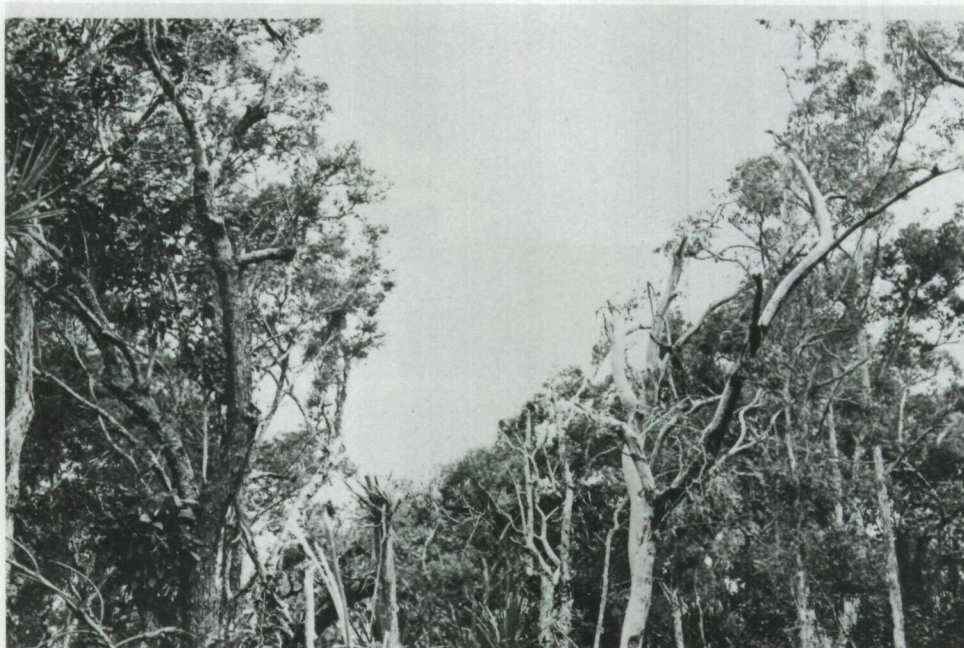
Large portions of both wings and part of the port tailplane were detached from the aircraft during its passage through the trees. The nature of this damage, and the damage to the trees, indicates that the aircraft was banked about 40° degrees right wing down and that it was descending along a flight path approximately 14° degrees below the horizontal in a normal flight attitude. There was no evidence of yaw.

Tree swathe viewed from ground impact point
