**BRITISH AIRWAYS TRIDENT G-AWZT
INEX ADRIA DC9 YU-AJR**

**Report on the collision in the Zagreb area,
Yugoslavia, on 10 September 1976**

**REPORT ON THE ACCIDENT OF
THE TRIDENT THREE AIRCRAFT, G-AWZT
AND THE DC-9 AIRCRAFT, YU-AJR
ABOVE ZAGREB VOR**

BEOGRAD 25 December 1976

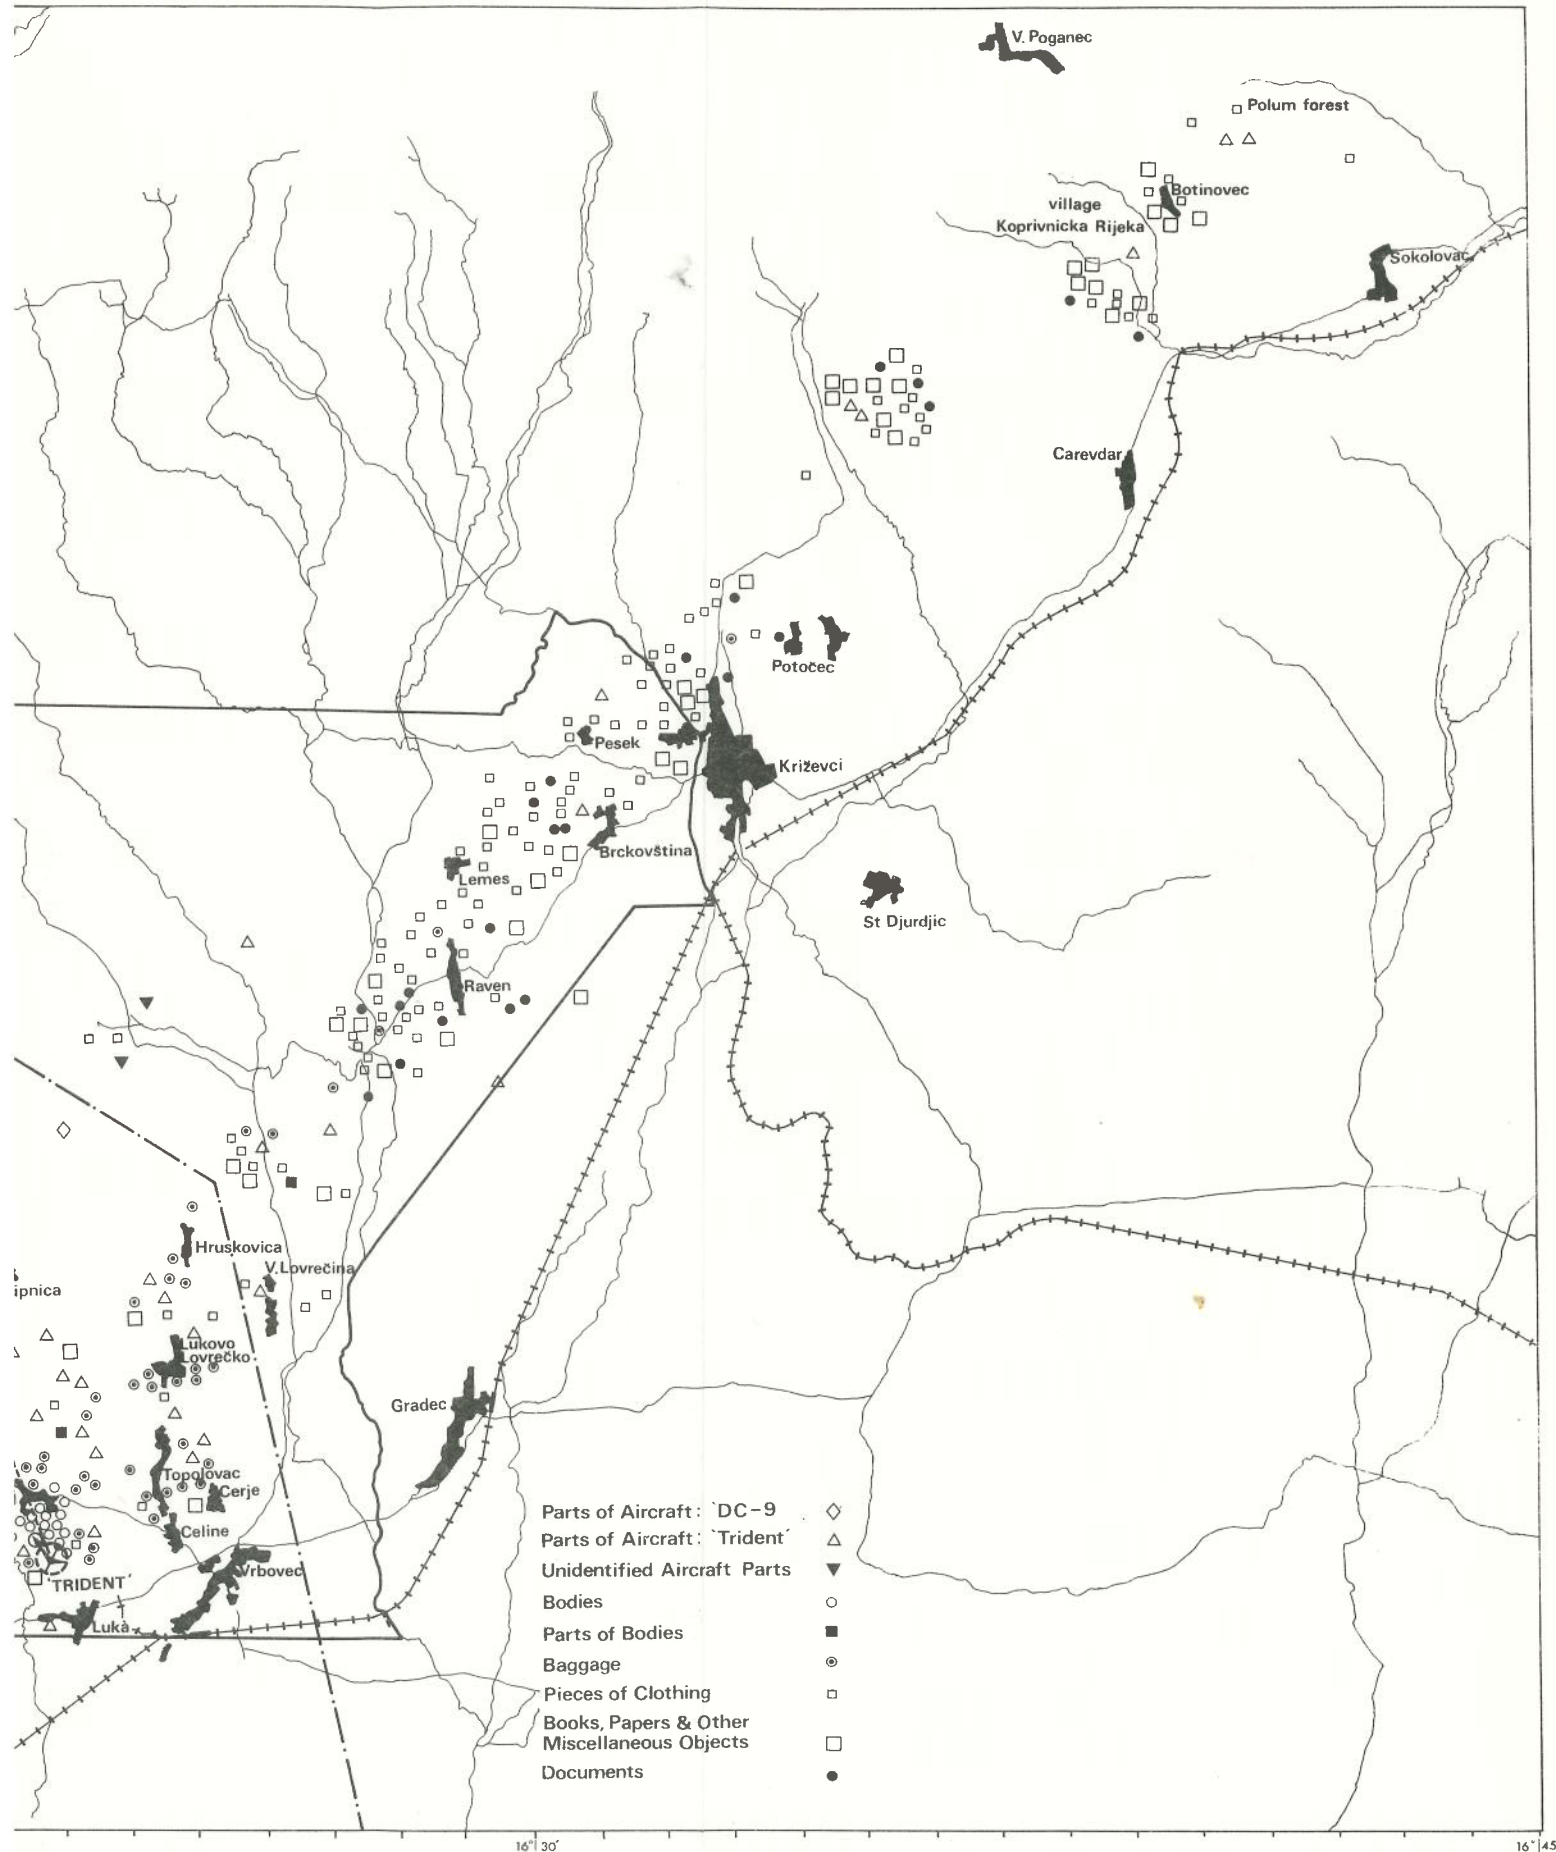
Map Showing Position of Wreckage

Many small and large parts of the aircraft and heavier passenger baggage were found in the area between the places Krkac – Graberanec to the north and Pirakovec-Vrboveč to the south. Several bodies and parts of passenger bodies were also found (cf. Attachment No.3). With the assistance of the British representatives – experts, the pieces of wreckage which were found were identified as the parts of the Trident Three aircraft and these were mainly the parts of the disintegrated fuselage from 18 to 33rd frame and the top of the cockpit. Some major parts were taken away for the purpose of reconstruction of the air collision.

The area extended from north-east of Vrbovec to 8 km. north-east from Križevci. The direction of this area is north-east (40°) to a distance of 32 km. (Tiny pieces of paper were blown away by wind to a distance of 90 km.). This area is marked on the chart at a scale 1 : 50,000. Small and light items such as parts of clothes, documents, magazines, journals, books and other tiny pieces of paper were found in this area.

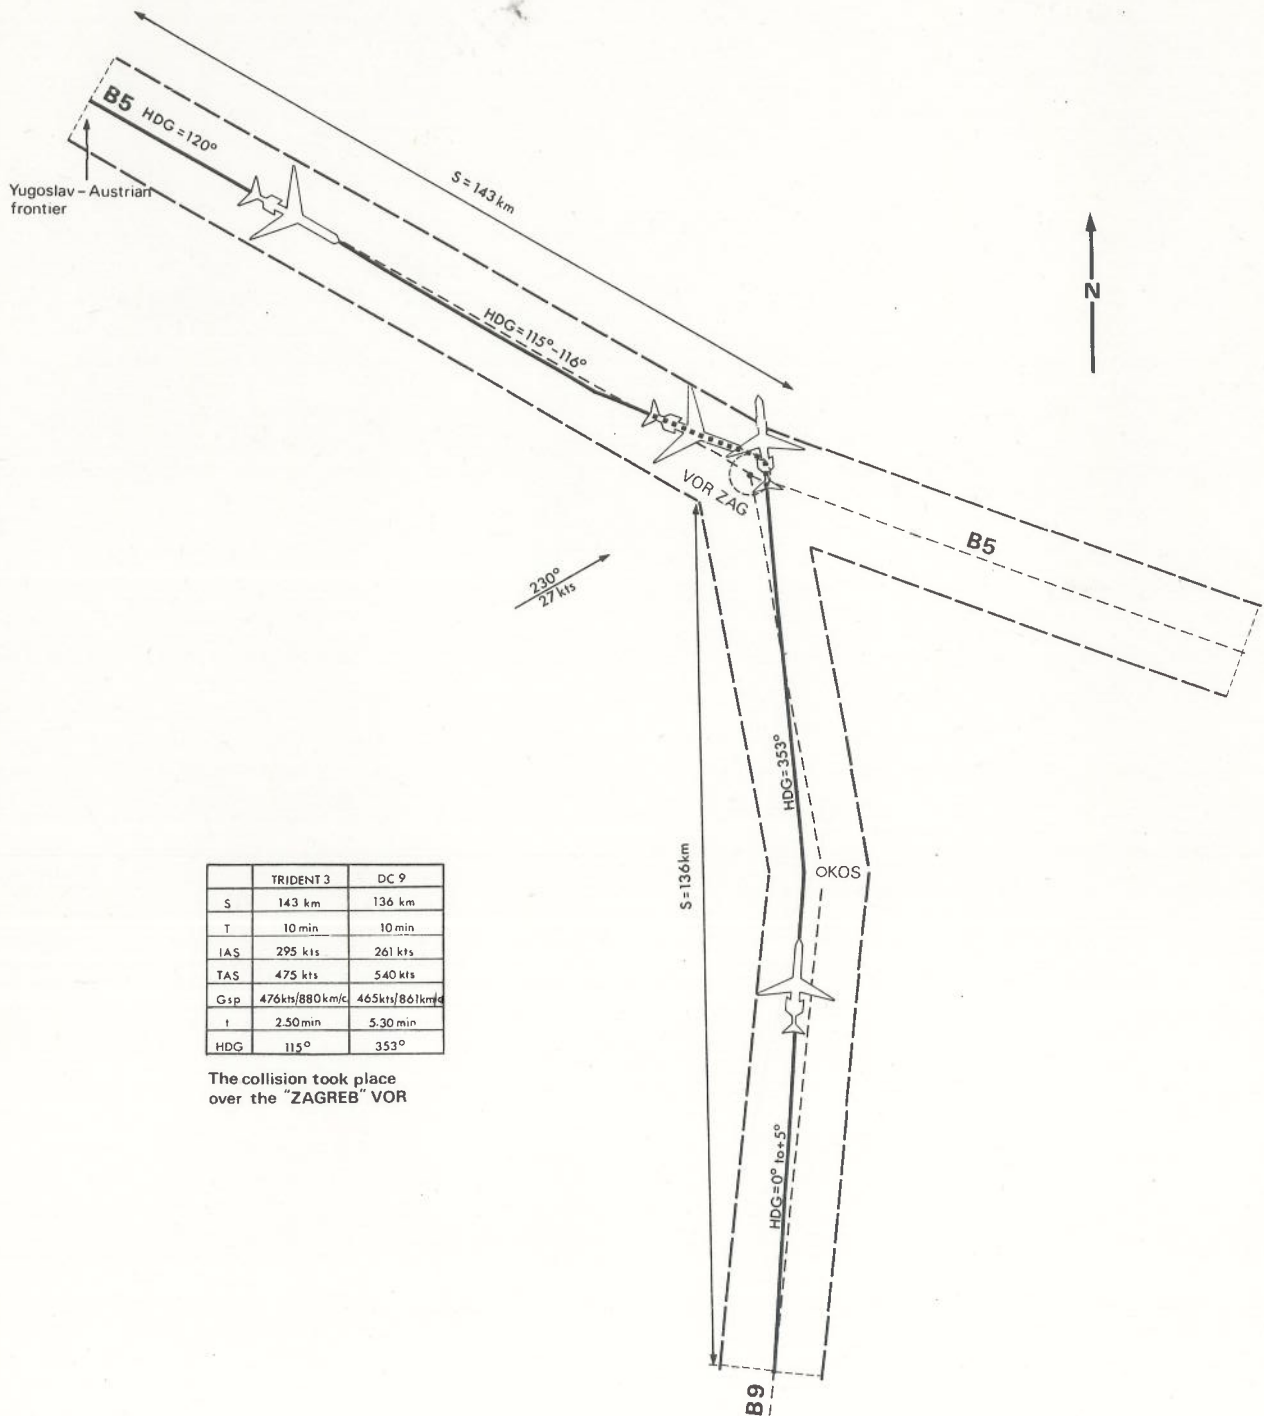
Calculation and schematic diagram of flight of Trident -3 and DC -9 aircraft from the moment when the T-3 crossed the Yugoslav - Austrian frontier

TRIDENT 3	DC 9
S	143 km	136 km
T	10 min	10 min
IAS	295 kts	261 kts
TAS	475 kts	540 kts
Gsp	476kts/880km/h	465kts/861km/h
I	2.50 min	5.30 min
HDG	115°	353°

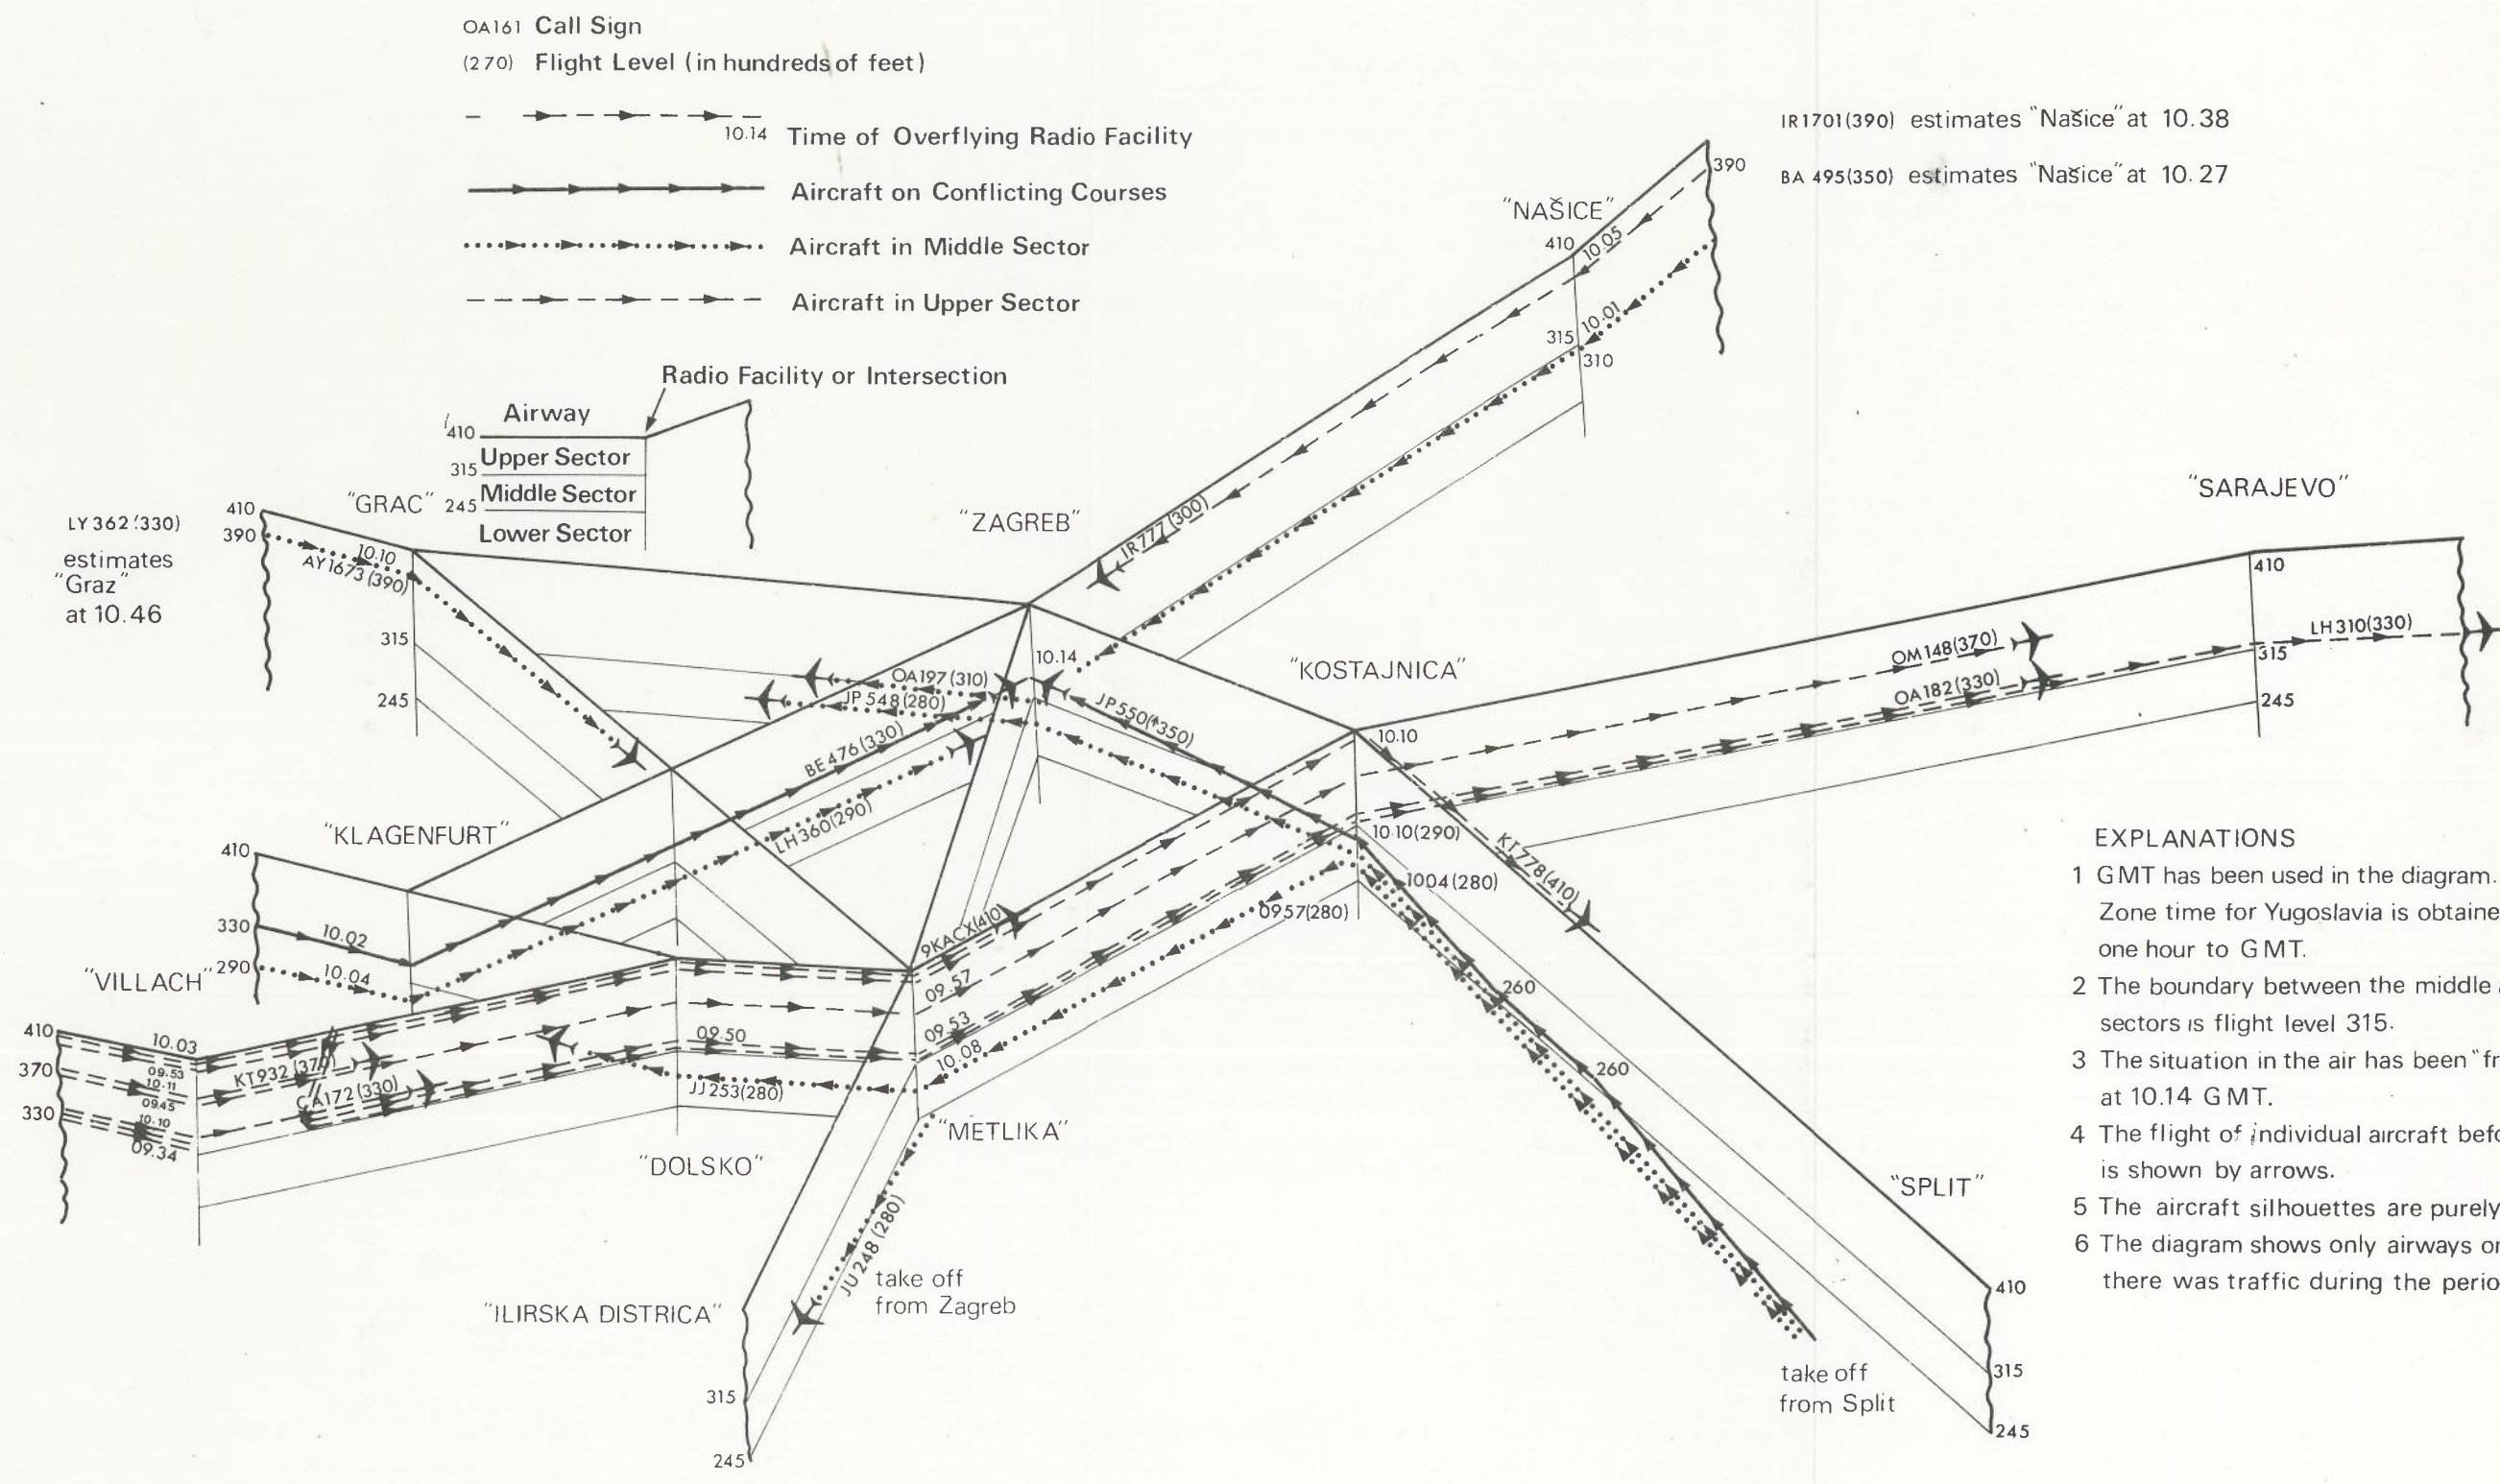
The collision took place over the "ZAGREB" VOR
