# National Transportation Safety Board Aviation Accident Final Report

<b>Location:</b>	Catawba, WI	<b>Accident Number:</b>	CEN17FA248
<b>Date &amp; Time:</b>	07/01/2017, 0153 CDT	<b>Registration:</b>	N2655B
<b>Aircraft:</b>	CESSNA 421C	<b>Aircraft Damage:</b>	Destroyed
<b>Defining Event:</b>	Loss of control in flight	<b>Injuries:</b>	6 Fatal
<b>Flight Conducted Under:</b>	Part 91: General Aviation - Personal

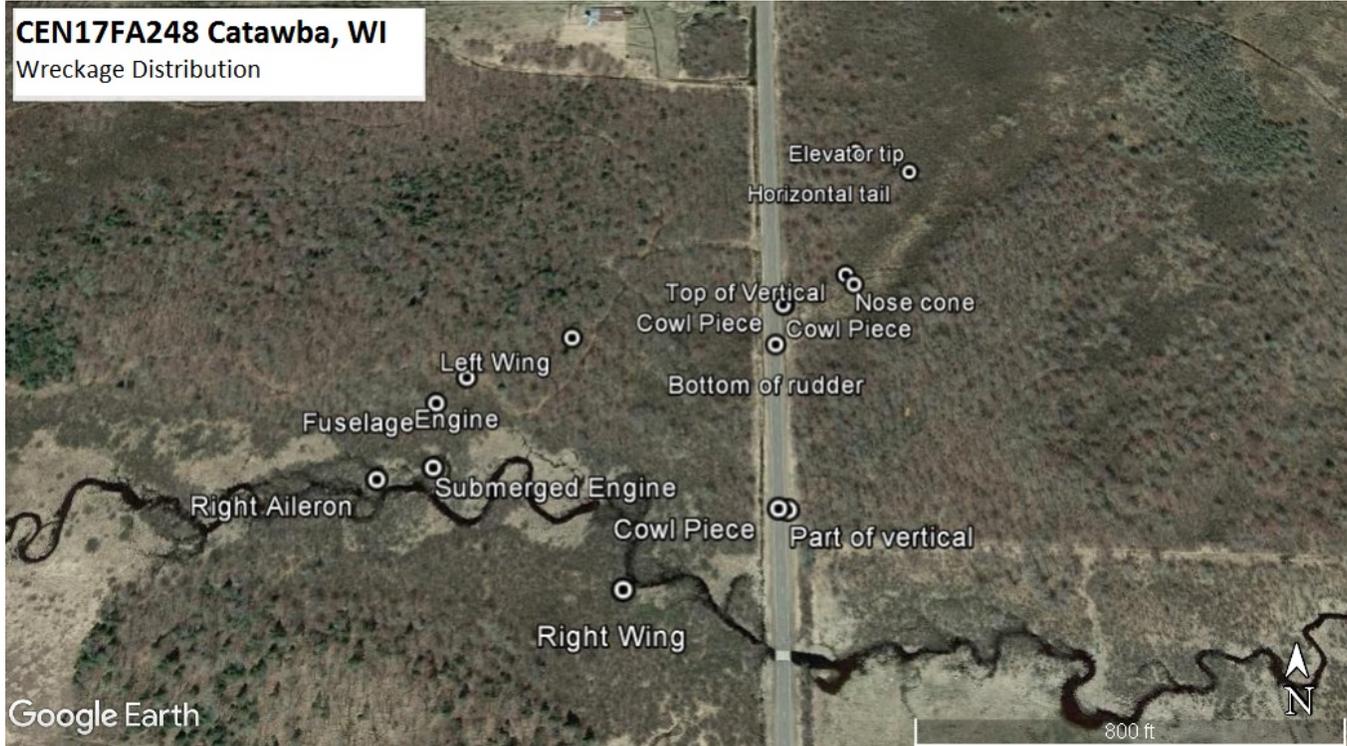
Figure 1. Wreckage Distribution

The distribution of the wreckage, which was scattered in an area with about a 1/4-mile radius, was consistent with an in-flight breakup. The left horizontal stabilizer and significant portions of both left and right elevators and their respective trim tabs were not found. Of the available components for examination, no pre-impact airframe structural anomalies were found. Examination of the engines and turbochargers did not reveal any pre-impact anomalies. Examination of the propellers showed evidence of rotation at impact and no pre-impact anomalies.

The accident site was located within densely vegetated terrain intersected by a road, with debris scattered on either side of and along the road surface in an area with a radius about 1/4 mile. Tree scars and ground impressions indicated that the main section of the fuselage impacted terrain in a nose-low attitude. The fuselage was found upright and oriented northeast. Both wings were found separated outboard of their respective nacelles. The empennage was not attached to the fuselage and was located about 1,200 ft from the main wreckage. The distribution of the wreckage was consistent with an in-flight breakup of the airplane. Due to the dense vegetation, muddy terrain, and limited horizontal visibility of the

accident site, a drone was used to locate parts of the wreckage that could not be found on foot.
