## **AIRCRAFT ACCIDENT REPORT**

**NORTHEAST JET COMPANY  
GATES LEARJET 25D, N125NE  
GULF OF MEXICO  
MAY 19, 1980**

**NTSB-AAR-81-15**

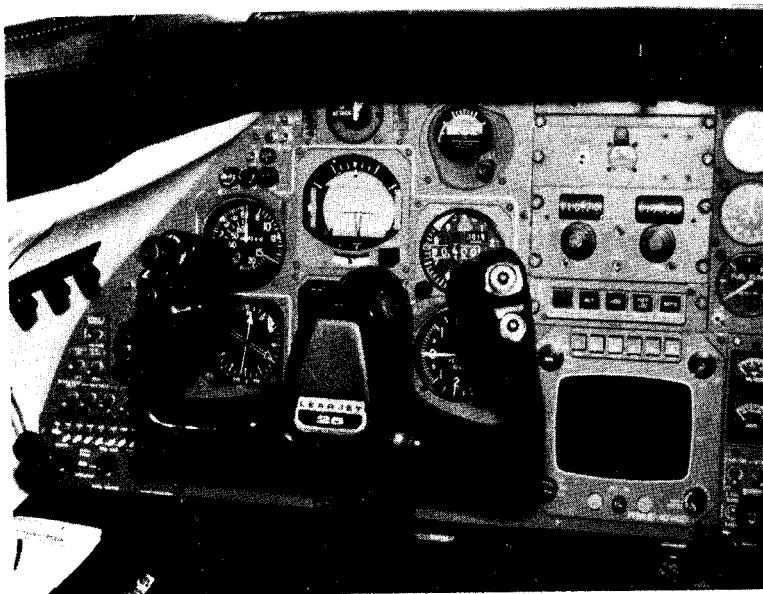
Figure 1.--Wheel master button on pilot's control wheel.  
The microphone switch is located on the front side of the  
wheel, opposite the wheel master button.

In a sudden upset, a pilot would reactively grab the control wheel in an attempt to maintain control of the aircraft. Under these circumstances, it would have been easy for the copilot to inadvertently key the microphone. Further, with the copilot holding the control wheel, the turbulence could have caused the force sensor to disconnect the altitude and heading hold functions of the autopilot, or he could have easily disengaged the pitch trim function with 6 to 8 pounds of force applied to the control column. Either type of disengagement would not have been readily apparent to the flightcrew because there are no associated artificial warnings. As a result, the copilot could have been confronted with a mistrim condition and a need to exert a significant amount of pull force to maintain level flight because of the possible nosedown trim the autopilot may have used to counteract the increased airspeed caused by the turbulence. The necessary pull force would have continued to increase with an increase in speed because of the "Mach Tuck" tendency. Additionally, since the wheel master button was inside the copilot's left hand grip, opposite the microphone switch, it is probable that he could have accidentally disengaged the autopilot and yaw damper. The absence of these critical items under these conditions would have significantly contributed to the copilot's difficulty in controlling the aircraft.

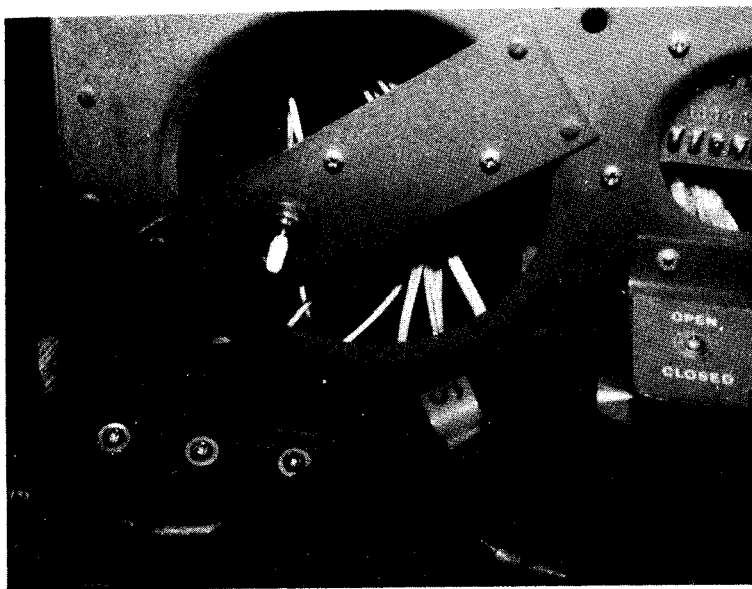
Figure 2.--The unauthorized overspeed warning horn  
cut-out switch is identified within the circle.

The lack of the Mach overspeed warning sound on the ATC tape probably indicates that the warning horn was disabled because of the cut-out switch. Not until 20.4 seconds after the burst of static is there recorded evidence that the flightcrew took action to correct the overspeed condition when the pilot gave the command to use the spoilers. However, his statement was made 12 seconds after the aircraft had already reached 0.81M<sub>1</sub>. Considering the computed rate of the aircraft's speed increase, the aircraft probably had substantially exceeded M<sub>MO</sub> before the spoilers were extended. Consequently, extension of the spoilers would have further aggravated the situation by significantly increasing the pull force needed to restore the aircraft to level flight.

11. There was no conclusive evidence of a failure or malfunction of the aircraft's systems. However, unauthorized installation of the overspeed warning horn cut-out switch rendered the aircraft unairworthy.

Shortly after the accident, the FAA issued a general notice alerting its field offices of the unauthorized switch installation. A special airworthiness alert was issued later which alerted all air carrier and general aviation operators of the unauthorized switch installation. The FAA expressed concern that all flightcrews and operators might not be aware of the existence of such a switch and that operators should have their aircraft inspected and have the switch removed, if installed.
