FINAL REPORT

This document is an English translation of the Final Report on the accident involving the Boeing 737-800 aircraft registered VQ-BJI that occurred on September 1, 2018 (UTC) at Sochi International Airport, Krasnodarsky Krai, Russian Federation.

INTERSTATE AVIATION COMMITTEE

Type of accident	Accident
Type of aircraft	Boeing 737-800, airplane
Registration	VQ-BJI
Owner	SB Leasing Ireland
Operator	UTAir Airlines
Aviation Administration	Rosaviatsia Tyumen ITO
Place of accident	Sochi airport, Krasnodarsky Krai, RF Coordinates: N 43°27'05.32" E 039°57'36.53"
Date and time of accident	01.09.2018, 02:58 local time (31.08.2018, 23:58 UTC), nighttime

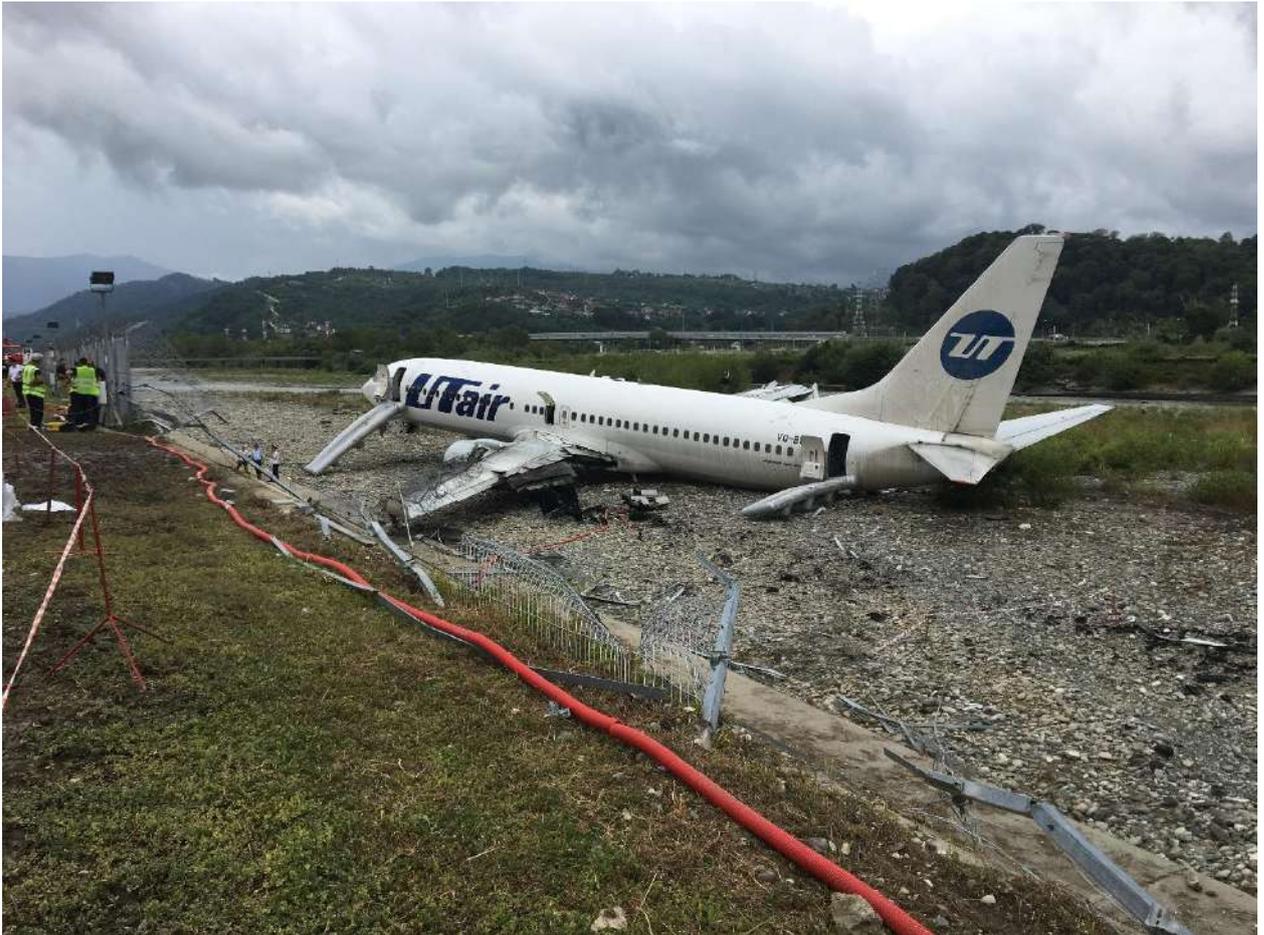
The aircraft when overrun the threshold, broke through the aerodrome fencing and came to rest in Mzymta river bed. This ended with the fire outbreak of fuel leaking from the damaged LH wing fuel tank. The left and right half wings, both engines, the nose and RH main landing gear legs; the LH landing gear leg had been separated and was found under the LH half wing. The fuselage showed the significant deformation. All structure elements were found lying together within one spot (see Fig. 2).

Fig. 2. The aircraft at the accident site.

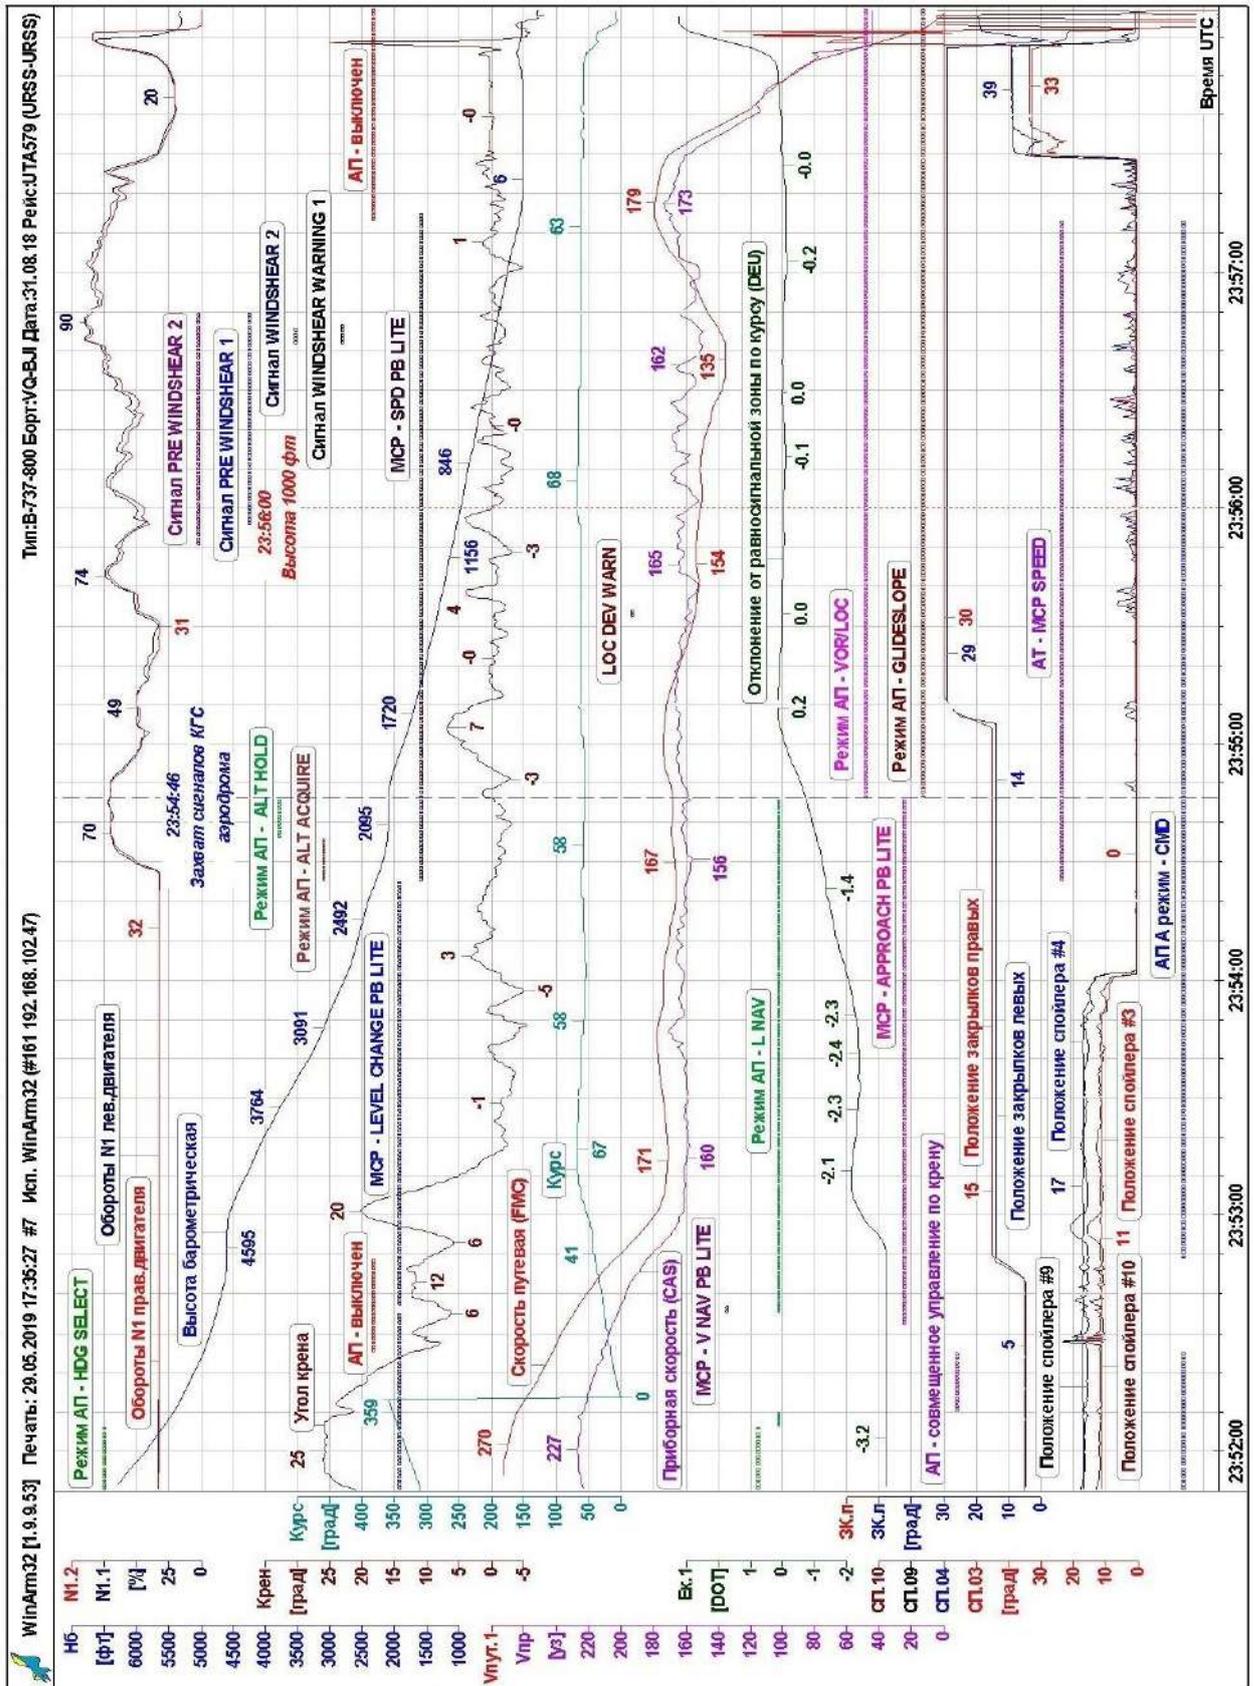
Fig. 11. Flight parameters during the second approach to landing

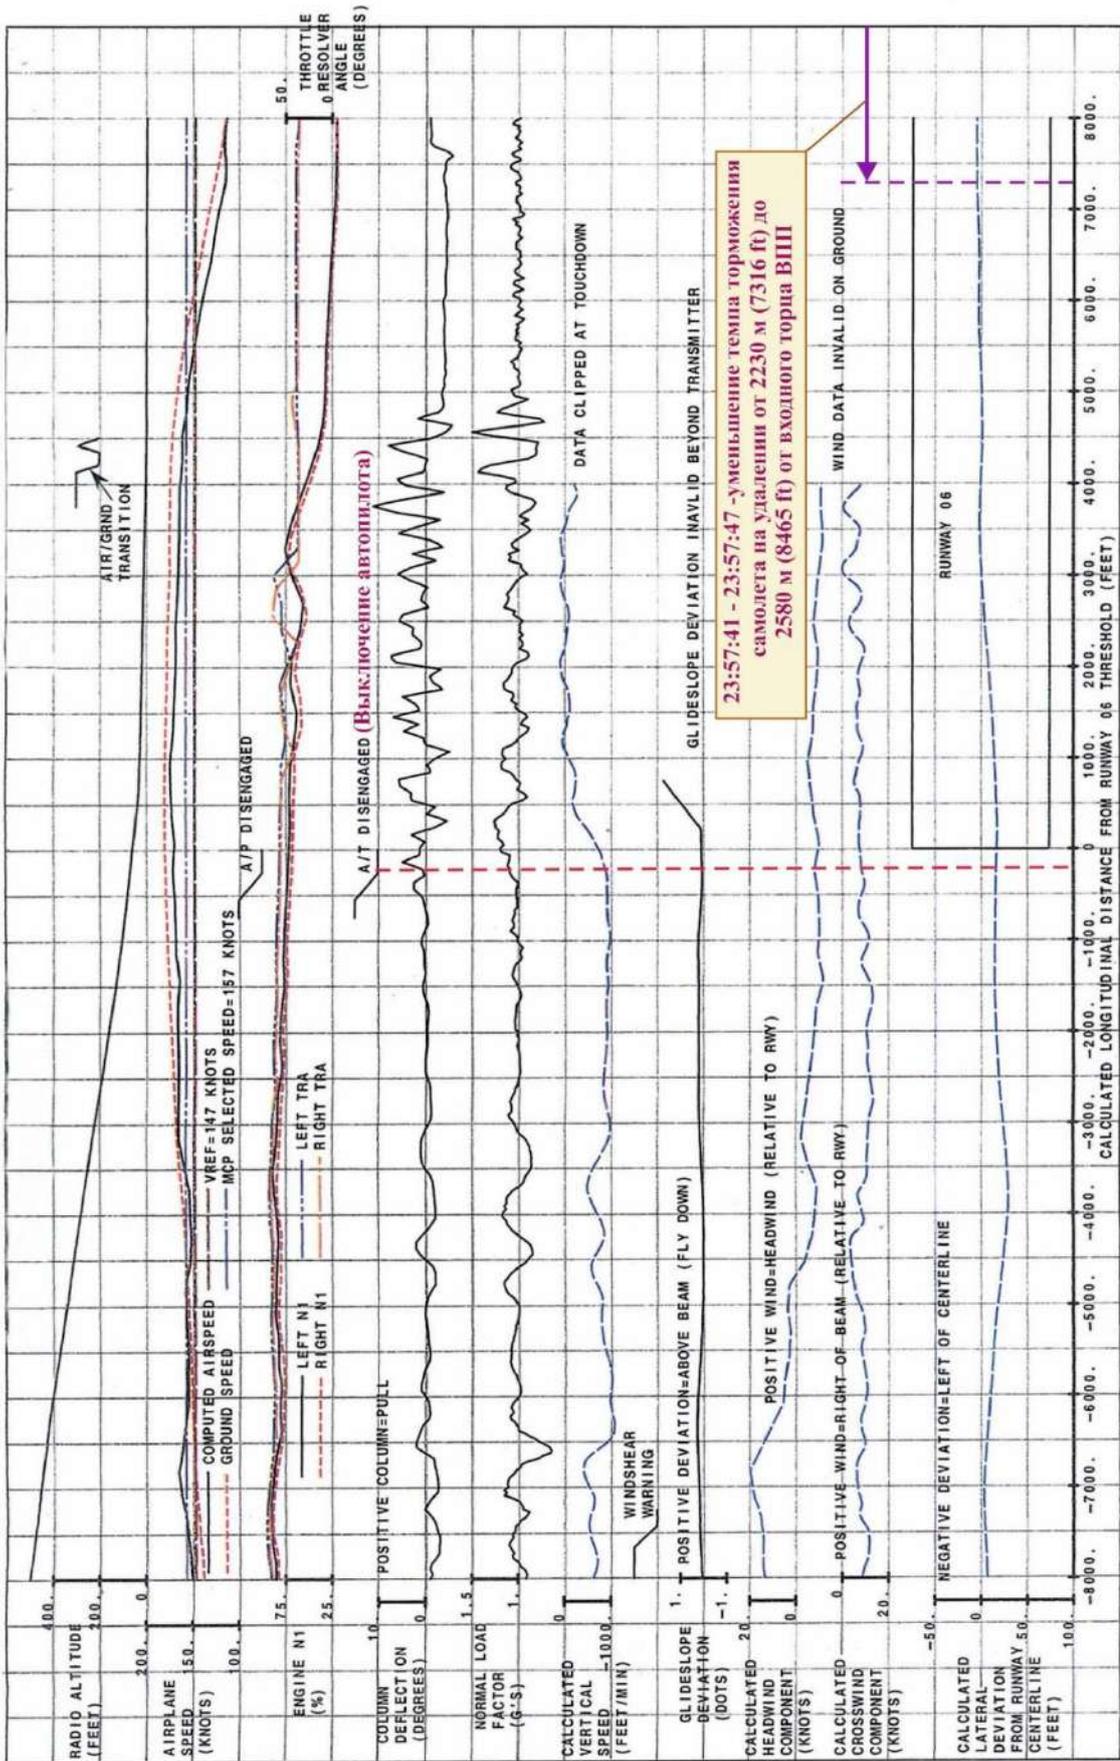
At 23:57:13, at height of 75 ft (≈ 25 m) and distance of 150 m to RWY threshold, PIC had disengaged the autopilot and autothrottle, and took the control manually. At this time, the aircraft was in the wind shear "epicenter". Exactly before that, the autothrottle started to reduce the engine rotation speed as the instrument speed to this moment had reached the value of 170 kts (≈ 315 km/h). Autothrottle disengaging caused "freezing" of the mode which was rather excessive for the actual flight conditions. It resulted in the instrument speed increase up to 173 kts (≈ 320 km/h). The instrument speed increase in combination with PIC control inputs caused a significant vertical speed decrease and flight profile fluttering (see Fig. 13, 14). At that, the ground speed was about 178 kts (≈ 330 km/h) as a result of tail wind influence. The aircraft when passed the RWY threshold was at height of about ≈ 54 ft (15 m). The total flight time left to the landing was 14 s.

Fig. 13. On landing – simulation of the aircraft movement

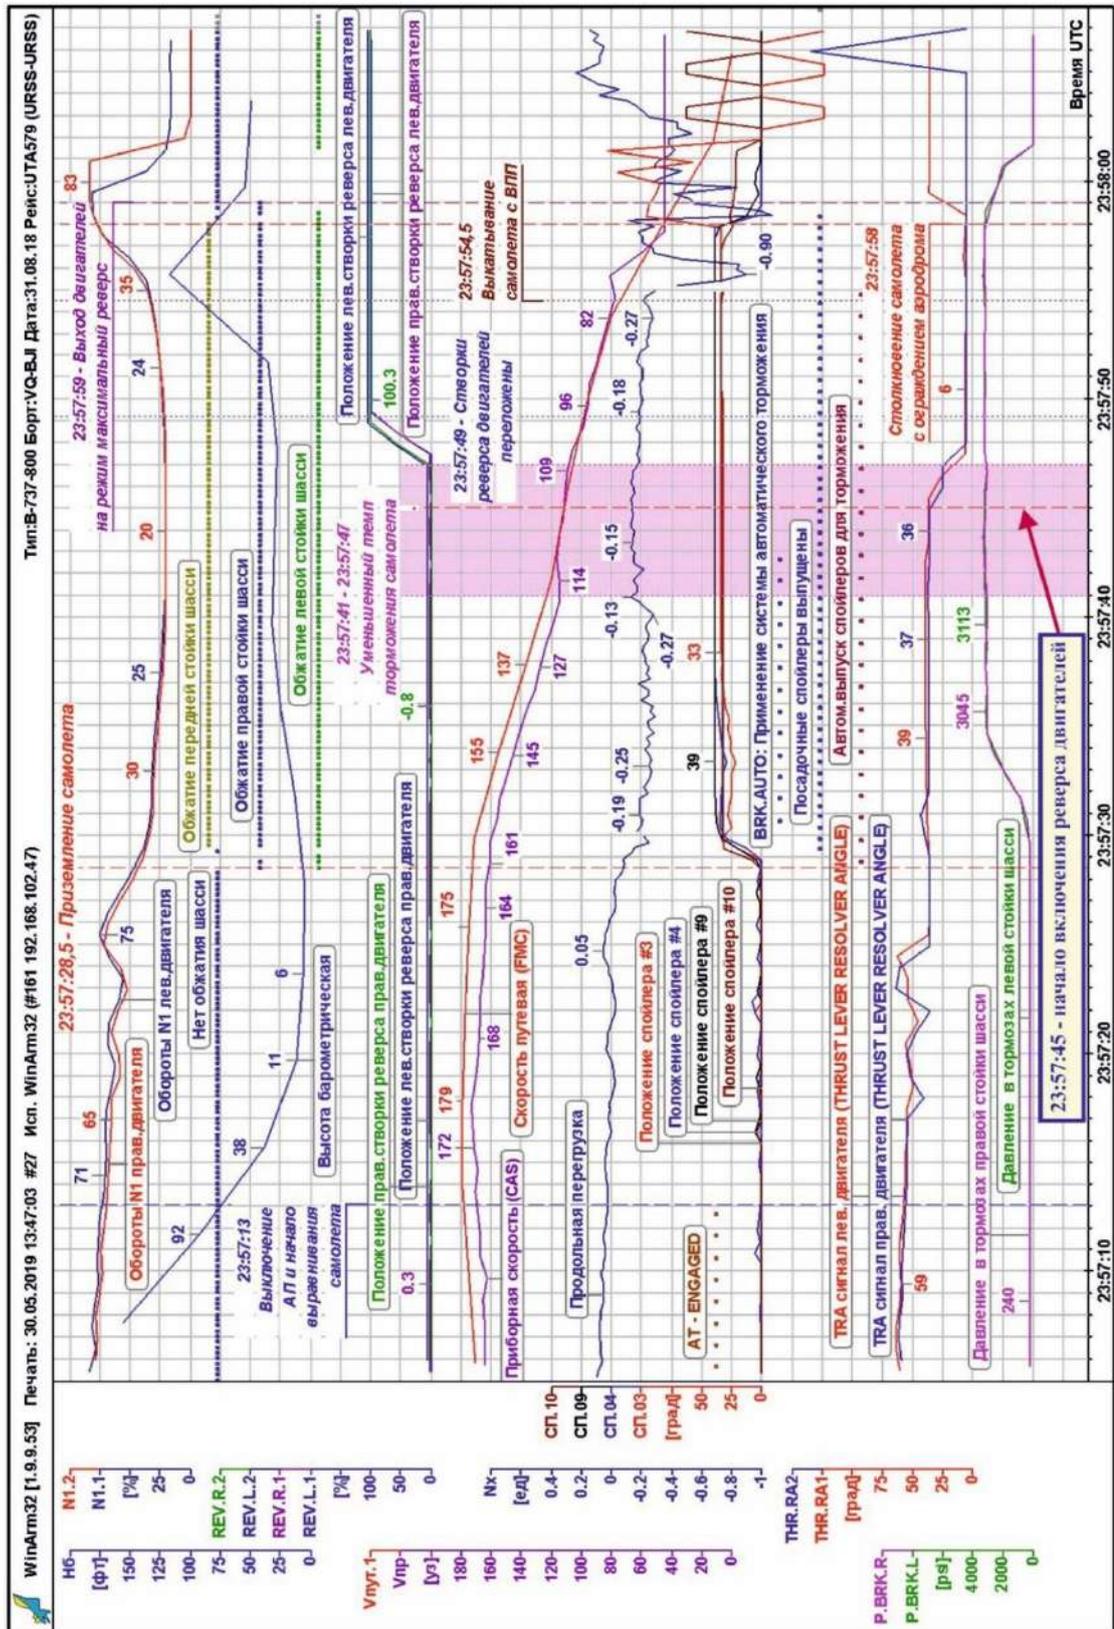
Fig. 14. Landing run – aircraft movement

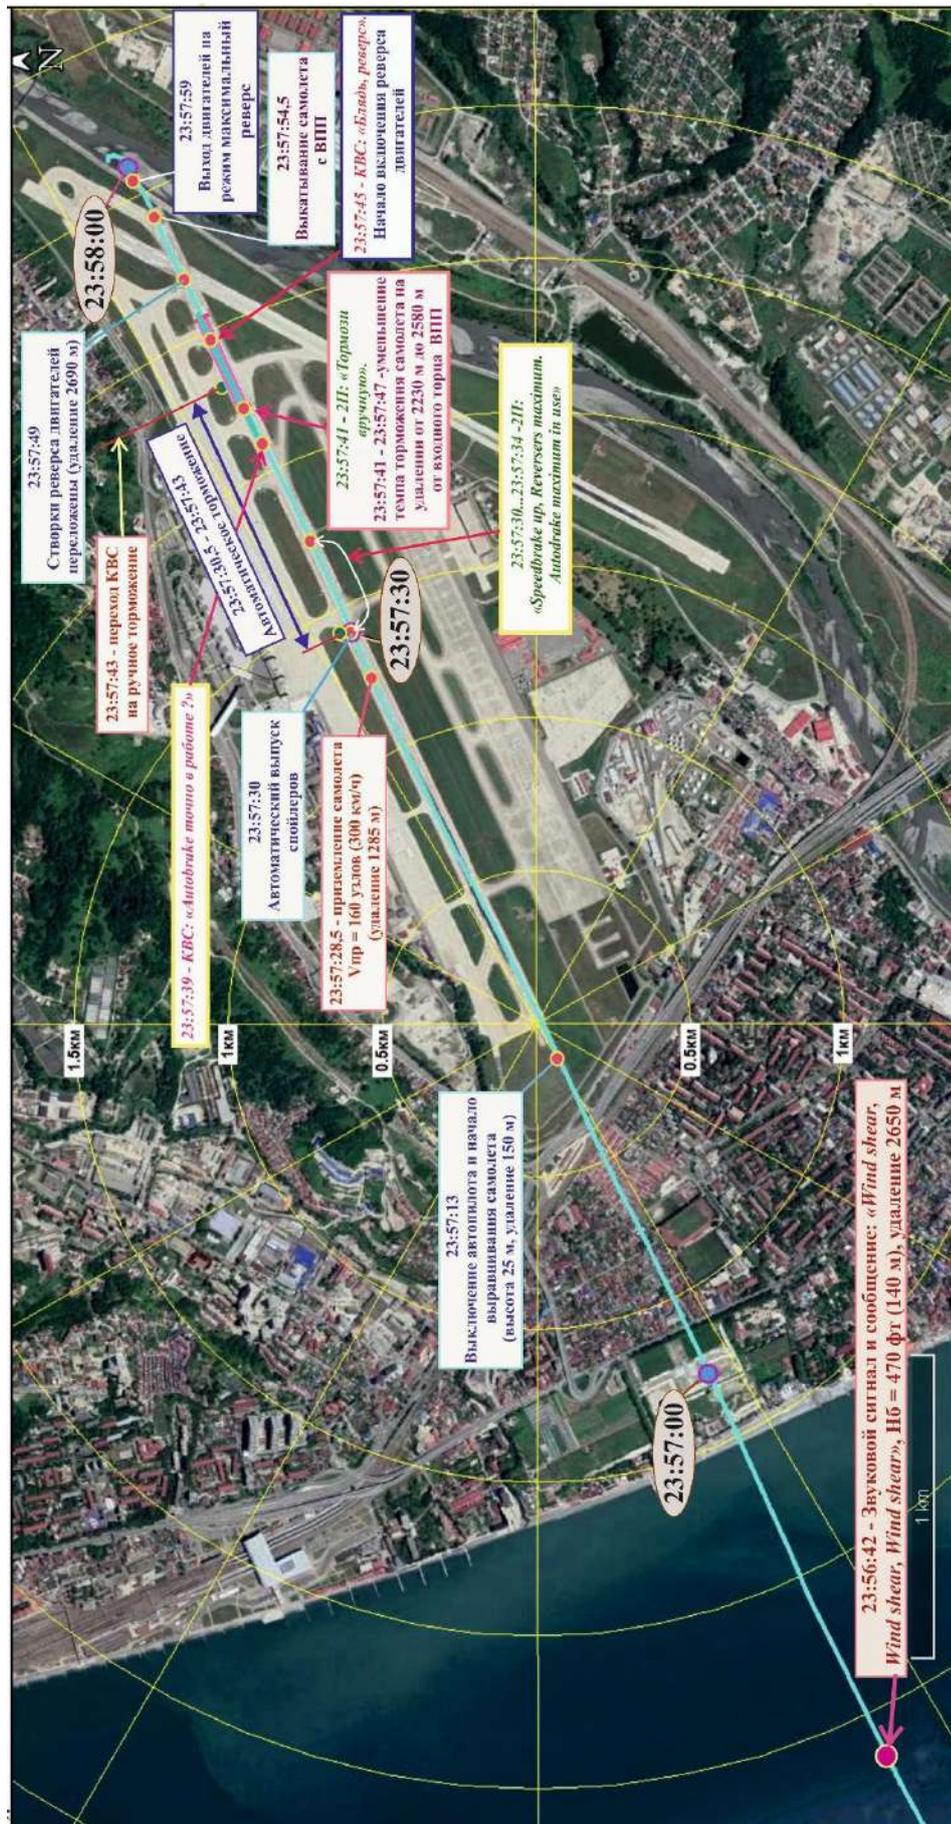
The aircraft landed at 23:57:28 behind RWY 06 threshold (see Fig. 15) at about ≈ 1285 m (it is according to FDR records) when the instrument speed was 160 kts (≈ 300 km/h) and ground speed was 170 kts (≈ 315 km/h).

Fig. 15. Aircraft on landing trajectory

Therefore, the increased instrument speed on final flight (after the control was changed to the manual one) and the influence of tail wind component led to landing at distance of 1285 m from the RWY threshold (about 385 m overshoot).

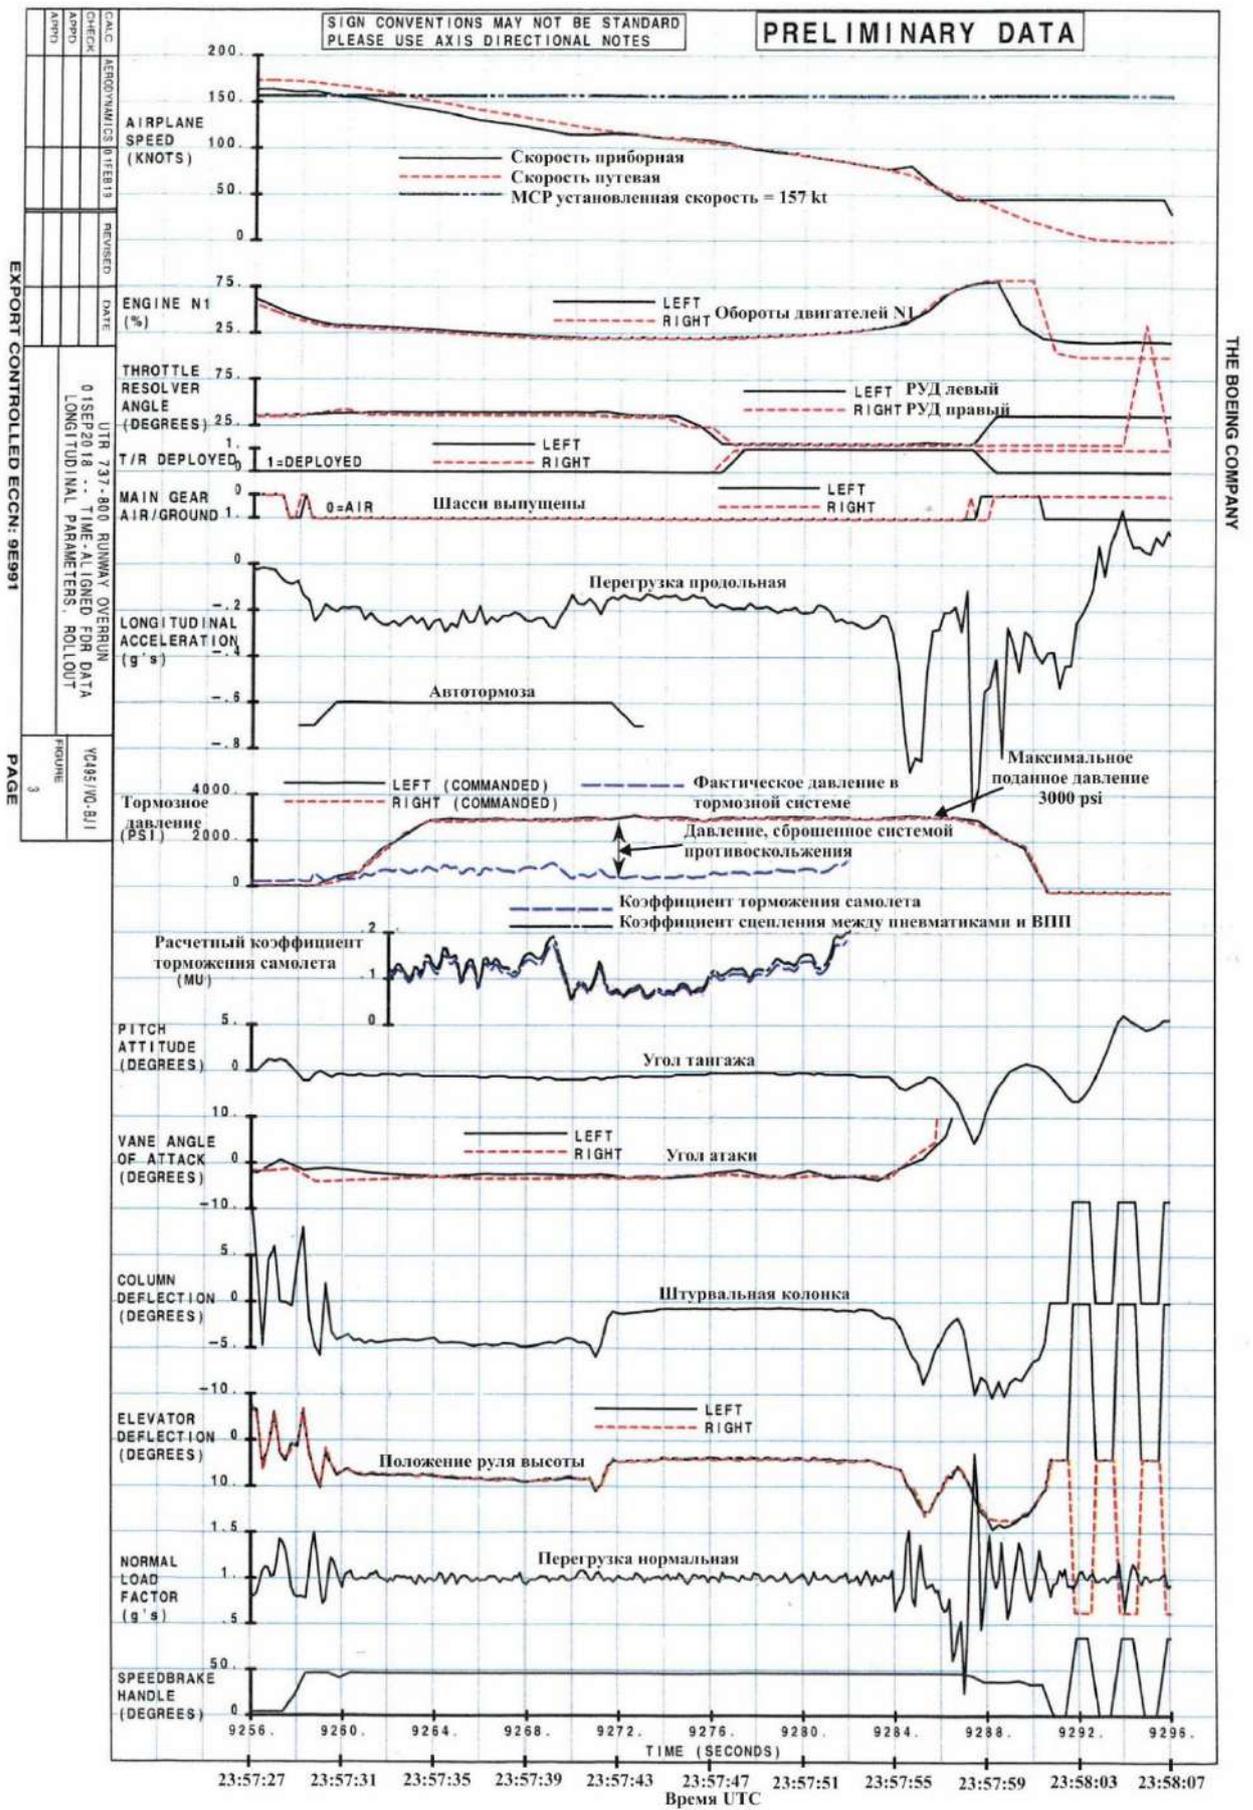
For the purpose to determine the effective brake pressure at the wheels of Boeing 737-800 VQ-BJI aircraft, the Boeing specialists provided the dynamic simulation of the flight in question on the landing roll. At Fig. 16, the result of this simulation are shown.

Fig. 16. Landing run – simulation of the aircraft movement
