AIRCRAFT ACCIDENT REPORT

**COIN ACCEPTORS, INC.
CESSNA MODEL 551, CITATION II, N2CA
MOUNTAIN VIEW, MISSOURI
NOVEMBER 18, 1982**

NTSB/AAR-83/04

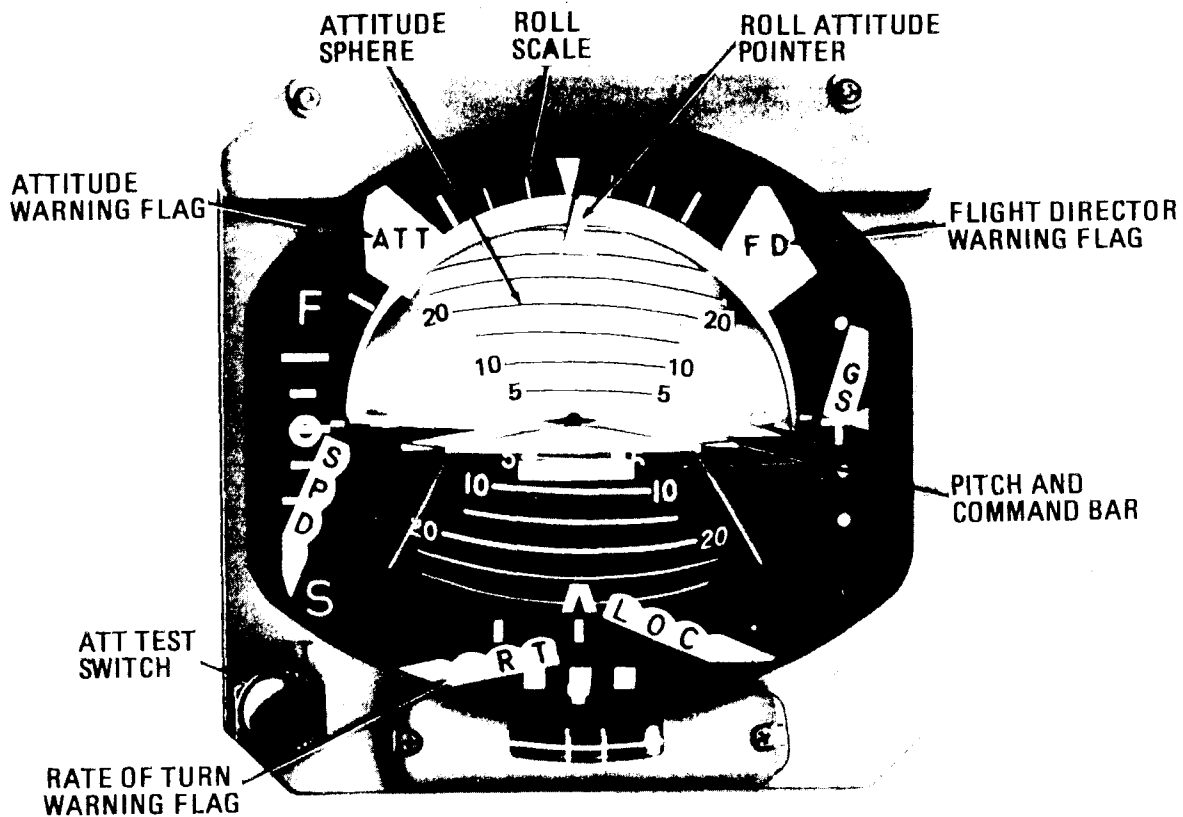
Figure 1.—Pilot's AD-600 Attitude Director Indicator.

If no power is applied to the ADI or if power is interrupted during normal operation, the attitude sphere will indicate a left bank. The roll-attitude pointer will be in the horizontal position with the blue portion of the sphere to the right of the pointer.

The tolerance of the ADI in the unpowered state is 90° left bank $\pm 25^\circ$. Once power is applied to the system and the vertical gyro reaches operating speed to drive the ADI, the attitude sphere will move to a position where the roll attitude pointer aligns with the zero mark on the roll scale. At that time, the attitude warning flag disappears, and the pitch and roll command bar appears. The flight director warning flag disappears when power is applied to the flight director and will remain concealed unless the command bar information is unreliable. The attitude warning flag will also remain concealed unless the attitude information is unreliable. The autopilot can be engaged only when the gyros, which drive the ADI and the HSI, are operating properly.

The Safety Board believes that the position of the attitude sphere of the pilot's ADI indicated the actual attitude of the airplane at impact -- 90° banked attitude to the left. The Safety Board realizes that the attitude sphere would have gone to the left bank position if there had been a power failure. However, it is unlikely that the attitude sphere would have gone precisely to the 90° point, since the tolerance of the RD-600 was 90° + 25°. Furthermore, the physical evidence near the impact site and the location of portions of the airplane wreckage in the impact site support the conclusion that the pilot's ADI essentially portrayed the bank attitude of the airplane at impact. This finding, and the absence of a history of ADI problems, leads the Safety Board to conclude that the pilot's ADI was functioning properly at the time of the accident.

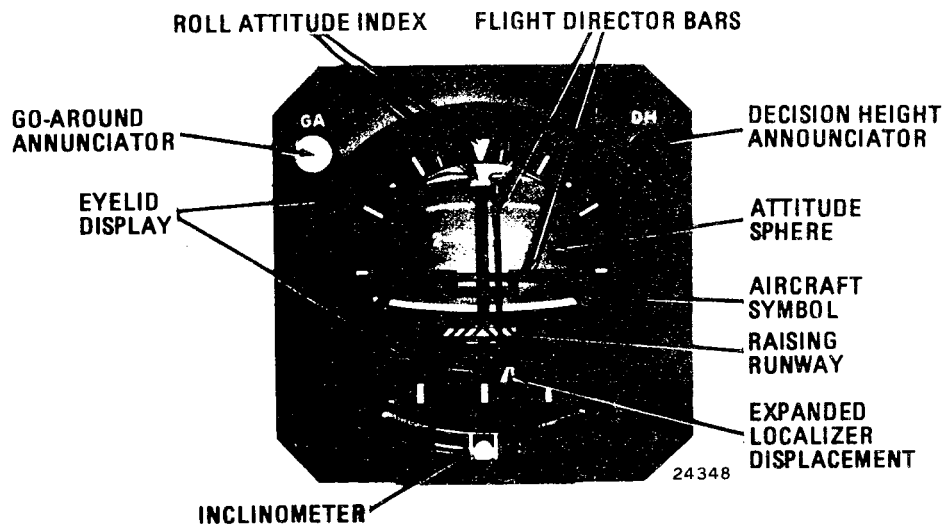
Figure 2.--Copilot's GH-14 Gyro Horizon Attitude Director Indicator.

The copilot's ADI, a GH-14 Gyro Horizon, was a double cue, 4-inch instrument, with a self-contained vertical gyro. (See figure 2.) It required the same time to become operationally usable as the AD-600.

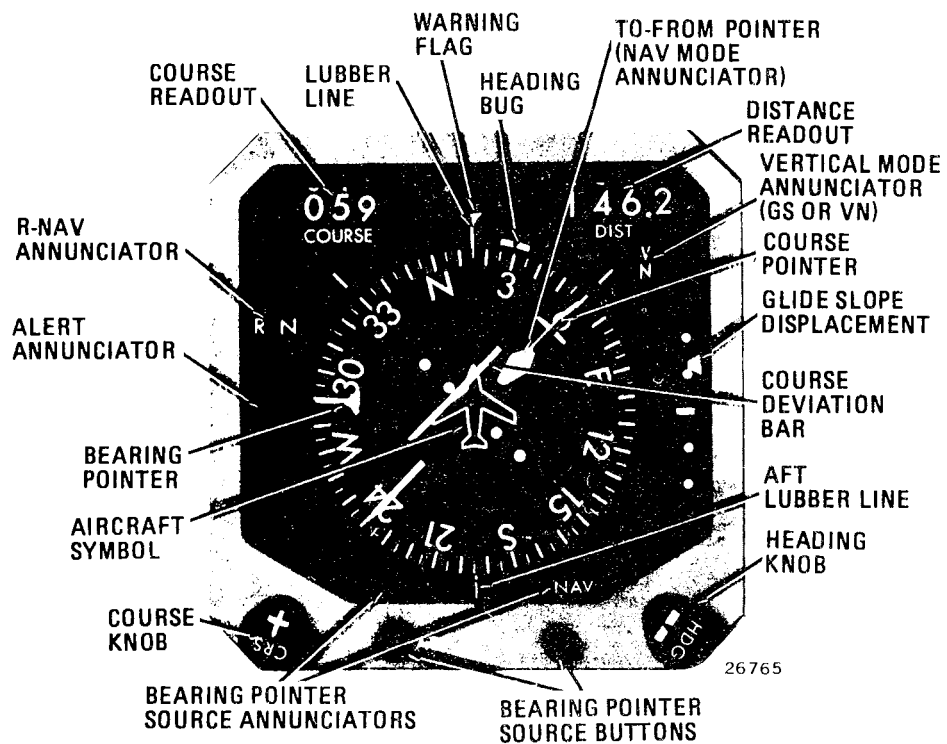
Figure 3.--Pilot's RD-600 Horizontal Situation Indicator.

Both the pilot's and the copilot's horizontal situation indicator (HSI) received extensive impact damage. The pilot's HSI indicated a heading of 20° on the compass card, and had a course pointer reading of 355°. Both NAV mode annunciator flags were in view. There were no pointers or flags remaining on the copilot's HSI. The compass card was in place and indicated a heading between 90° and 120°.

The pilot's HSI was a RD-600 5-inch display. (See figure 3.) The instrument is powered by a C-14 Gyrosyn Compass System (directional gyro), which provides primary

Although both HSI's were damaged severely, the copilot's compass card indicated a heading of 90° to 120°, which was generally coincident with the airplane's heading at impact. The pilot's HSI indicated 20°. If the gyro which drove the pilot's HSI was slow in bringing the HSI up to speed, as had occurred according to the chief pilot in previous flights, the difference between the two compass readings can be explained. It was concluded that the copilot's HSI was operating properly and providing accurate heading information to the pilot, while the pilot's HSI had not become completely operationally usable at impact. A difference in the times required for the HSI's to come up to speed had been noted by the chief pilot, who also said that the pilot had used the copilot's HSI for heading information on the previous day because the pilot's HSI was slow in becoming operationally usable. In summary, the evidence points to a conclusion that the two HSI's on the airplane were not completely functional. However, it appears that the copilot's HSI was providing accurate heading information and that the pilot's ADI probably was providing accurate attitude information at impact.
