AIRCRAFT ACCIDENT REPORT

**CENTRAL AIRLINES FLIGHT 27
HUGHES CHARTER AIR
GATES LEARJET MODEL 25 (N51CA)
NEWARK INTERNATIONAL AIRPORT
NEWARK, NEW JERSEY
MARCH 30, 1983**

NTSB/AAR-84/11

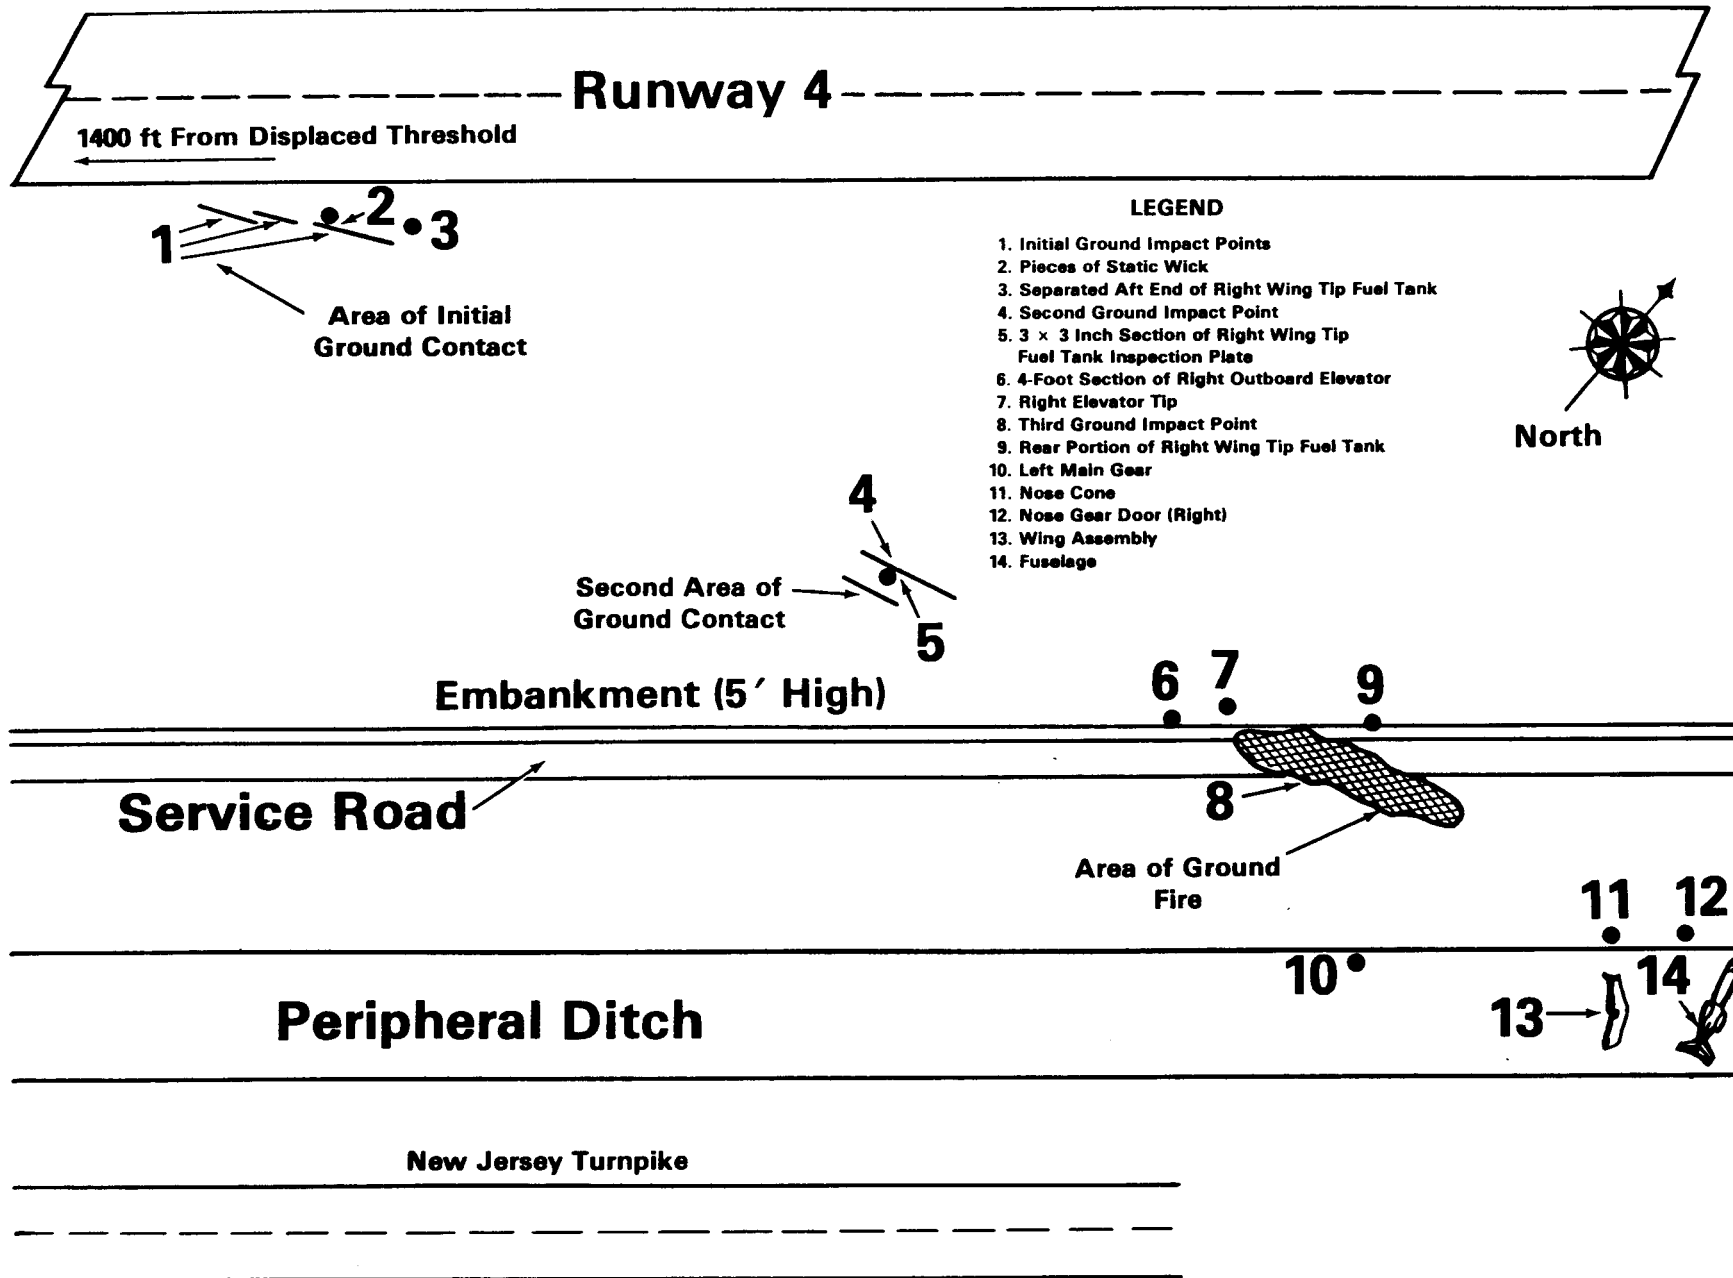
Figure 1.—Wreckage Diagram.

The airplane came to rest about 750 feet to the right of runway 4 right, about 1,500 feet from the point where it departed from the runway. (See figure 1.) The fuselage came to rest partially submerged in a canal alongside the New Jersey Turnpike. The wing section came to rest about 50 feet from the fuselage in the middle of the canal. The airport crash/fire/rescue crew extinguished the ground fire about 3 minutes after the accident. The accident occurred during dawn at location 40° 42' N and 74° 10' W.

The first identifiable marks on the ground made by N51CA were found about 18 feet to the right of the edge of runway 4R about 1,400 feet beyond the runway displaced threshold. No marks made by N51CA could be located on the runway surface where it presumably touched down. The initial impact area was an area of three ground scars made by the right wingtip fuel tank and the landing gear. The scars were aligned about 30° to the right of the runway heading. (See figure 1.) A second area of ground impact was located about 600 feet beyond the initial marks along a path oriented about 070°. These marks were gouges made by the right wing and right horizontal stabilizer/elevator.

A third area of impact was located at the edge of an airport perimeter service road, about 600 feet beyond the second area. This area was about 86 feet long and 66 feet wide. Pieces of the cockpit windshield were embedded in the dirt along with numerous small pieces of debris from the cockpit. The main fuselage came to rest in a drainage ditch about 150 feet from the road surface. The fuselage was oriented in a northerly direction and was partially submerged in the water. The entire wing section, which had separated from the fuselage, came to rest partially submerged in the center of the ditch about 50 feet to the south of the fuselage.
