Accidents Investigation Branch

**Report on the accident to
Britten-Norman Islander BN 2A-26
G-BDVW at Sanday Island Airfield, Orkney
on 1 June 1984**

Aircraft Accident Report No. 1/85
(EW/C874)

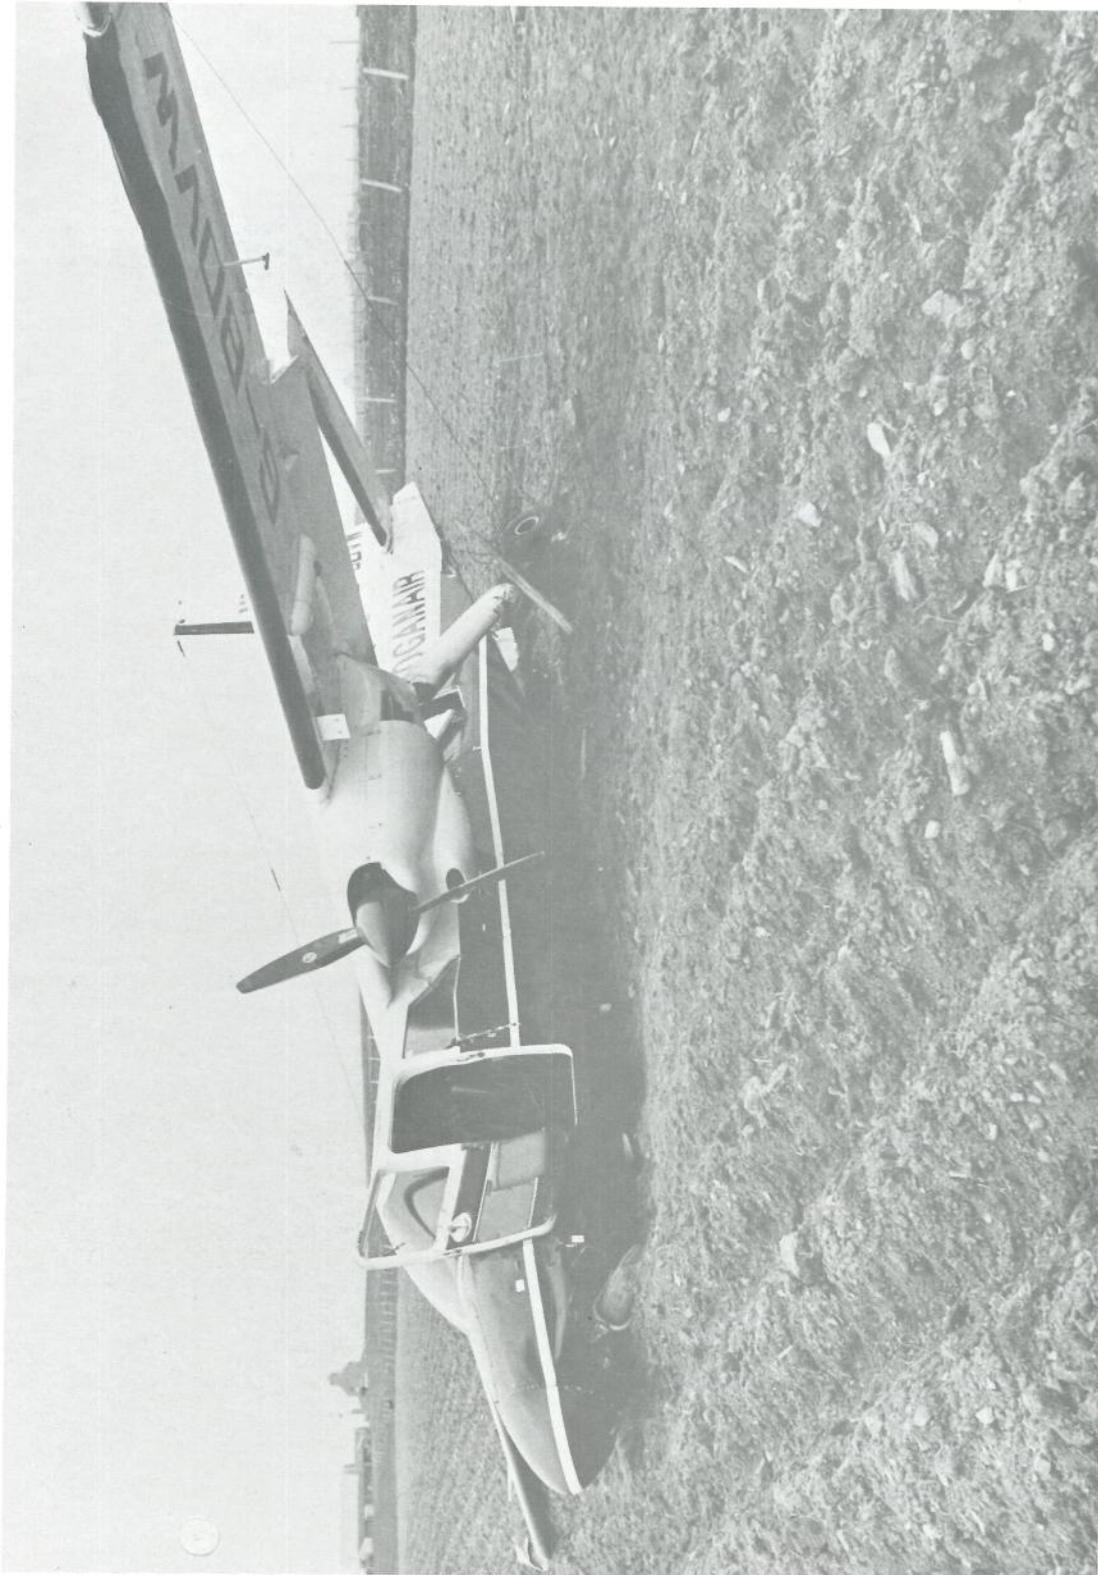
Significant structural deformation had occurred to the fuselage, wings and right tailplane. The passenger cabin floor had moved several inches to the left, with reference to the roof, and this was sufficient to cause the left propeller blades to slice into the fuselage wall just behind the pilot's position. The propeller blades also displayed compacted earth particles on the leading edges. Although the pilot's entry door could be operated, both passenger cabin doors had jammed but their pull-in windows had been operated successfully.

G-BDVW following the accident

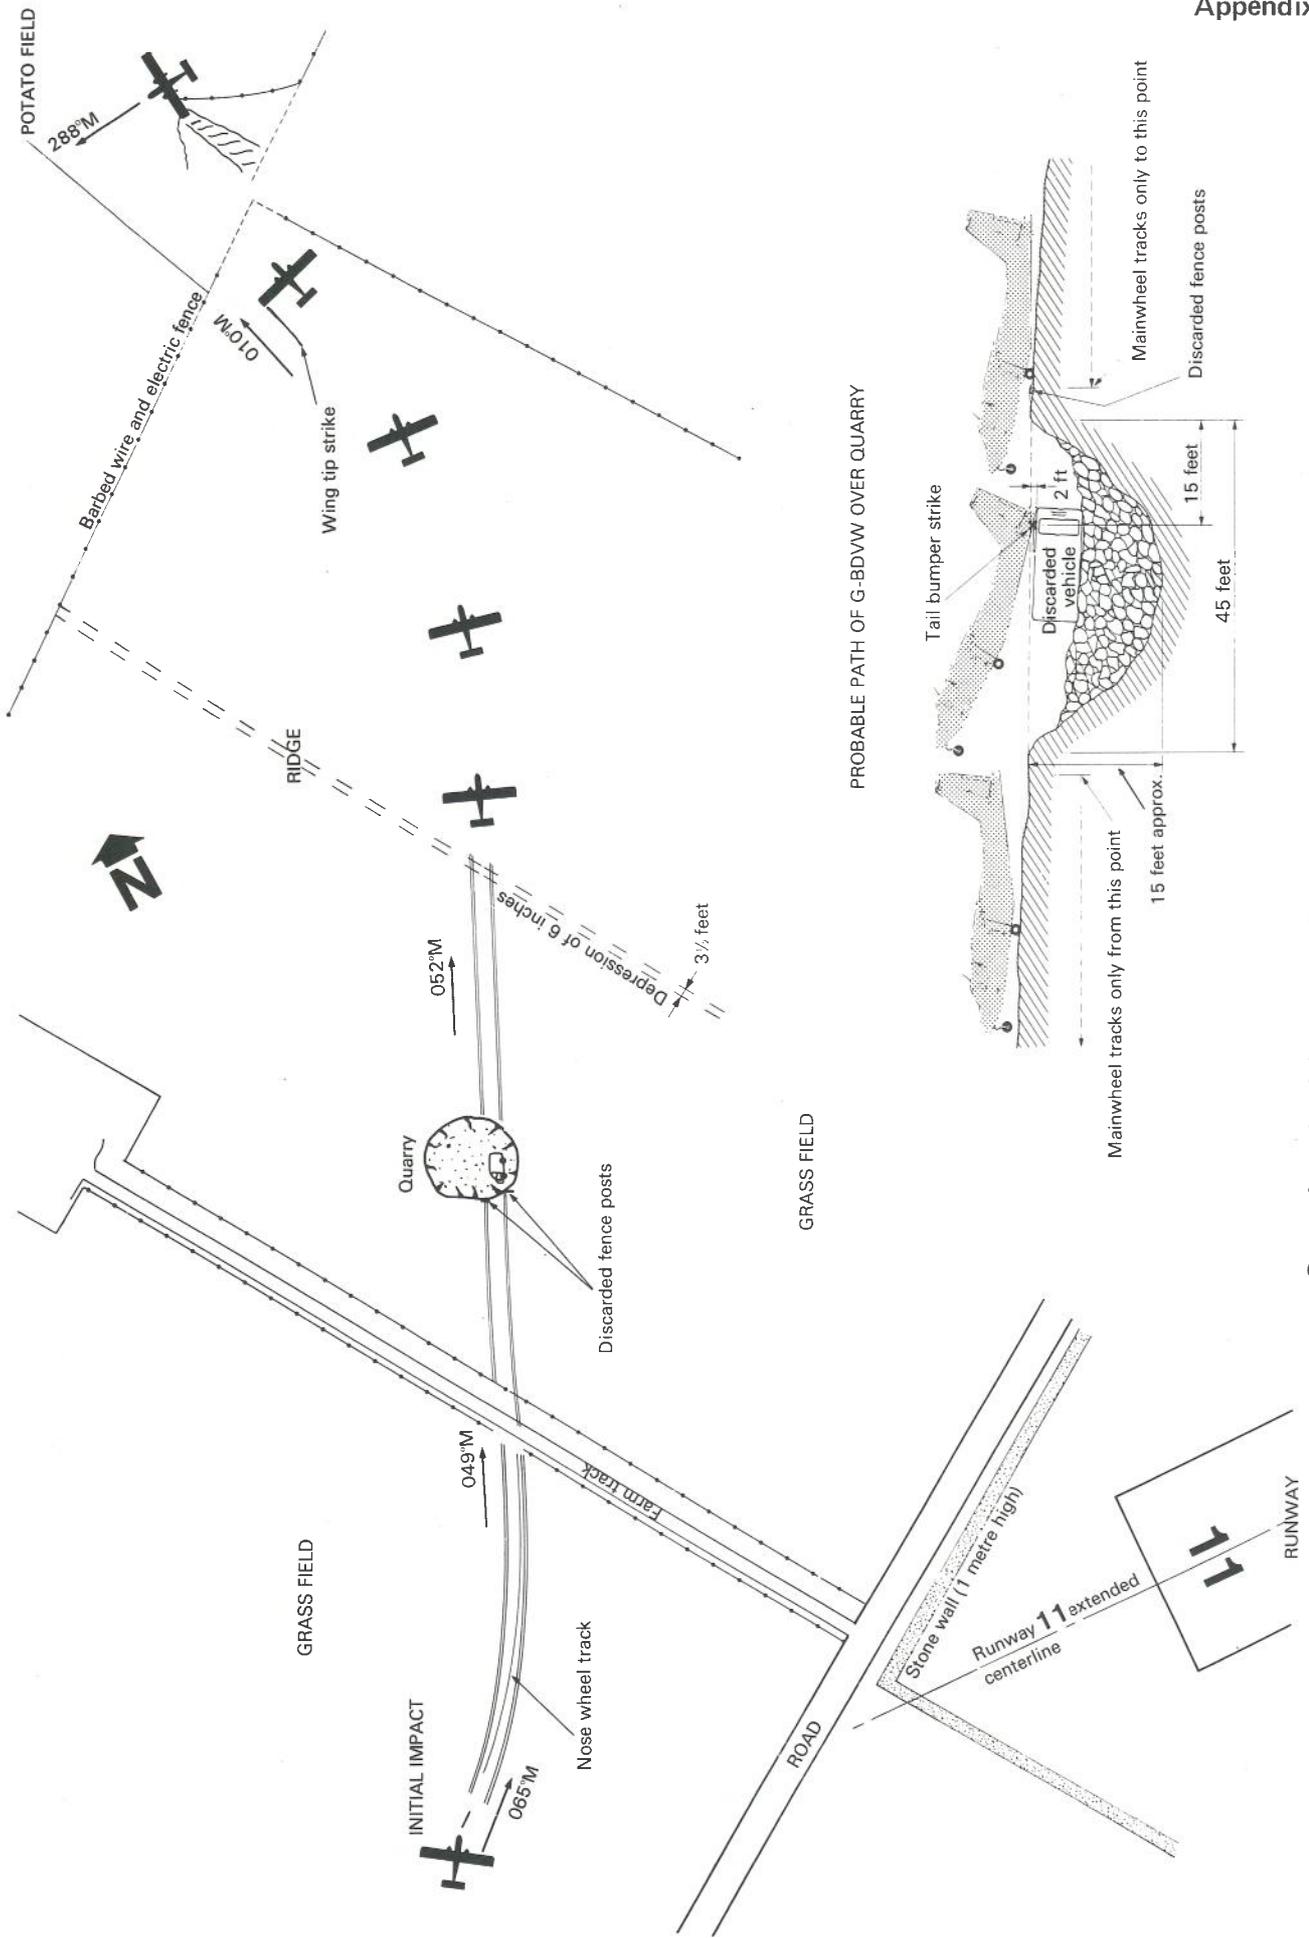
This had the effect of slowing the aircraft and slewing it to the left, such that it skated sideways to the right on the underside of its nose, with the remainder of the aircraft clear of the ground. During this part of the accident sequence the nose leg collapsed to the left and the left main undercarriage leg attachment failed in a rearward sense.

Ground track of G-BDVW following initial impact
