AIRCRAFT ACCIDENT REPORT

AIR CONTINENTAL GATES LEARJET 23
BRADLEY INTERNATIONAL AIRPORT
WINDSOR LOCKS, CONNECTICUT
JUNE 4, 1984

NTSB/AAR-85/02

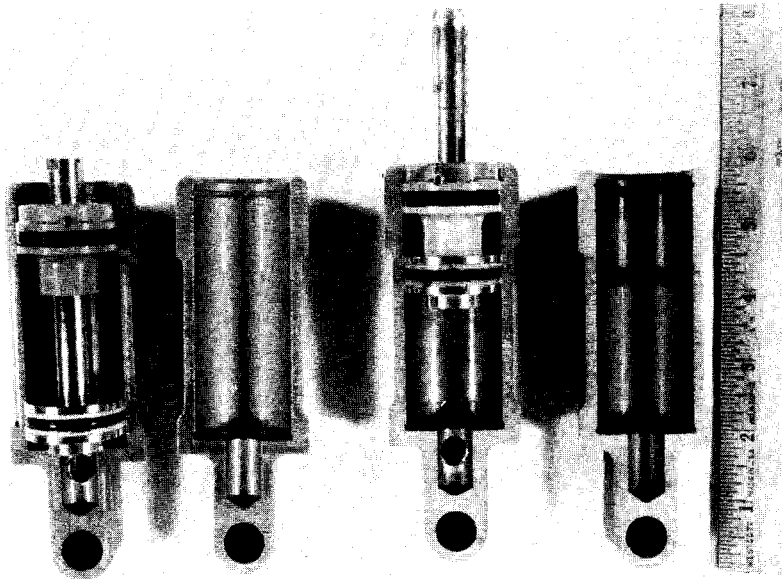
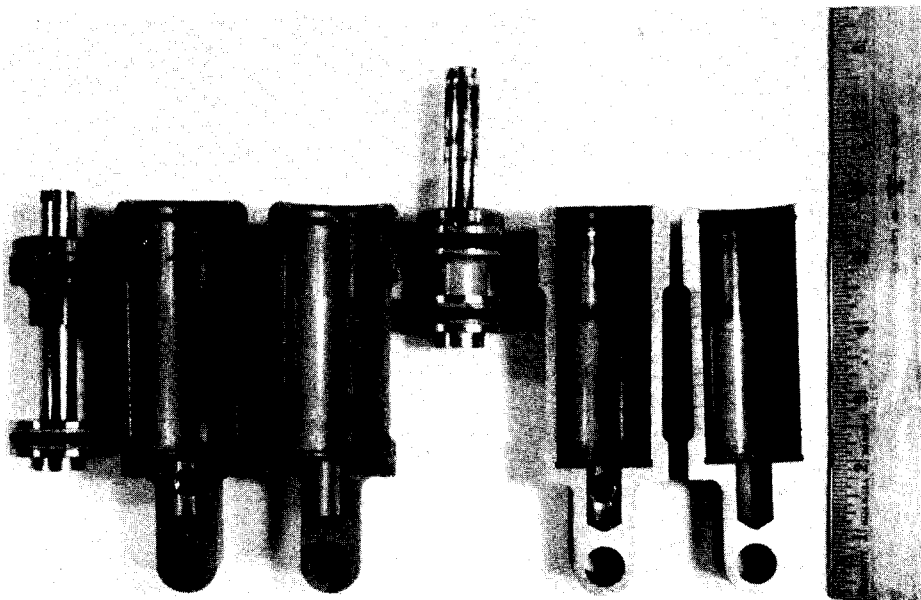
Pistons out of barrel.
Figure 1.

The left and right spoiler actuators were split in half lengthwise and examined by an engineering firm to determine if a materials trace pattern could be identified to indicate the position of the spoilers at impact or during the ground fire. (See figure 1.) The left spoiler actuator was not damaged by the ground fire; however, traces of rubber specks were found on the inside walls of the actuator, and a faint band was found on the actuator walls, corresponding to the piston O-ring in the extended and the retracted positions. The retract end of the left spoiler actuator barrel assembly was faintly scored; the circular scoring was aligned with the end of the piston rod. (See figure 2.) The right spoiler actuator was damaged by ground fire; heat decomposed rubber specks were found on the actuator walls and a heavy band of dark color was found on the actuator wall corresponding to the piston being in the extended position. The retract end of the barrel assembly was scored; the circular scoring was aligned with the end of the piston rod.

Pistons in barrel

A laboratory inspection of the right spoiler actuator revealed a heavy band of discolored metal on the interior wall that corresponded to the piston being in the extended position, indicating that the spoiler was in the extended position while exposed to the postaccident ground fire. Although circular scoring marks were found on the retract end of the spoiler actuator barrel assembly, examination of the marks was not conclusive in determining whether the scoring was caused by in-service use or by impact damage. The left spoiler actuator barrel assembly had faint scoring marks. Based upon the weight of the physical evidence and the reactions of the airplane during the last part of the flight, the Safety Board concludes that the spoilers were asymmetrical at impact. The aileron trim actuator was recovered in a position toward full travel for left wing down which points to the possibility of a lateral control problem and indicates that the pilot attempted to counteract an uncommanded airplane roll to the right by using aileron trim.

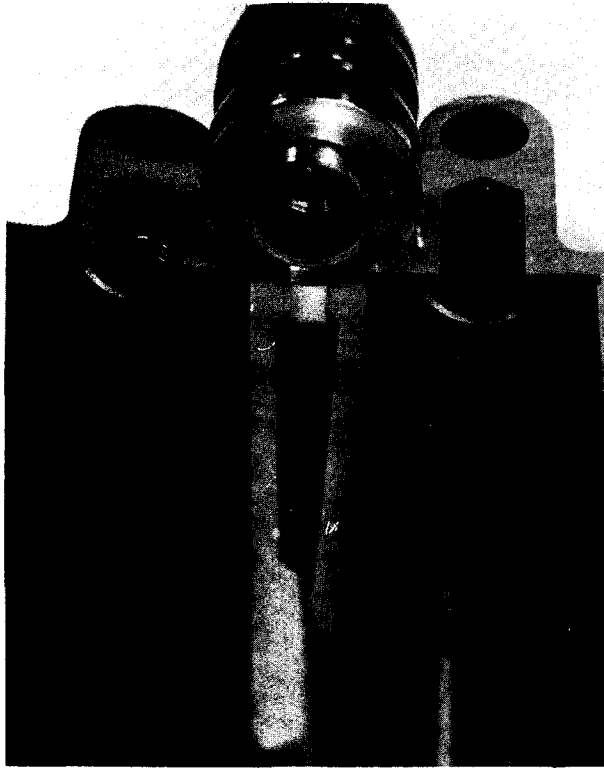
Figure 2.--Scoring at top of barrel, piston at center top.

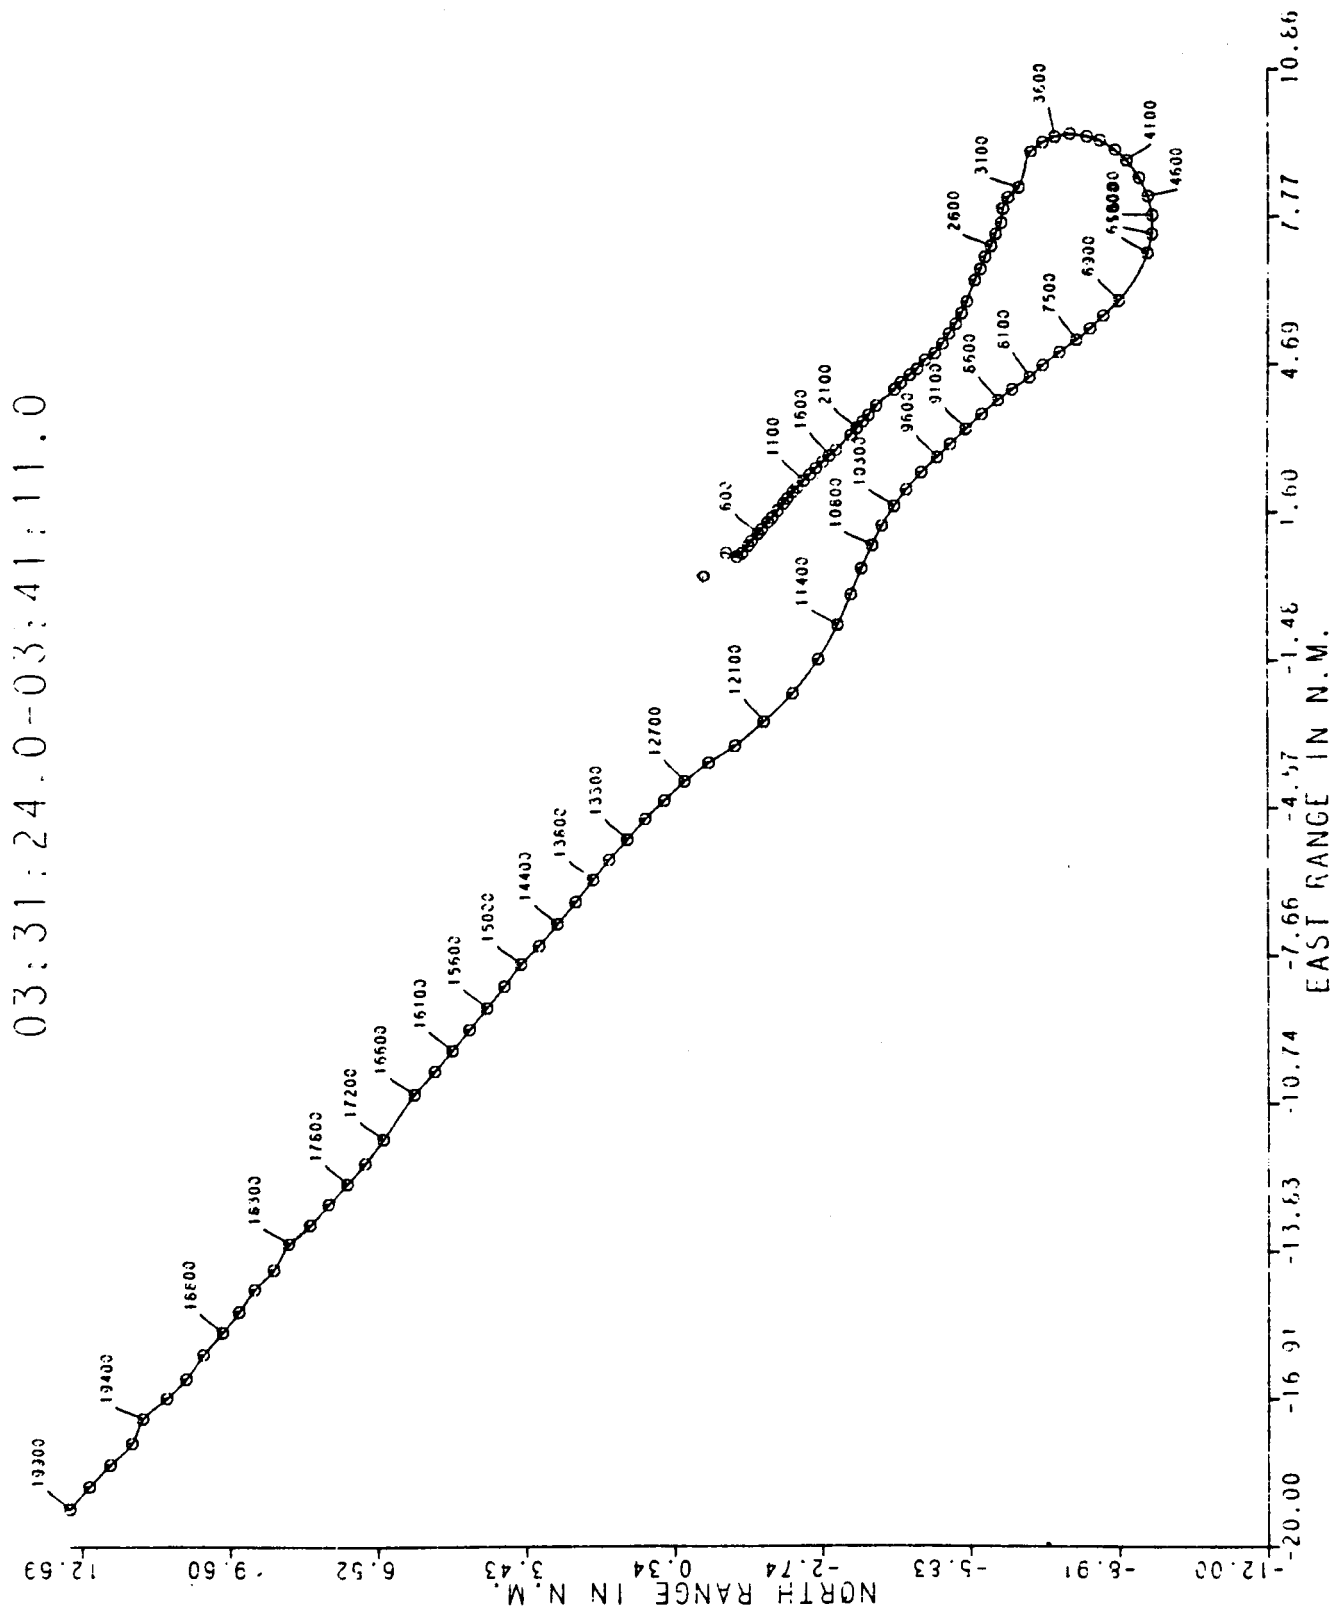
Figure 1.--Plotted data of accident flight.

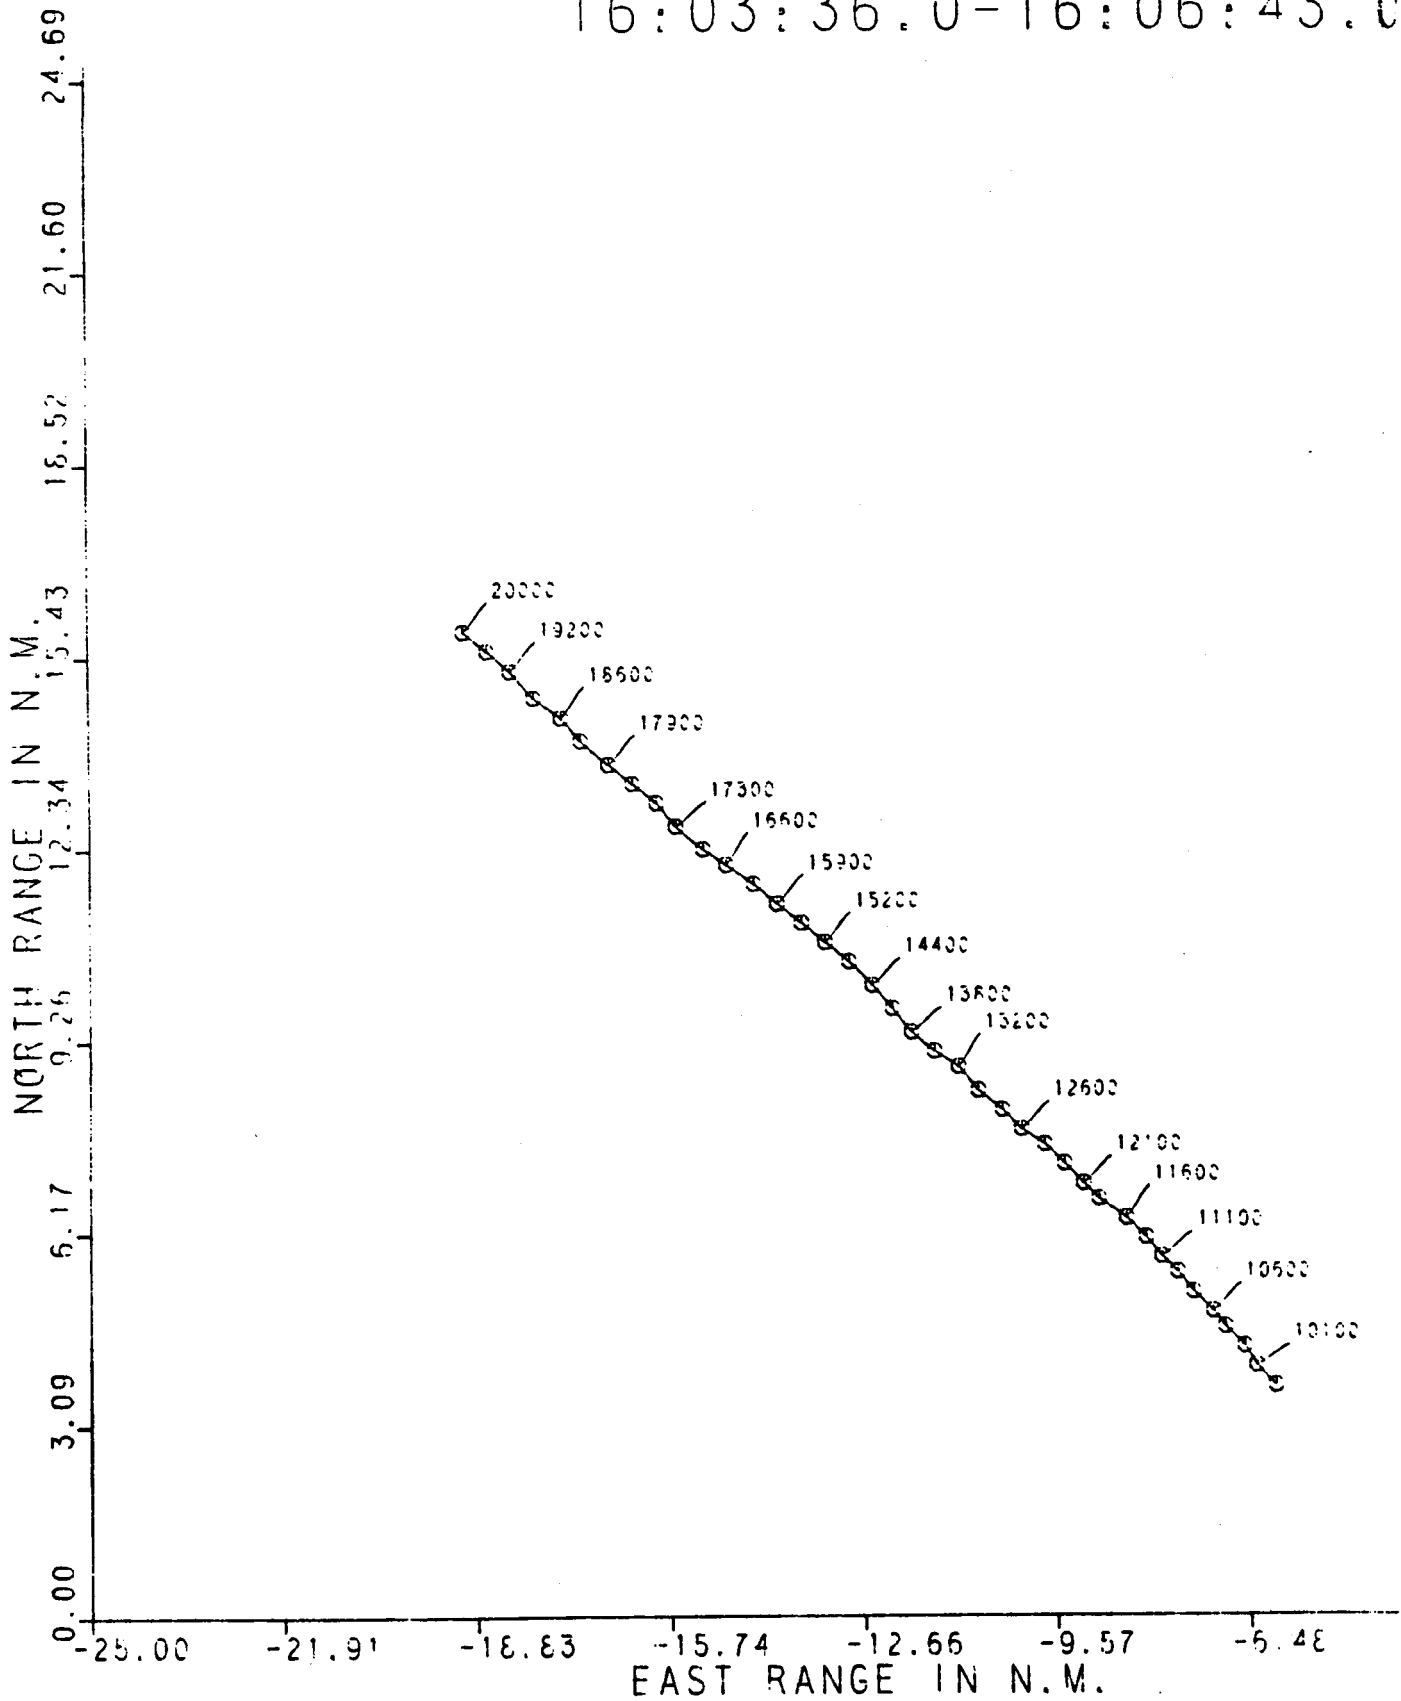
Figure 2.--Plotted data from first profile, spoilers retracted.

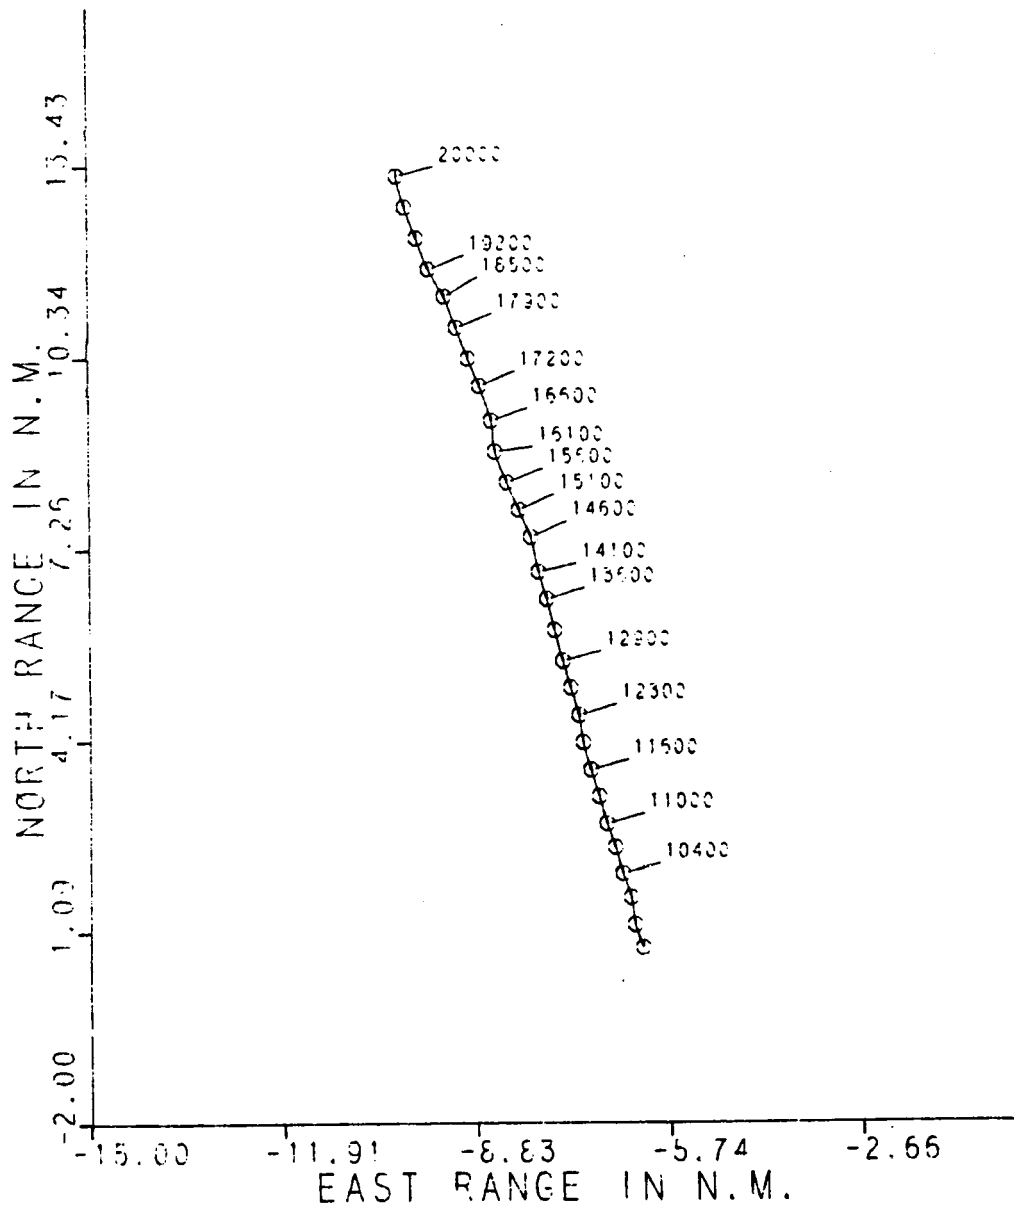
Figure 3.--Plotted data from second profile, spoilers extended.

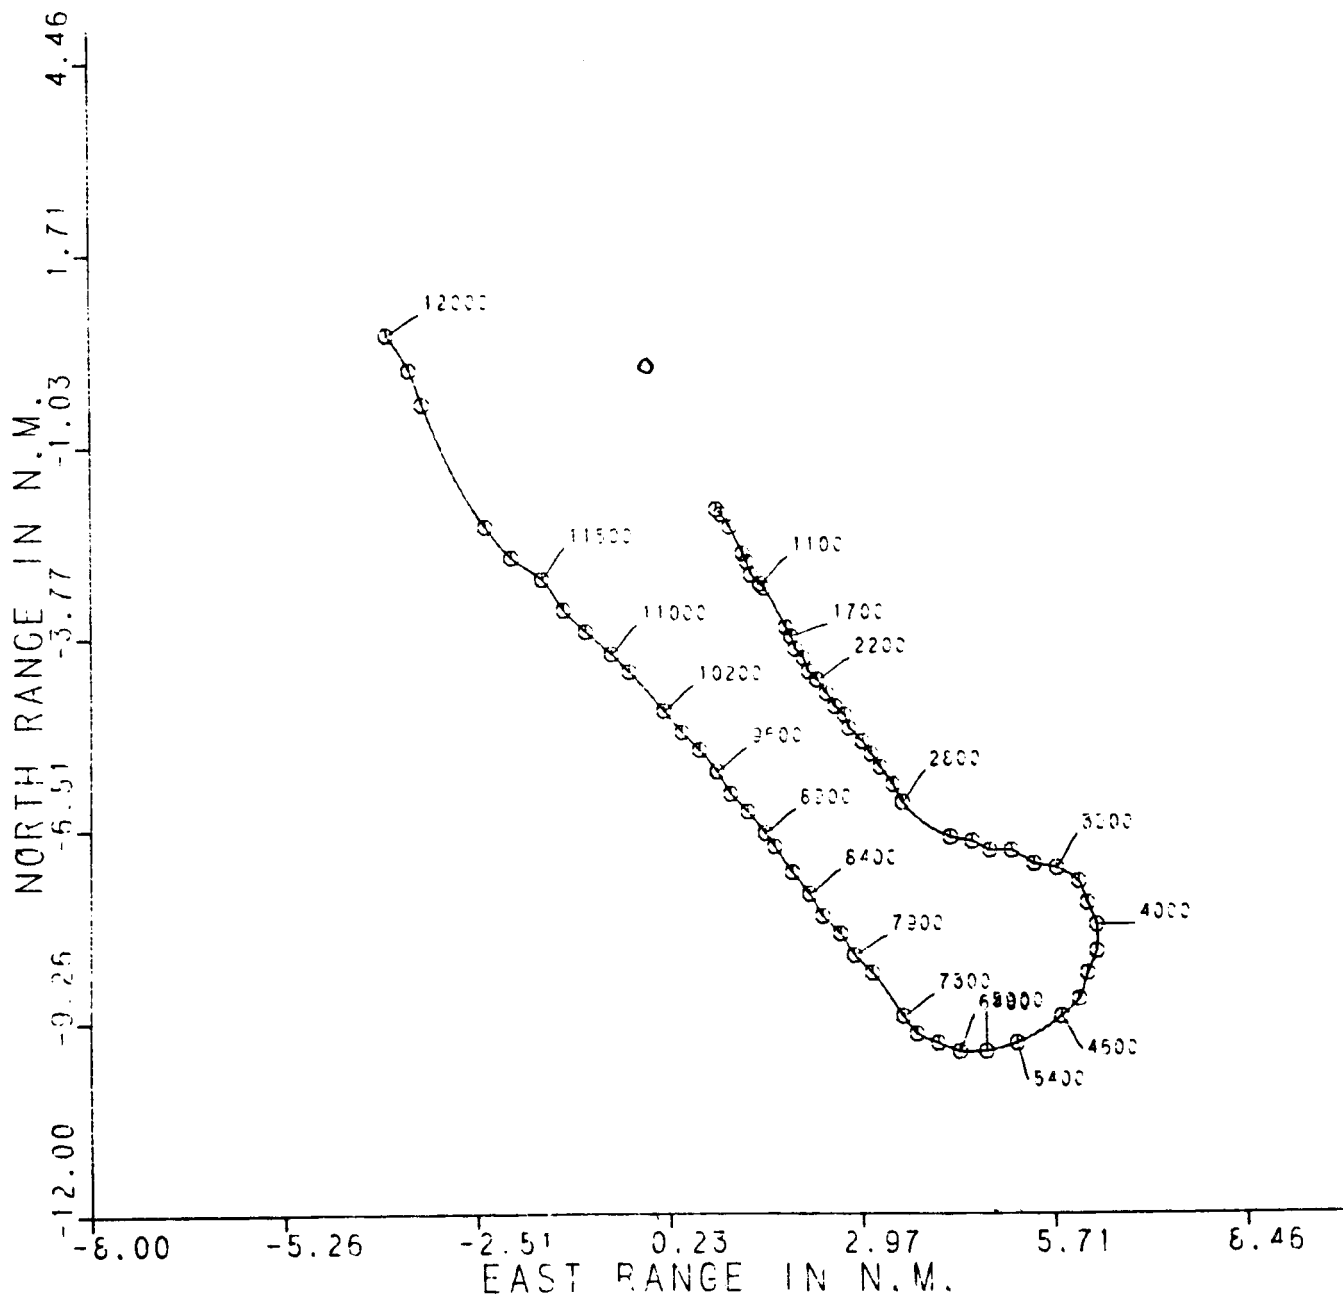
Figure 4.--Plotted data from third profile, spoilers retracted.

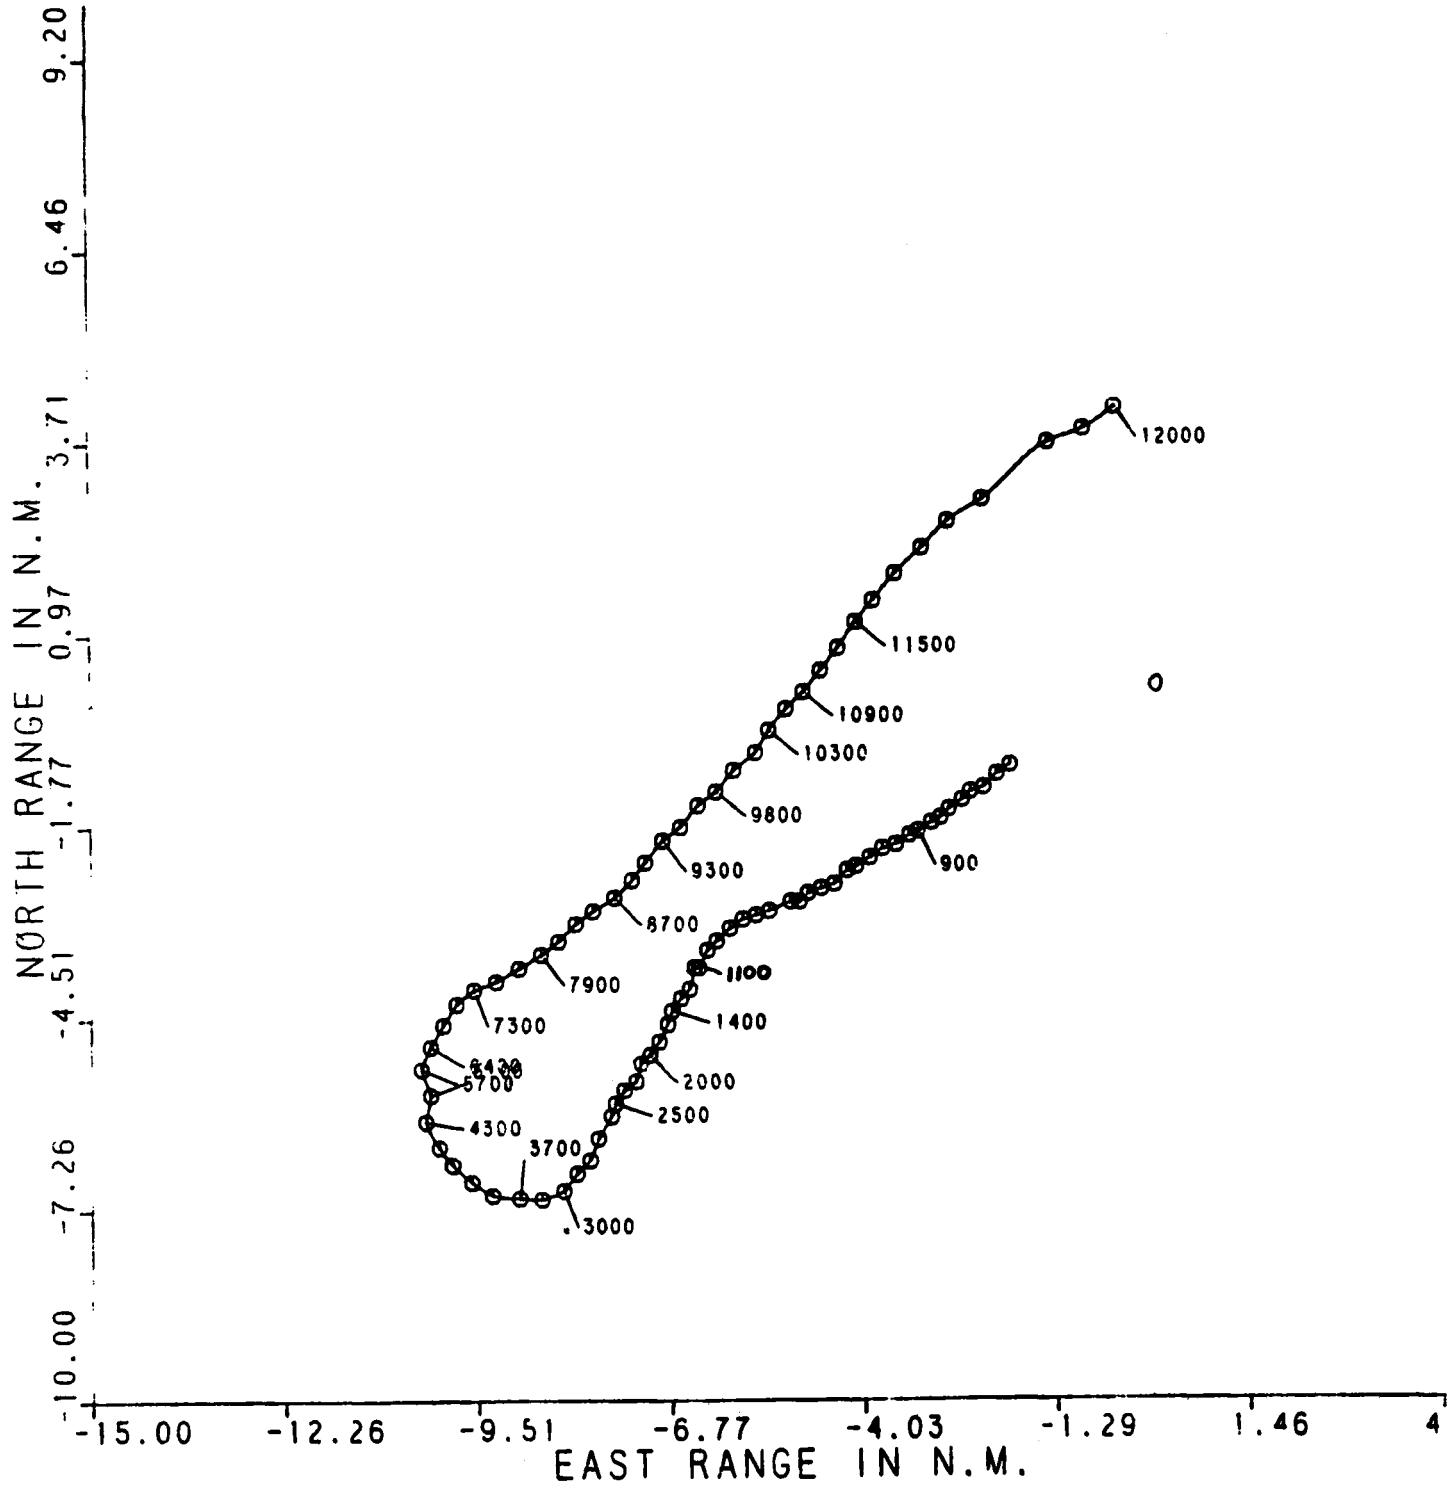
Figure 5.--Plotted data from fourth profile, spoilers extended.
