# **NATIONAL TRANSPORTATION SAFETY BOARD**

## **AIRCRAFT ACCIDENT REPORT**

**KOREAN AIR LINES  
McDONNELL DOUGLAS DC-10-30, HL7339,  
SOUTHCENTRAL AIR PIPER PA-31-350, N35206  
ANCHORAGE, ALASKA  
DECEMBER 23, 1983**

**NTSB/AAR-84/10**

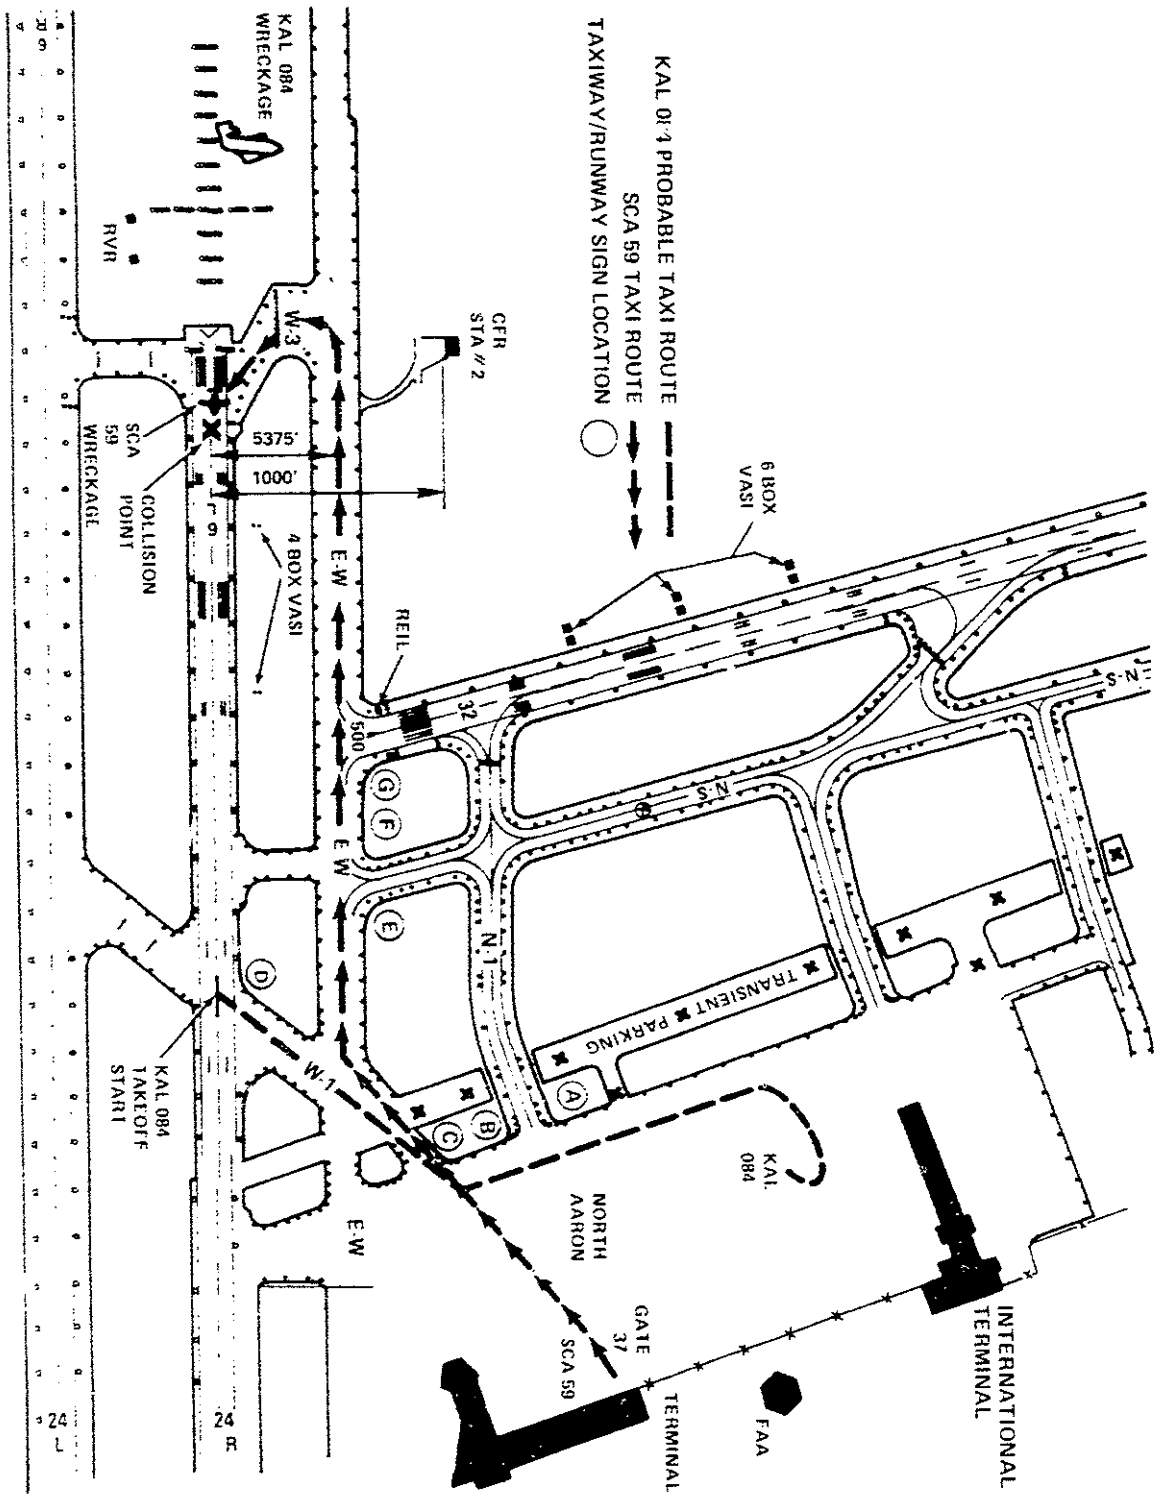
Figure 2.- Airplane taxi routes. Circled letters show locations of corresponding signs in figure 3.

SCA 59 arrived at the intersection of runway 6L and taxiway W-3 at 1344. KAL 084 started to taxi at 1355, 11 minutes after SCA 59 had completed taxiing. The Safety Board investigation team examined possible taxi routes used by KAL 084 to determine which route was most likely used. A transcript of recorded communications between Anchorage tower controllers and the pilots of both airplanes was zero-timed to the start of KAL 084's taxi. (See appendix D.) A SouthCentral Air Piper T1040 turboprop airplane was used and was taxied at a speed comparable to that of observed heavy turbojet aircraft. The transcript was read aloud as the airplane taxied from the parking ramp to the intersection of runway 6L/24R and taxiway W-1 and to runway 31 by various routes. A VHS audio and video record was made by the team member who occupied the copilot seat. The best correlations of time and position were accomplished using the following route (see figure 2):

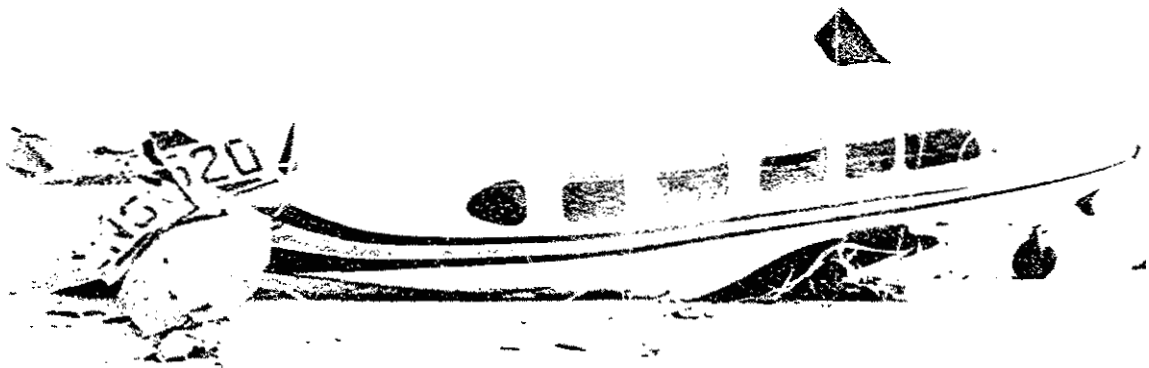
Figure 4.—Wreckage of Southcentral Air Piper PA-31-350, N35206.

PA-31-350.—The PA-31-350 was pushed backwards about 125 feet by the collision and came to rest about 380 feet from the runway 6L threshold identification lights. (See figure 4.) The fuselage of the airplane was aligned with runway 6L. The airplane was resting on the left main gear, nose gear, and aft portion of the fuselage. The right cockpit windshield was cracked through on the right side and the upper section was missing. The top of the fuselage on the right side was creased and caved inward from the windshield attachment area aft to the side window rear post. There were black marks on the dented area.

The right wing of the PA-31-350 was sheared from the fuselage at the wing root. All portions of the right wing, right engine and propeller, and right main landing gear were located and identified. The left wing was separated just outboard of the left engine nacelle. The left engine and associated propeller remained attached to the nacelle structure. A large section of engine cowling remained partially attached to the nacelle lower structure. One of the three propeller blade tips was bent in the aft direction. The wing span of the PA-31-350 is 40 feet 8 inches. The distance from the sheared right wing root to just outside of the left engine nacelle is about 10 feet 6 inches. The upper half of the vertical stabilizer was torn away. The upper portion of the rudder also was torn away but remained attached to the vertical stabilizer at its lower attachment point. The horizontal stabilizer remained intact and attached to the fuselage structure. Both sections of the horizontal stabilizer and associated elevator assembly tip were bent aft. There was no indication of any preaccident malfunction of the airplane's structure, systems, powerplants, or flight control system.
