# **NATIONAL TRANSPORTATION SAFETY BOARD**

## **AIRCRAFT ACCIDENT REPORT**

**BRITTEN-NORMAN BN-2A-6 ISLANDER, N589SA**

**NTSB/AAR-85/08**

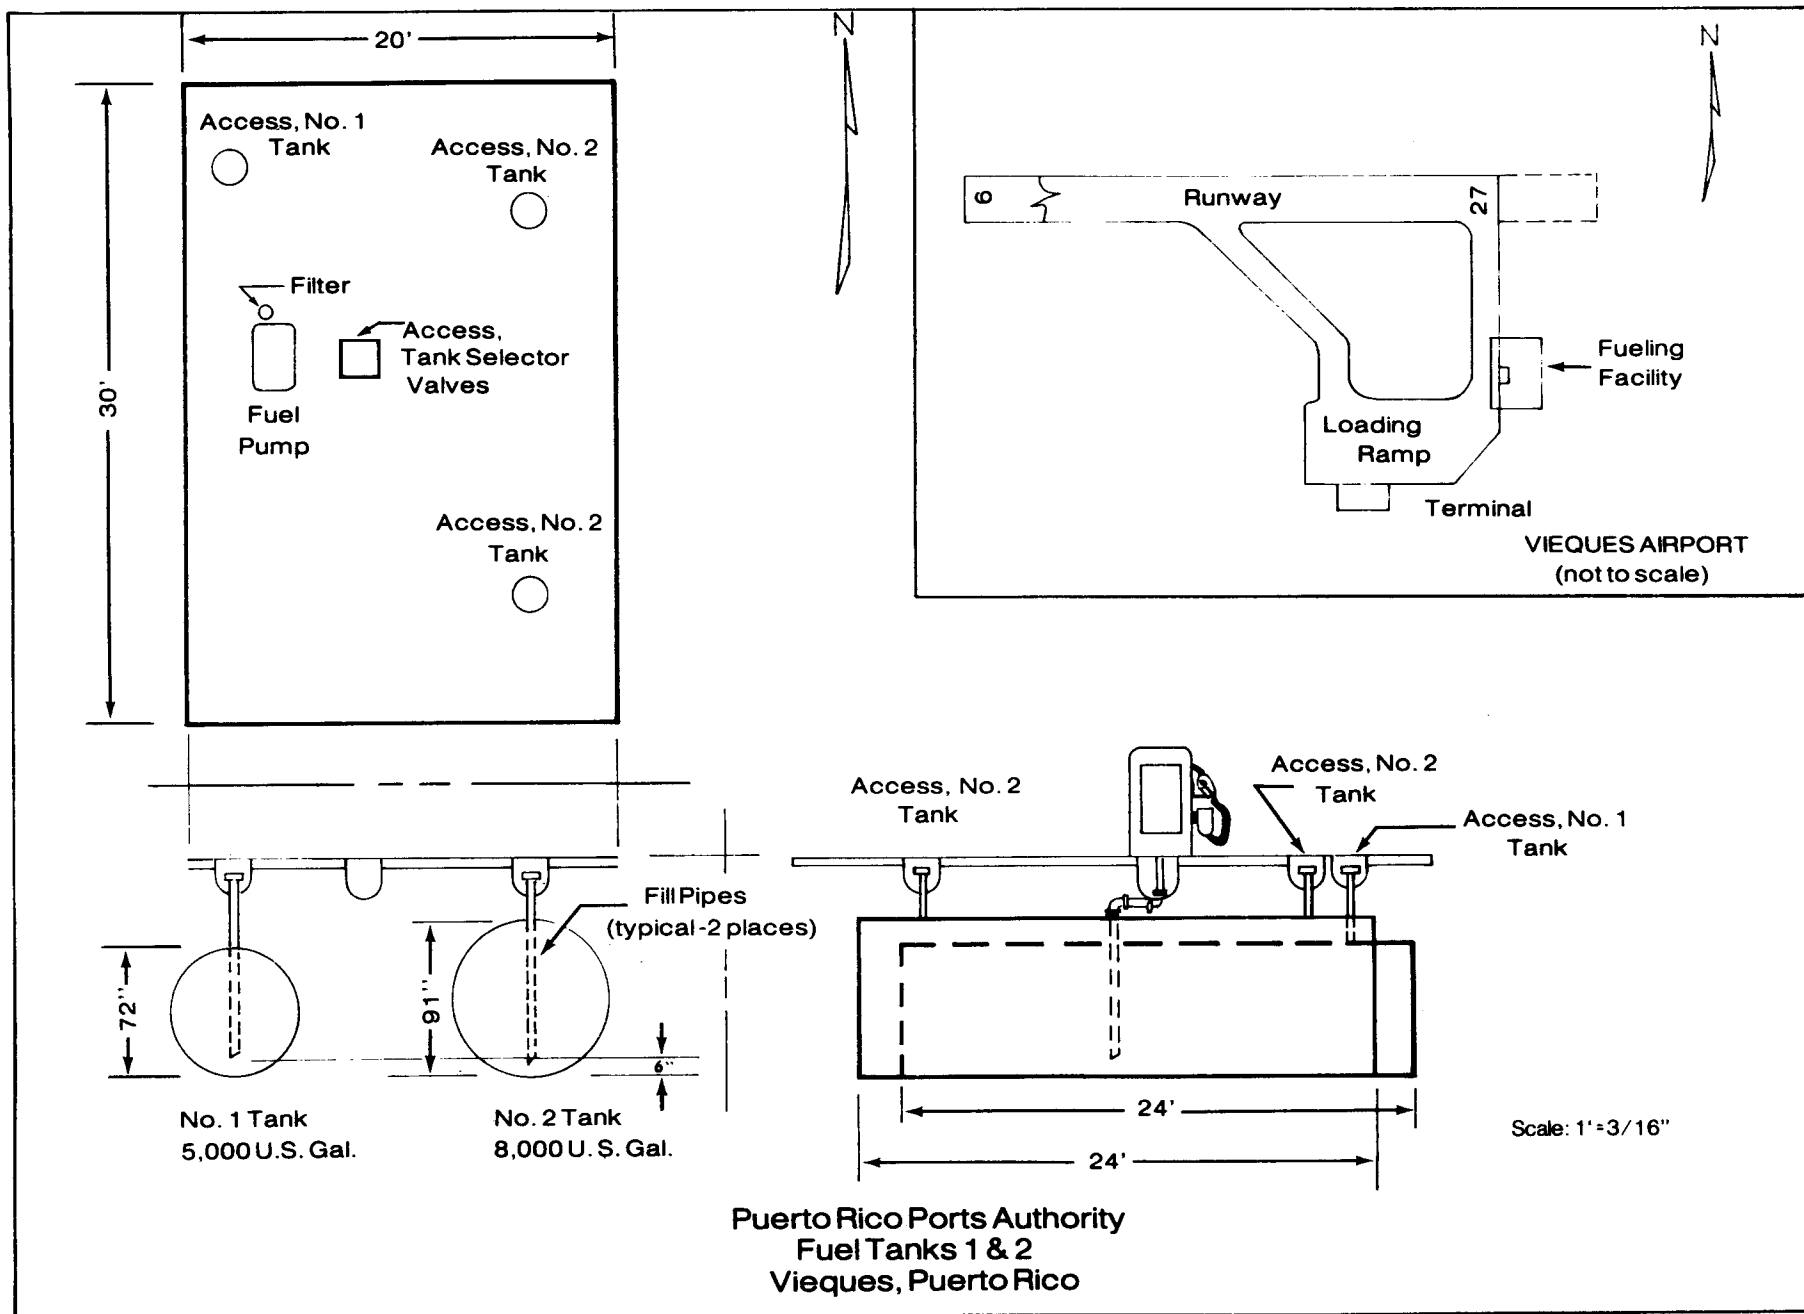
Figure 1.—Fuel facility.

The fueling facility operated by PRPA was located at the east end of the ramp area about 300 feet south of runway 9/27. (See figure 1.) The fueling station consisted of two in-ground steel tanks and one aboveground electric, automotive-type delivery pump.

The investigation revealed that 1 day after the accident the gravel base of the No. 2 fill pipe wells was wet and one of the fill pipe caps was loose on its fill pipe adapter, even though the cam locking levers were down (closed position). The cap could be moved vertically and did not provide an air-tight seal. A portion of the cap's gasket was missing; it measured about 1/4 inch wide in circumference. The outside and inside dimensions of the gasket were different from the gaskets on the other fill pipe caps. The loose gasket was red and the other two were black. The loose gasket was harder than the others and it appeared to have been manufactured locally.

After a very hard rain 2 days after the accident, Safety Board personnel found both fill pipe wells of the No. 2 in-ground tank to be full or partially full of water.
