COMMISSION OF  
INQUIRY INTO THE  
AIR ONTARIO CRASH  
AT DRYDEN, ONTARIO

Final Report

Volume I

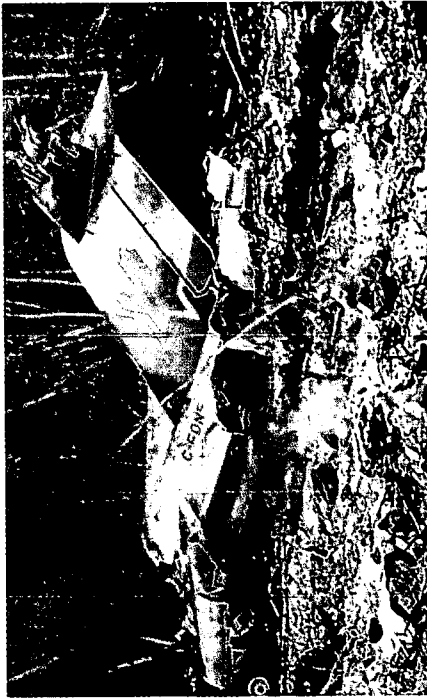
These photographs, taken by one of the fire-fighters in mid-afternoon March 10, 1989, convey the intensity of the fire which, by this time, is nearly extinguished.

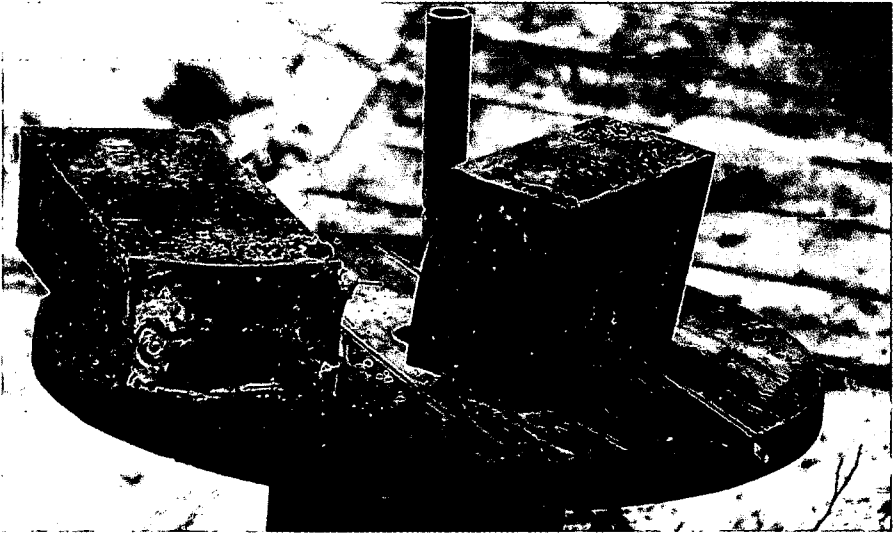
The cockpit voice recorder and flight data recorder were recovered, buried in debris, approximately 24 hours after the crash. On disassembly, it was discovered that the recording medium of both recorders had been destroyed by severe heat damage.

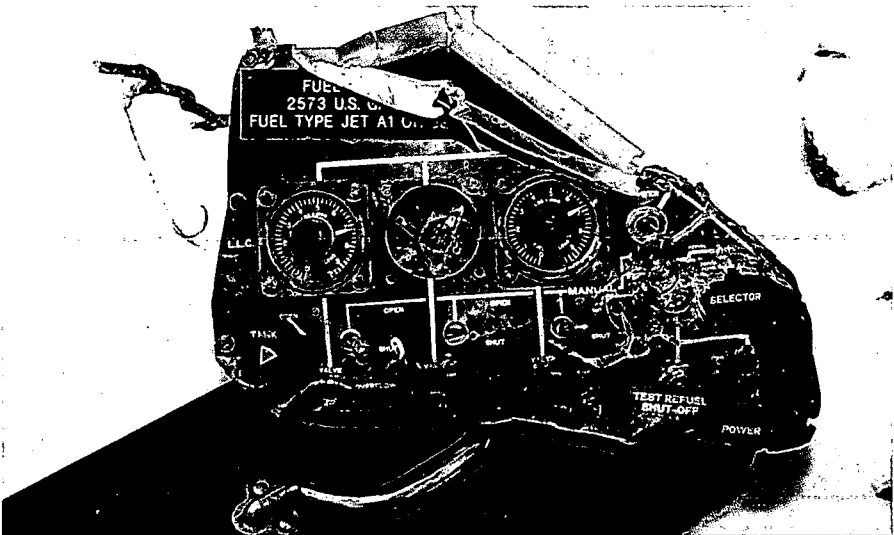
The refuelling panel, located in the wing, shows a fuel load of approximately 14,000 lbs.

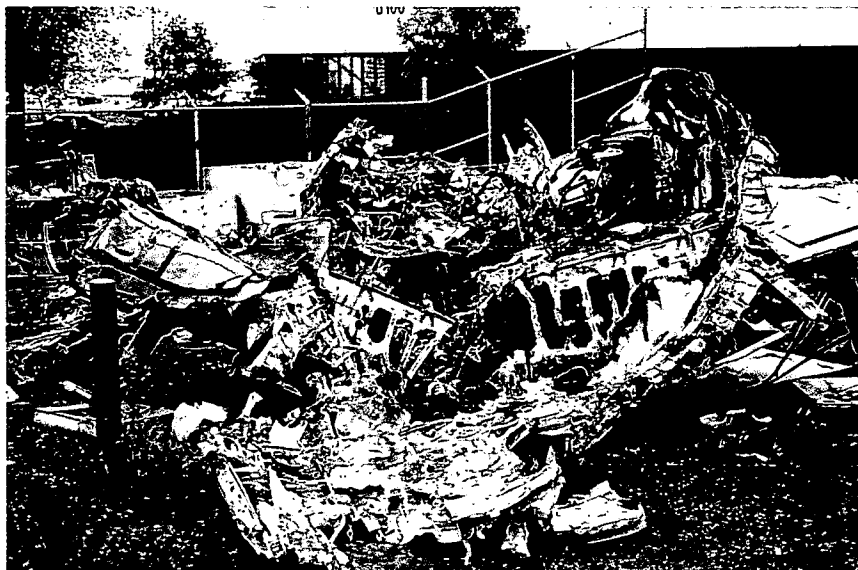
**Figures C-1, C-2**

**Fuselage view from rear showing burnt out cabin area.**
