AIRCRAFT ACCIDENT REPORT

No. 89-032

**BRITTEN NORMAN BN-2A-21
ISLANDER ZK-SFE
Northwest Bay, Pelorus Sound
19 March 1989**

**Transport Accident Investigation Commission
Wellington • New Zealand**

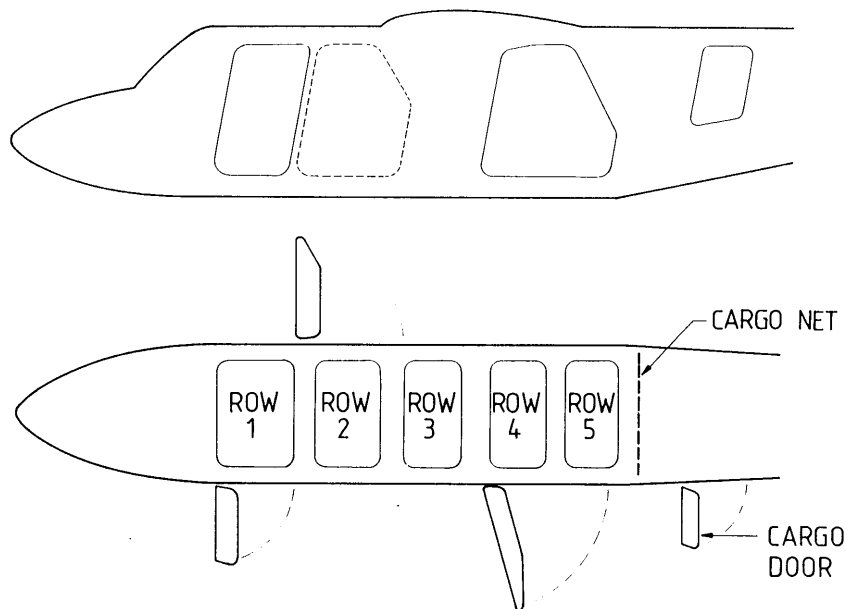
DIAGRAM 1. — SEATING AND DOOR LAYOUT

1.6.6 Doors which hinged forward and outward were located as shown in Diagram 1. These were also the emergency exits of first resort, although an interlock on the pilot's door prevented operation unless the left engine magnetos were switched off, or an override lever (on the inside of the door) was operated.

1.12.4 The aircraft's right hand passenger door was found in the bay. (See Diagram 1) Divers advised that this door had been in place and had been disturbed by them during their original investigation of the wreckage. The emergency exit panel was still in place.

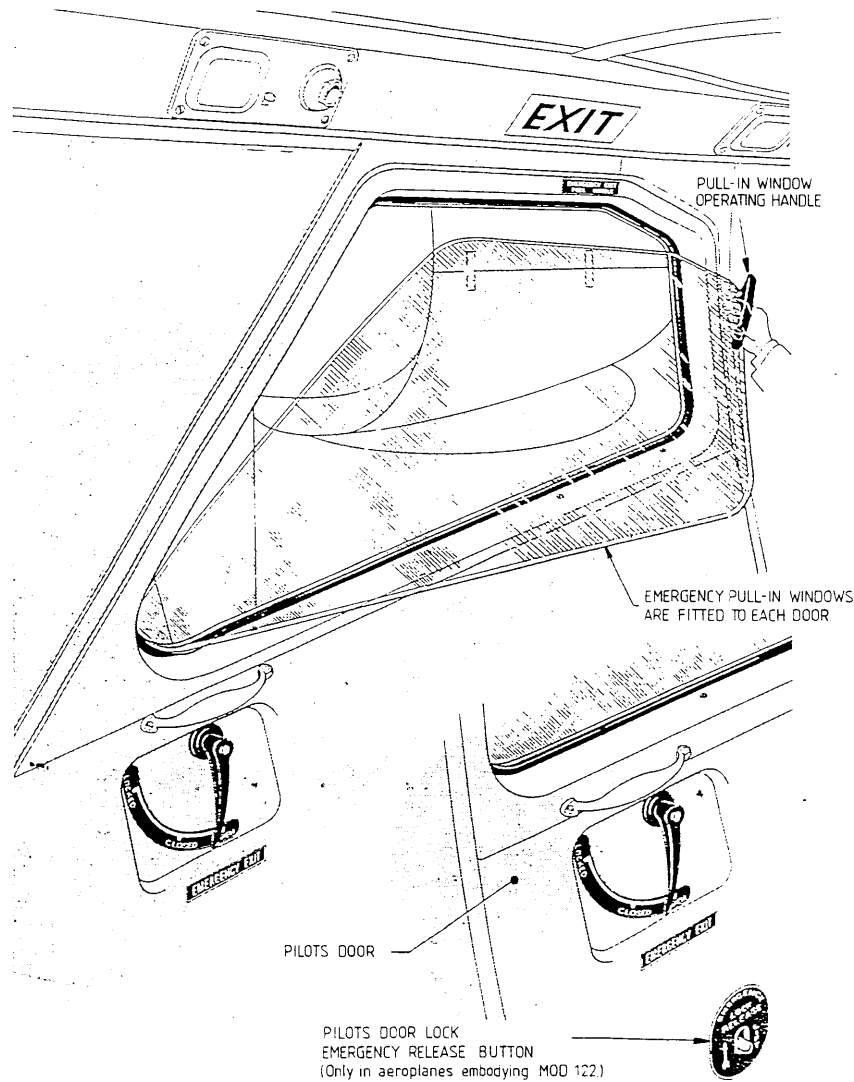
DIAGRAM 2. — EMERGENCY EXITS.

1.6.8 The red handle appeared to have been designed to act as a lever; pulling on the longer side of the asymmetric handle would cause the shorter side to bear on the window surround and thus assist in dislodging the window. However this was not evident either from looking at the handle or from the adjacent instructions which said "Ditching Exit Pull Handle". Diagram 2 appeared in the maintenance documents, not in the approved Flight Manual.

1.6.9 The windows had been sealed against the ingress of rain by use of a polymerising sealant. In subsequent tests a strong man, standing beside a door was unable to remove the window, though he was able to crack the perspex.

2.36 As was to be expected in a ditching, some of the aircraft’s doors could not be opened. However the emergency exits would not open either because they were sealed in place to prevent rain water leaking in. It was unlikely that they had ever been tested to see if they could be opened. It was fortunate that the cargo netting between the cabin and the cargo bay had come adrift in the accident and that a strong passenger recovered sufficiently quickly to reach the cargo door and kick it open. This situation indicated the desirability for any door which might be used in an emergency to have a large and obvious handle with which to open it.

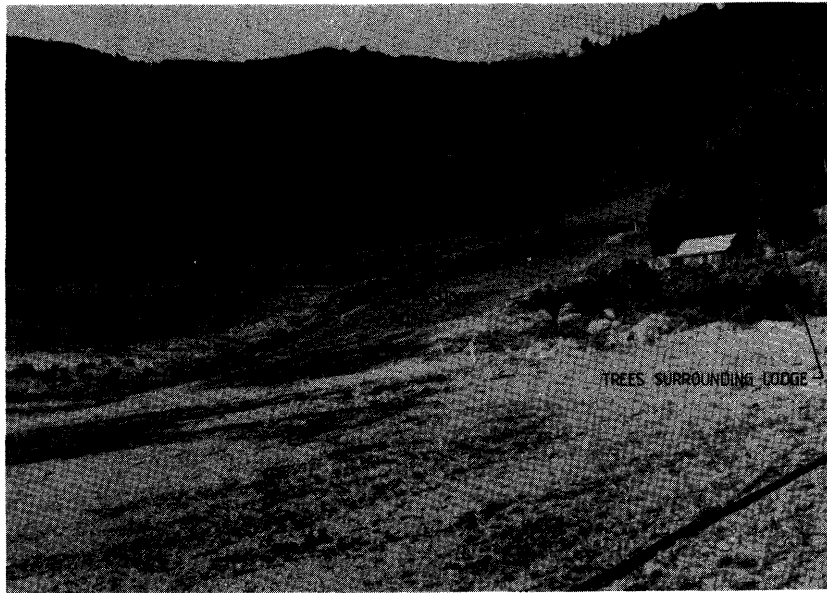
DIAGRAM 4. — AIRSTRIP FROM TURNING BAY.

eastern boundary fence. The broken telephone pole was just outside the fence. The wire had been at 4.7 m above ground level at the pole and would have passed some two metres above the top of the fence. There was no indication of the aircraft having struck either the fence or the pole.

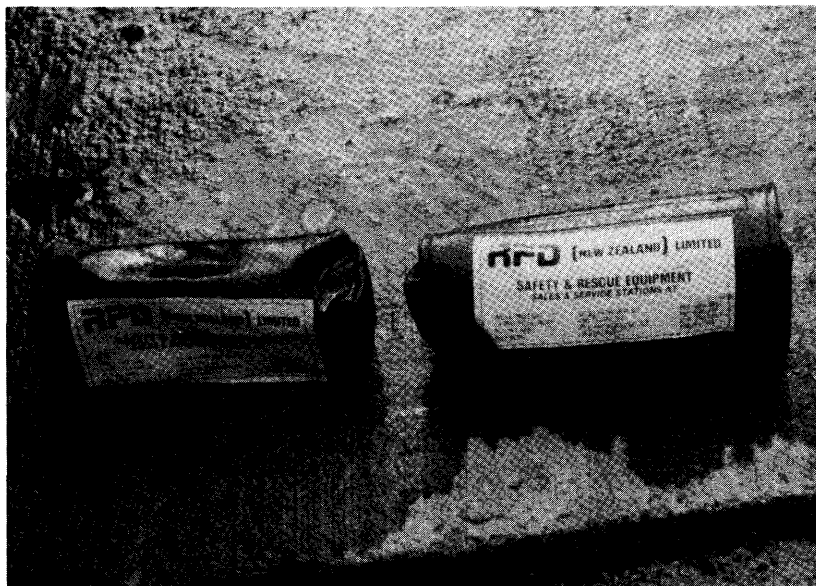
DIAGRAM 5. — LIFEJACKETS IN SATCHELS.

1.15.2 The aircraft's life jackets were in individual sealed plastic satchels, stowed in a bag near the pilot's seat. The passenger seated behind the pilot was aware of this and when it seemed to her that the aircraft might dive into the sea, she passed two of the life jackets to the passengers seated in the row behind her. The writing on the life jacket's satchels did not indicate what the contents were, how to open them, or how to don the life jacket. (See Diagram 5) The recipients, unaware of what they were, discarded them as being of no value in the imminent accident.

2.35 The life jackets had been stowed in a valise near the pilot’s seat. The Regulations expressly required them to be stowed within reach of each passenger while seated. It was fortuitous that the passenger seated behind the pilot knew where the life jackets were and started to hand them out, but her efforts were unavailing because the life jackets were contained in satchels which did not indicate what the contents were, let alone how to use them. The lack of available, clearly marked life jackets might have caused fatalities had rescuers not arrived at the wreckage promptly.
