AIRCRAFT ACCIDENT

No. 89-112

**CESSNA 207 ZK-DAX
and
CESSNA 207 ZK-DQF**

30 December 1989

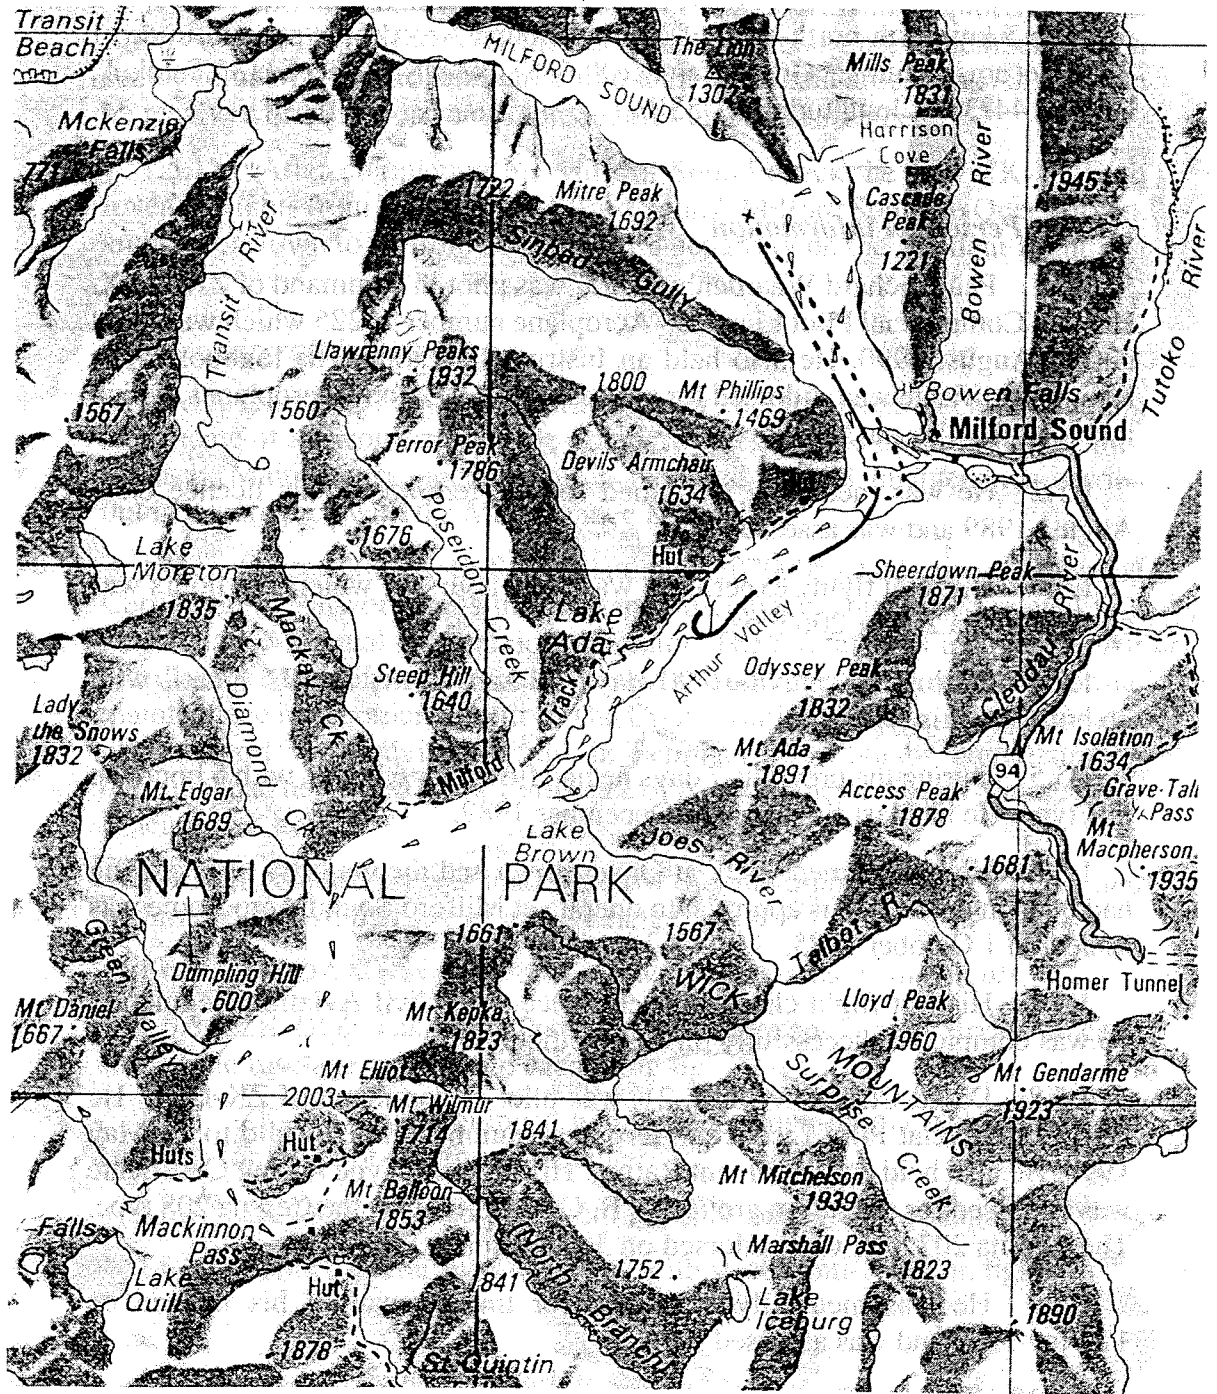
FIGURE 1

1.1.6 ZK-DAX, the last aircraft of the group in the Arthur Valley, had been turned after the first aircraft of the group had passed, to follow it back down the Arthur Valley to Milford Sound. The pilot had broadcast by RTF of his return as he passed Lake Ada, some 5 nautical miles (nm) from the aerodrome and this transmission had initiated the action taken by the supervising pilot and the pilot of ZK-DQF in turning over the aerodrome to head down the Sound.

▷▷▷ STANDARD ROUTE TO MACKINNON PASS

----- ZK-DQF TURN BACK AT AERODROME

- · - · - ZK-DAX TURN BACK AT LAKE ADA

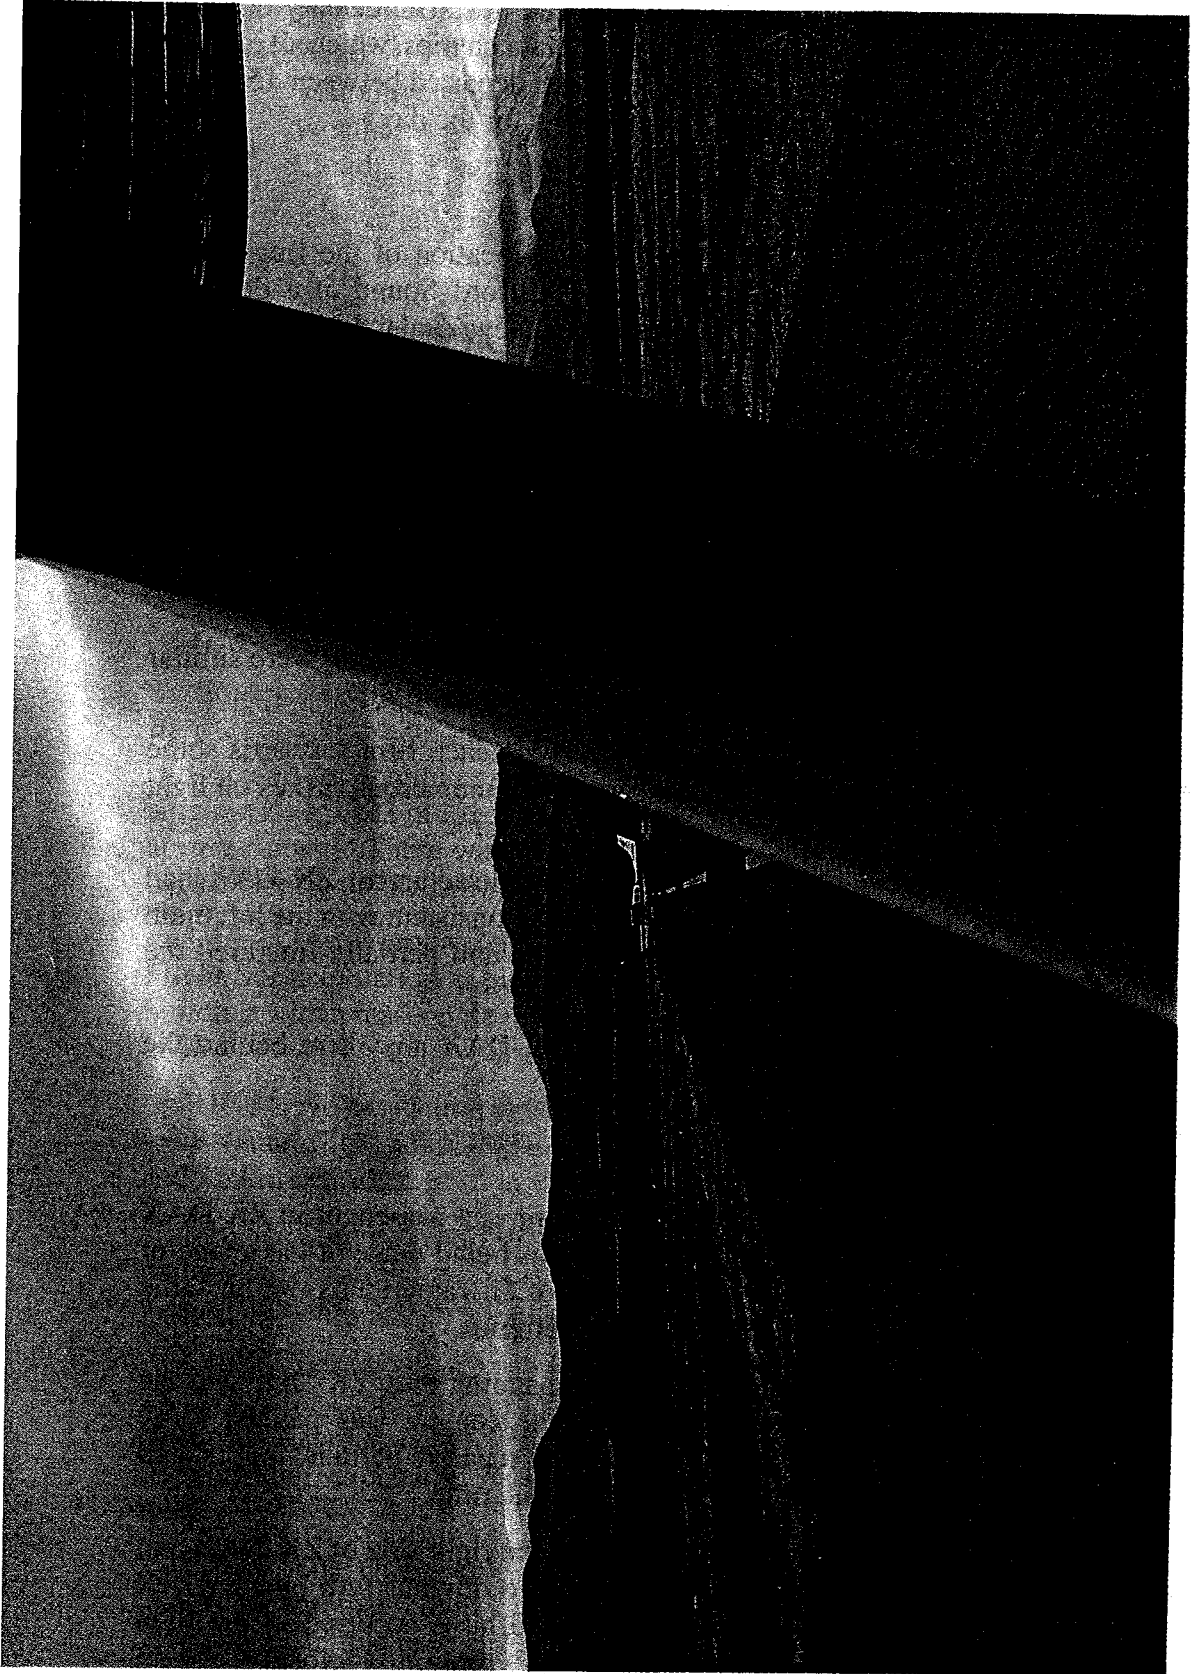
FIGURE 2

Simulation of ZK-DAX passenger's video; aircraft 280m apart, about 20 seconds before collision (80mm lens used)

1.16.5 The second period, at about 12 seconds, showed ZK-DQF at approximately 287 m away, and to have made a slight heading change towards ZK-DAX.

1.16.8 Two similar C207 aircraft were positioned on the ground at the three calculated distances apart, to simulate the views displayed on the videotape. The resulting views of the right hand aircraft compared well with the video, generally confirming the similar height of the two aircraft and the calculated distances (See Figure 2).
