NATIONAL TRANSPORTATION SAFETY BOARD

AIRCRAFT ACCIDENT REPORT

CONTROLLED COLLISION WITH TERRAIN
EXPRESS II AIRLINES, INC./
NORTHWEST AIRLINK FLIGHT 5719
JETSTREAM BA-3100, N334PX
HIBBING, MINNESOTA
DECEMBER 1, 1993

**Adopted: May 24, 1994
Notation 6250A**

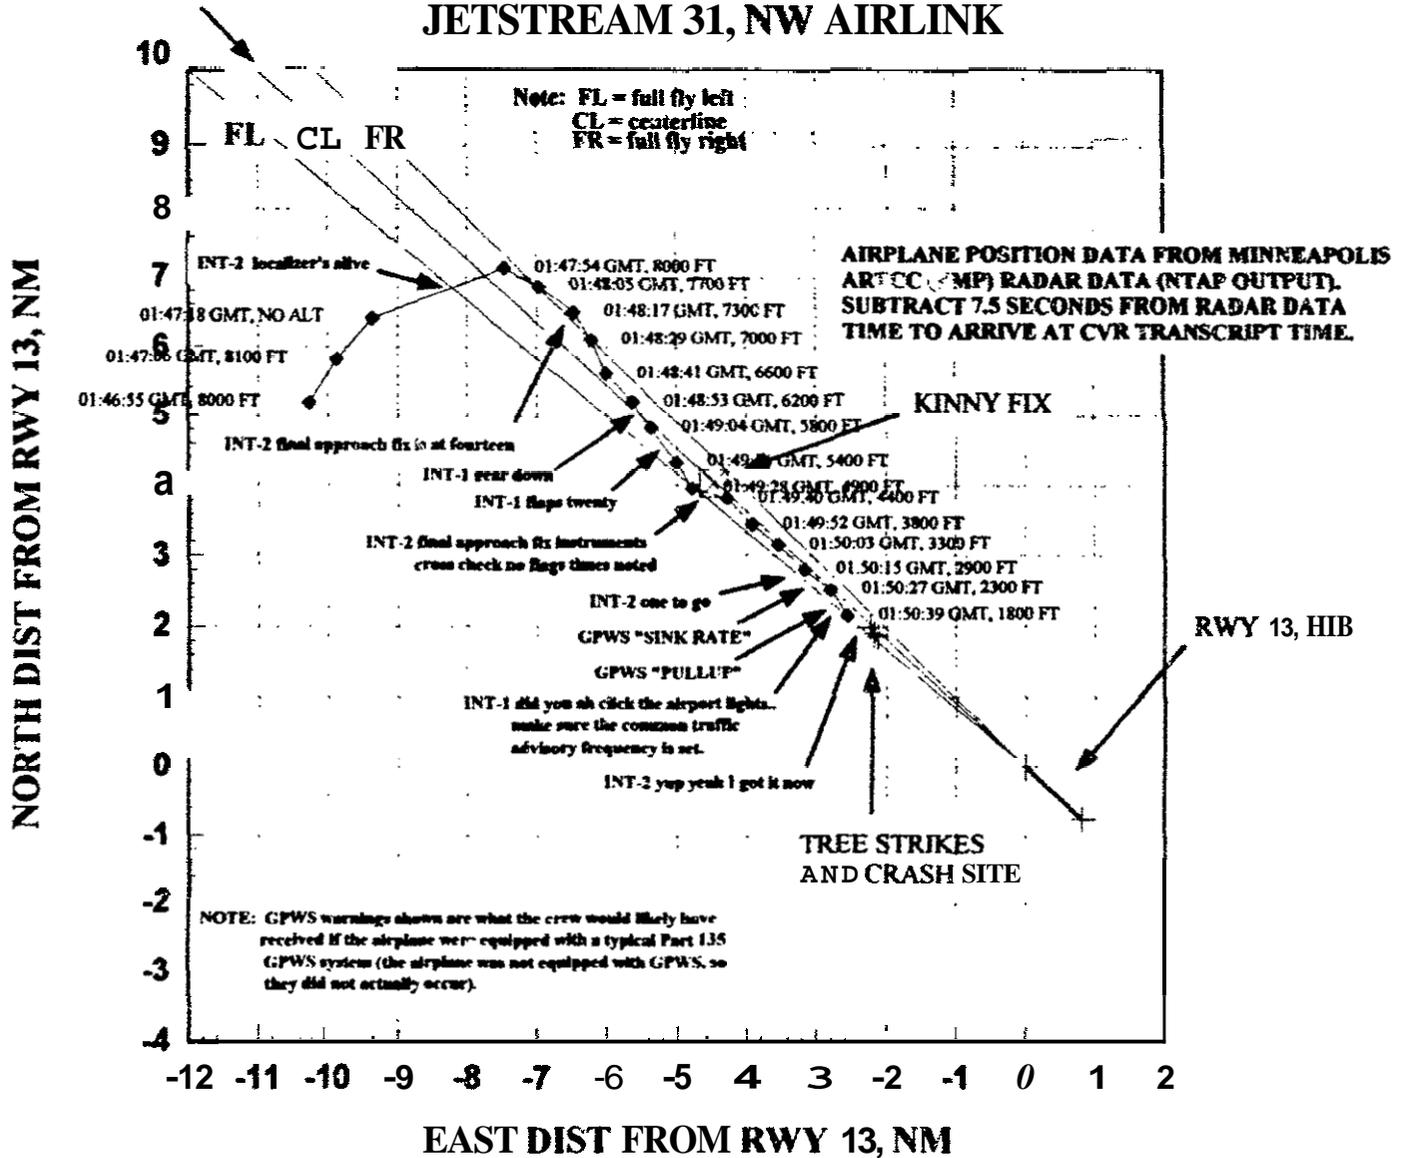
Figure 2.--Plan view of HIB approach.

The accident occurred about 1950, and the airplane was found 2.89 nmi northwest of the **HIB** runway 13 threshold. A special weather observation was taken at 2028 that reported
