Report 96-016

Fletcher FU24-950

ZK-EGQ

Aircraft Accident Report 96-016

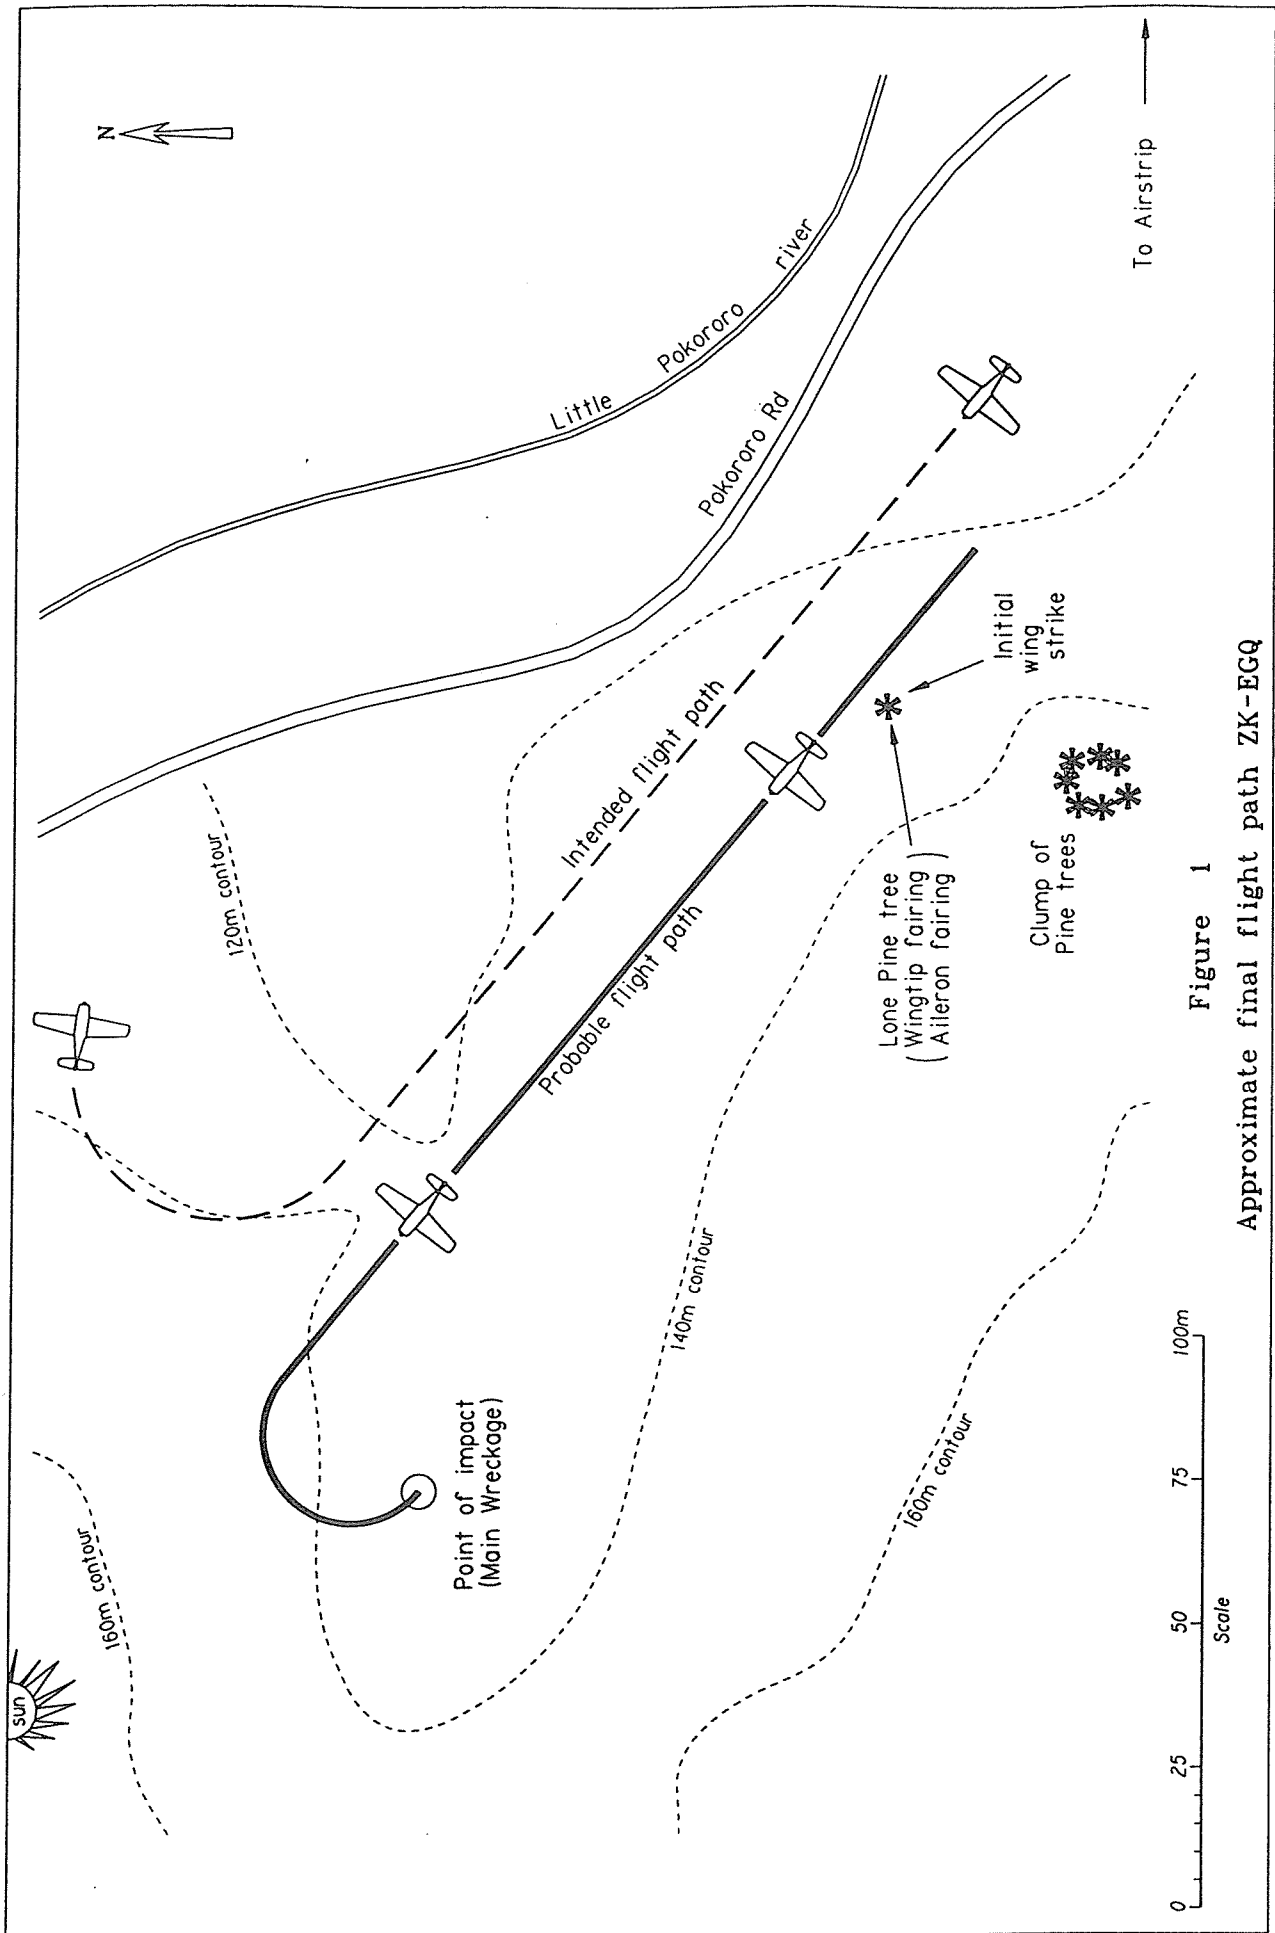
Figure 1
Approximate final flight path ZK-EGQ

- 1.17 The aircraft had collided with the northern face of a ridge situated on the southern side of a valley which ran in an east-west direction. The aircraft had been flying in a westerly direction and sowing along the ridge on the south side of the valley. The collision occurred toward the top of the ridge where the slope was 30°. The aircraft had turned left through 180° prior to the impact and appeared to have stalled, striking the ground nose-first. The ground strike marks showed that the left wing was tilted down parallel with the slope, indicating the aircraft was banked significantly to the left at the time. It was estimated that about half of the load remained on the aircraft at the time of the collision. There was no evidence that the pilot had attempted to jettison this load. The aircraft had struck the face of the ridge heavily, rebounding a short distance, coming to rest upright. The accident was not survivable. See Figure 1 for a diagram of the accident area.

- 2.2 The final flight path of the aircraft suggested that the pilot was not able to turn the aircraft to the right, away from the ridge and towards open terrain, but only to the left toward rising terrain. It is likely the control disruption caused the aircraft to turn to the left, or the wing collision could have yawed/rolled the aircraft left, and the damage prevented the pilot rolling the aircraft back to the right. In an attempt to retrieve the situation, and avoid a collision, the pilot applied full power and probably increased the angle of bank. The aircraft subsequently stalled at a low height from which recovery was not possible.
