REVISED FINAL REPORT

Accident on 6 November 2002 in Luxembourg to the Luxair Fokker 27 Mk050 registered LX-LGB

REVISED ISSUE: JULY 2009

Report N° AET-2009/AC-01

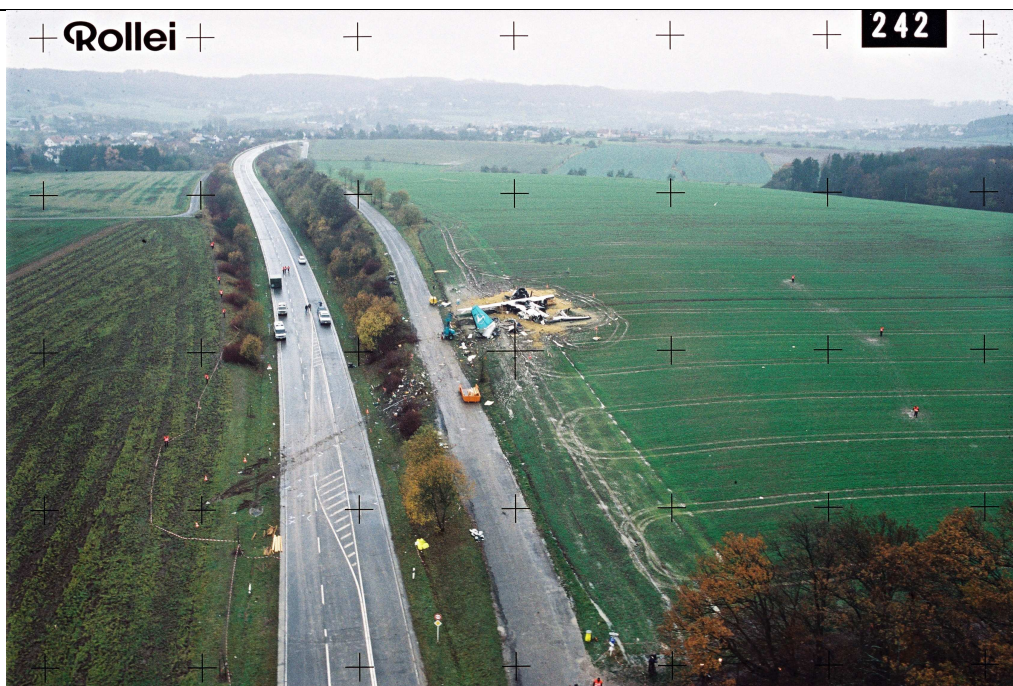
The aircraft touched down approximately on a heading of 295°, as indicated by the general direction of the debris. The first impact marks are found on the south edge of the road RN1. They represent the two main landing gears and the fuselage tail cone.

Scraping marks on the road, notably from the left wing tip show that the aircraft scratched across the road before hitting an embankment at the north side of the road RN1.

Aerial view of RN1 and the site

The major part of the damage results from this impact during which the aircraft lost three blades from the right propeller and two from the left propeller, wheels from the left and right landing gear.

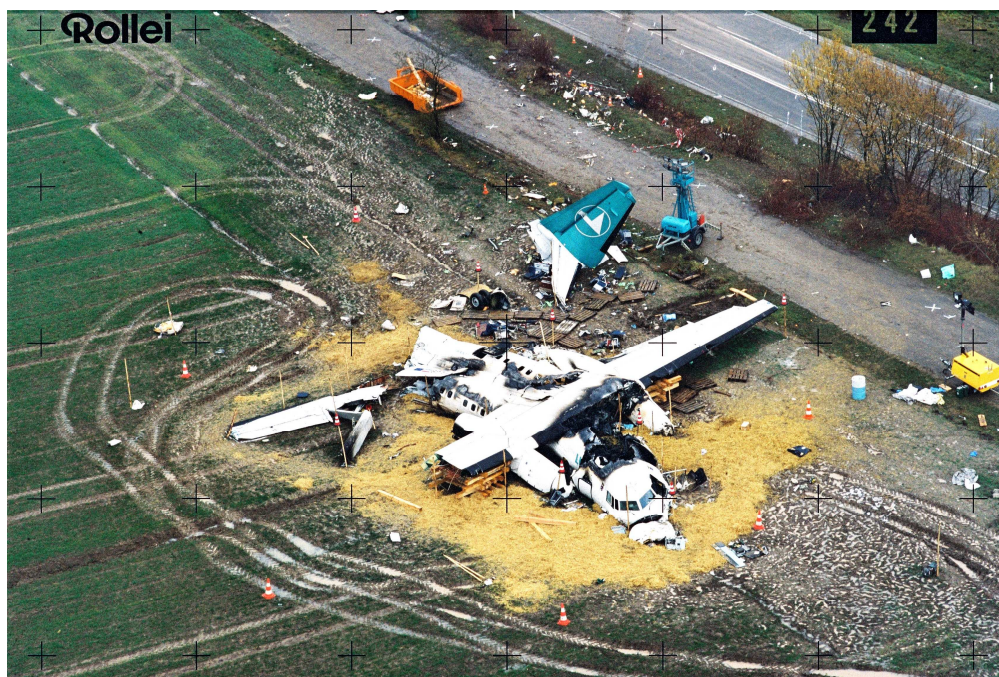
After this bounce, the empennage and part of the right outboard wing broke away, the aft portion of the fuselage turned around to the right and the aircraft came to rest 25 meters further away in a field.

Aerial view of the right hand side of the aircraft

The fuselage and the wings remained attached. The aft portion of the fuselage, including the rudder and the horizontal stabiliser, were detached from the aircraft. The flight data recorders were ejected by impact and found close to the detached aft portion of the fuselage. On the fuselage a more important deformation was noted on the right hand side as compared to the left side. The central part of the fuselage was burnt.

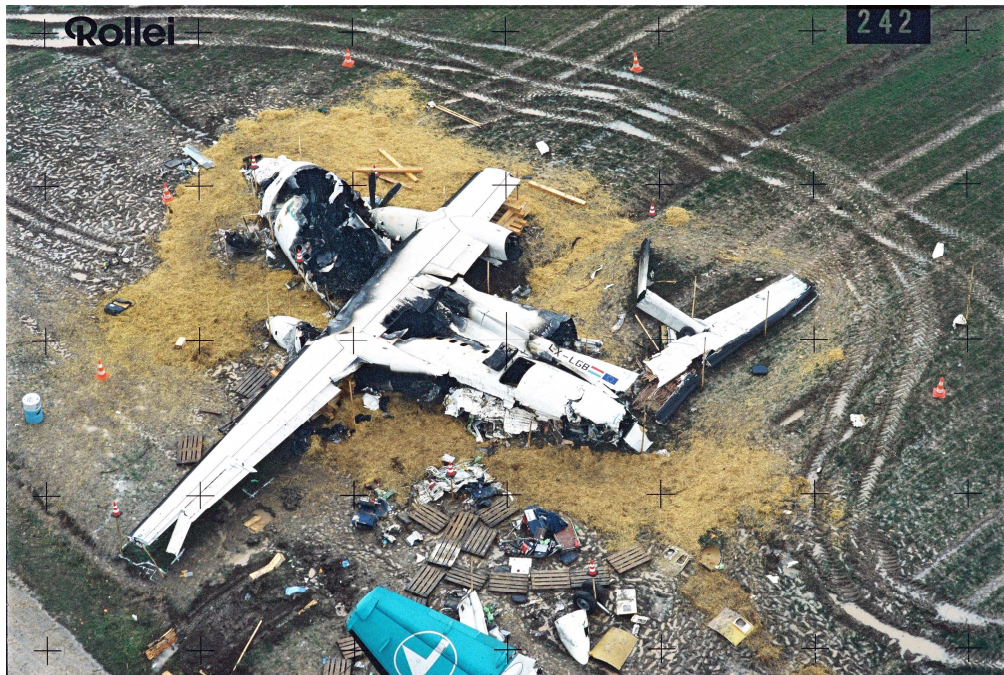
Aerial view of the left hand side of the aircraft

The engines suffered light damage, except for the lower parts that were in contact with the ground. On the left hand side, all propeller blades are broken at their root. On the right hand side, three propeller blades out of six remain attached to the hub. All blades, of composite construction, are damaged. Some are delaminated and others are totally destroyed.

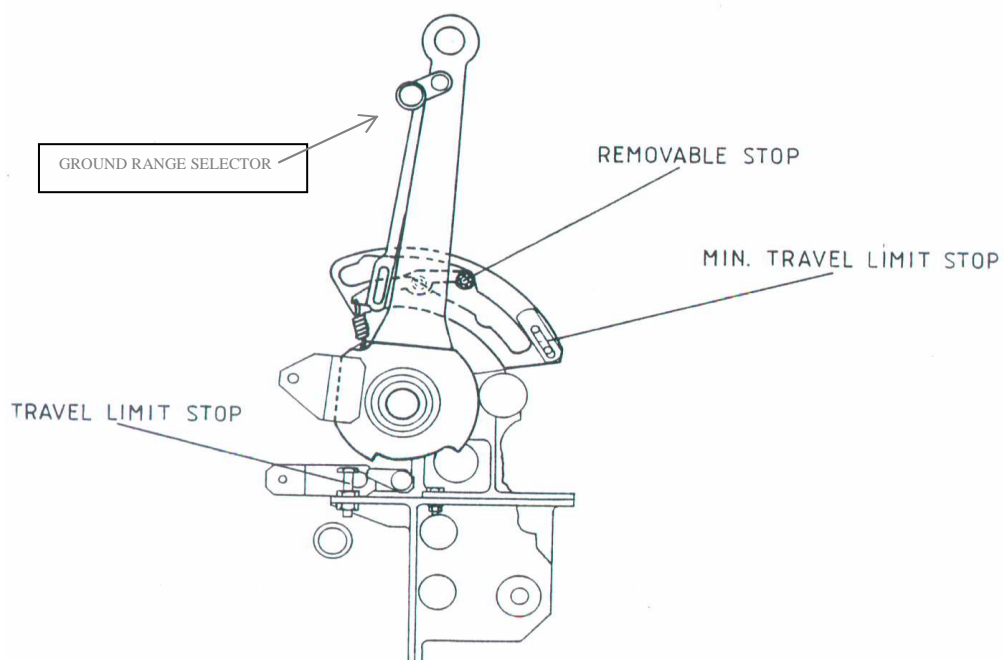
- a mechanical primary stop (ground range selector) on the power levers. This primary stop requires a positive, distinct and separate pilot action, as required by certification regulations

Power levers and ground range selector

During the investigation it was found that, with the power levers in flight idle, it is possible to lift the ground range selectors (primary lock) and move the power levers a small distance further aft until blocked by the secondary lock. This is a deliberate action by the pilot.

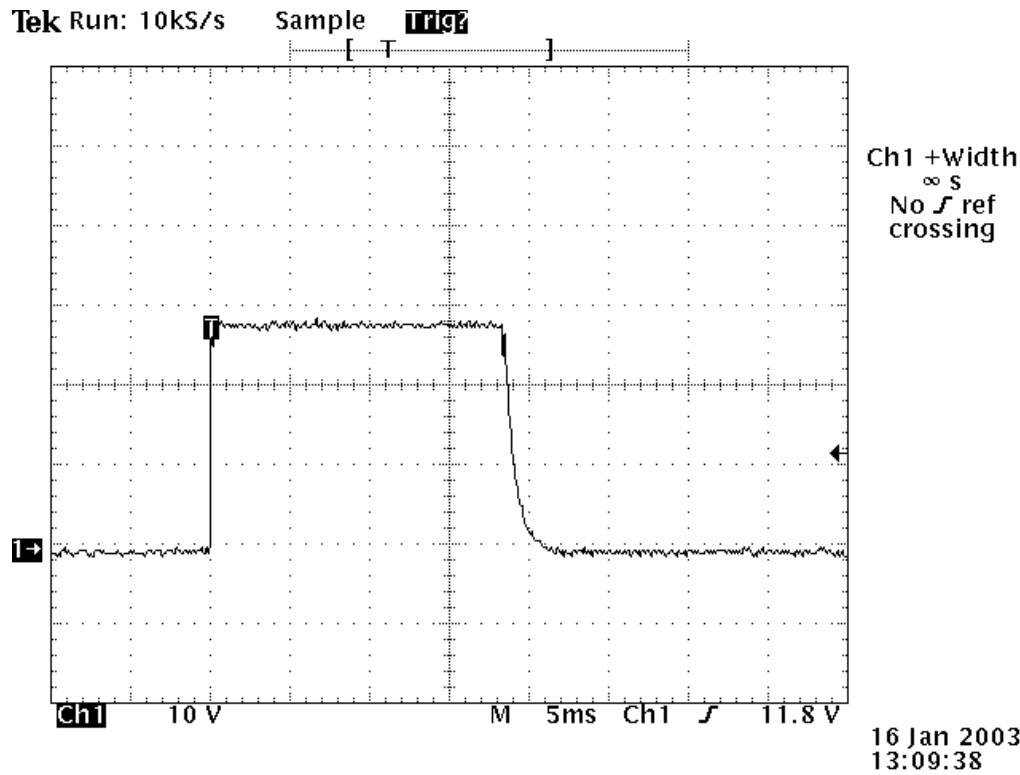
The four wheel speed discrete relays were tested separately in the modes FLT and GND in order to verify their power up behaviour. In mode FLT, the duration of the power up signal was found to be in the range from 13 ms to 20 ms for the four relays. In mode GND, the signal duration was slightly less in the range from 11 ms to 19ms. All signals looked identical,

only the duration varied and the same repeated tests produced always the same results. The following illustration shows the signal from the right hand outboard relay.

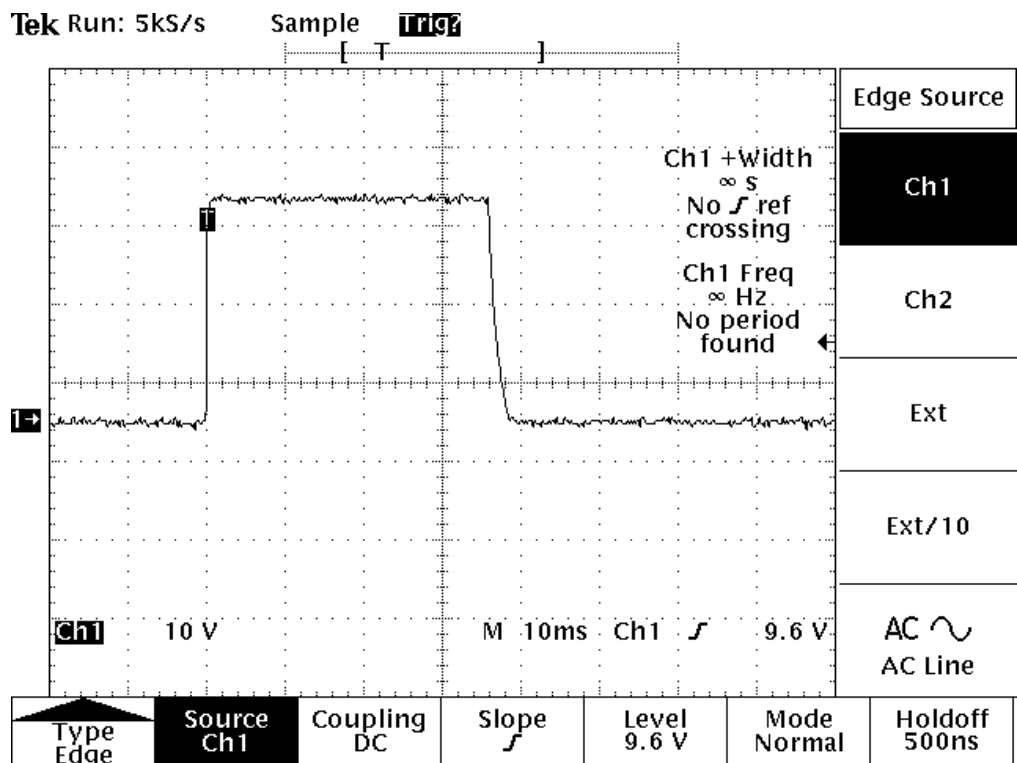
In order to reproduce the aircraft installation, where two relays are connected in series for the left and right hand gear legs, the test set up was reconfigured to observe the power up behaviour, this time only in mode FLT in order to duplicate the aircraft configuration. The duration of the power up signal is found to be 36 ms for both the right and the left hand side. The signal from the RH side is illustrated below.

All signals resemble each other and repetitive tests produce each time the same results.

These tests show the working characteristics of the installation associated with the antiskid control unit, part number 6004125 as installed on the accident aircraft.

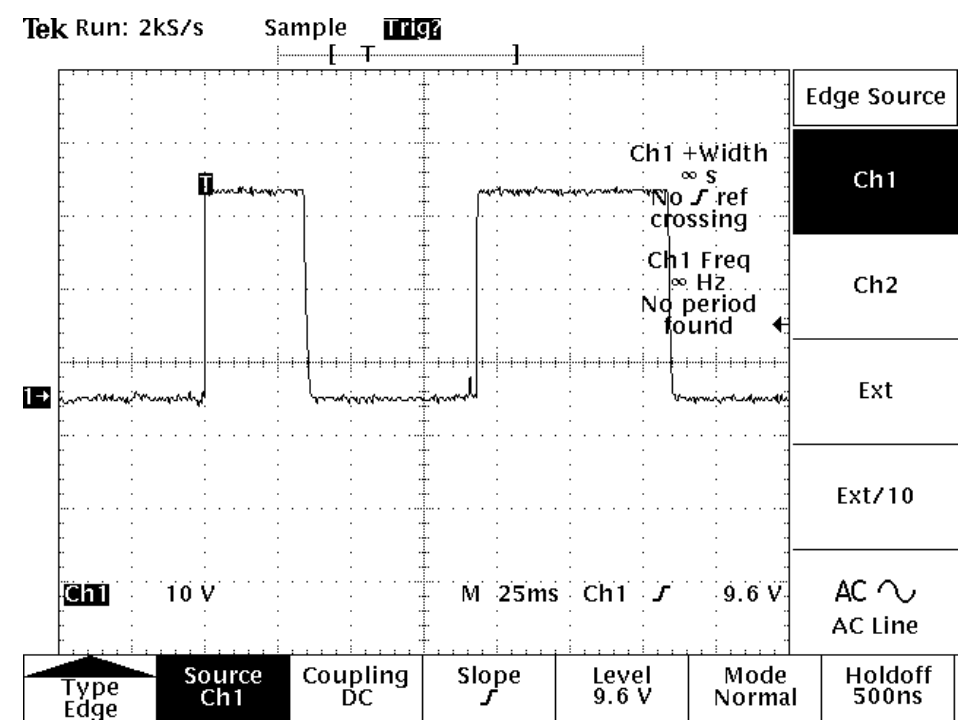
An electrical signal introduced on the TEST button of the antiskid control unit simulated an EMI signal during power up. These tests were executed in mode FLT. It is noted that a new signal is generated repeatedly on power up, showing a duration of around 65 ms. The tests were performed on the unmodified and the modified control unit. The following picture illustrates the signal output of the LH outboard and LH inboard discrete relays for the unmodified control unit.

The result was that the first impulse (~35 ms) was due to the power up of the unit through the release of the main gear up-locks and the second impulse (~65 ms) was triggered by the EMI signal.

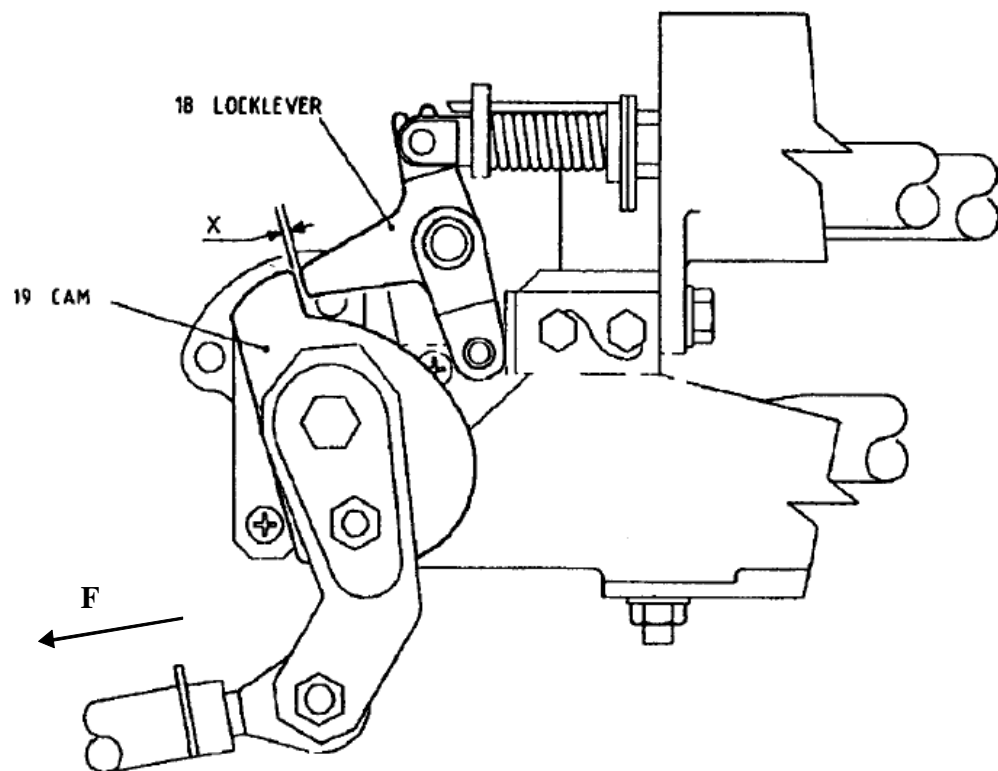
A final test was set up for the determination of the force required to prevent disengagement of the flight idle locklever and cam (see illustration below).

When the flight idle cam is pulled against the flight idle lock lever and the flight idle solenoid is energised, then the amount of force applied, determines whether the flight idle lock can disengage.

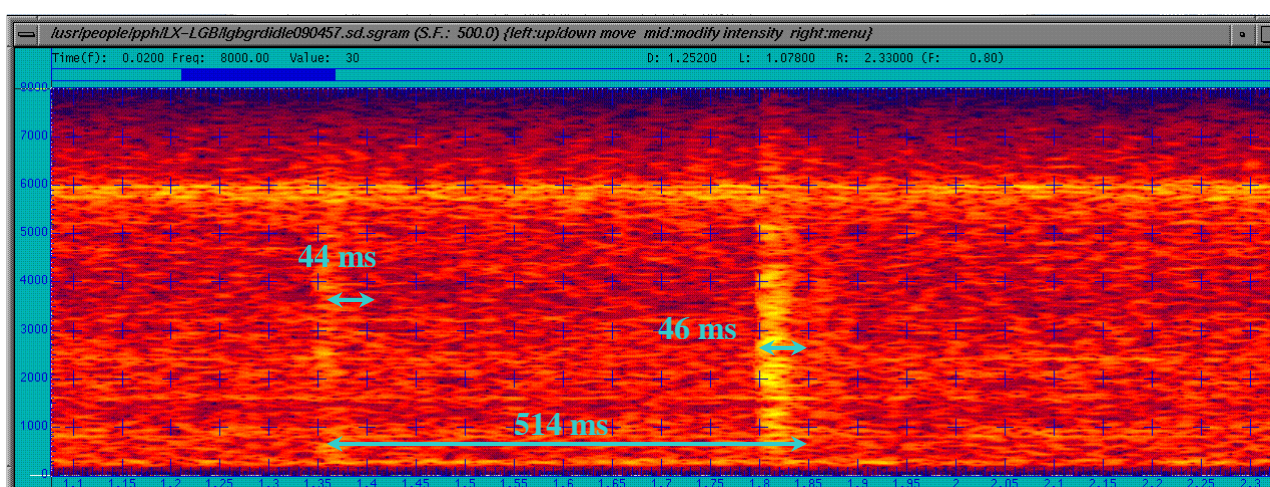
09 h 04 min 58 s : "Bruit de sélecteur similaire au déplacement du Ground Idle Stop" / "Sound similar to the operation of the Ground Idle Stop Selector"

Fig. 6: Représentation Temps – Fréquence du bruit transcrit. Time – Frequency representation of the transcribed noise.

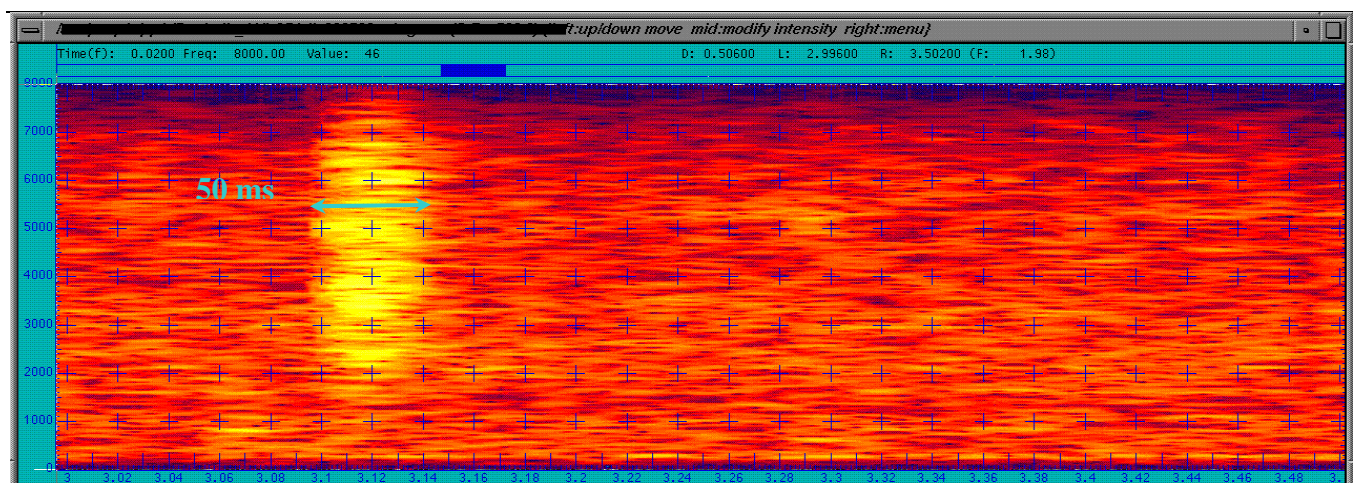
This noise is generated when, from the Flight Idle position of the throttles the pilot has to lift two levers called Ground Range Selector permitting the movement of the throttles into the Beat range. A noise can be heard for each lever, left and right. However, when the operation is done simultaneously for both sides, the two noises appear to be one.

Fig. 10: Représentation Temps – Fréquence du bruit transcrit. Time – Frequency representation of the transcribed noise.

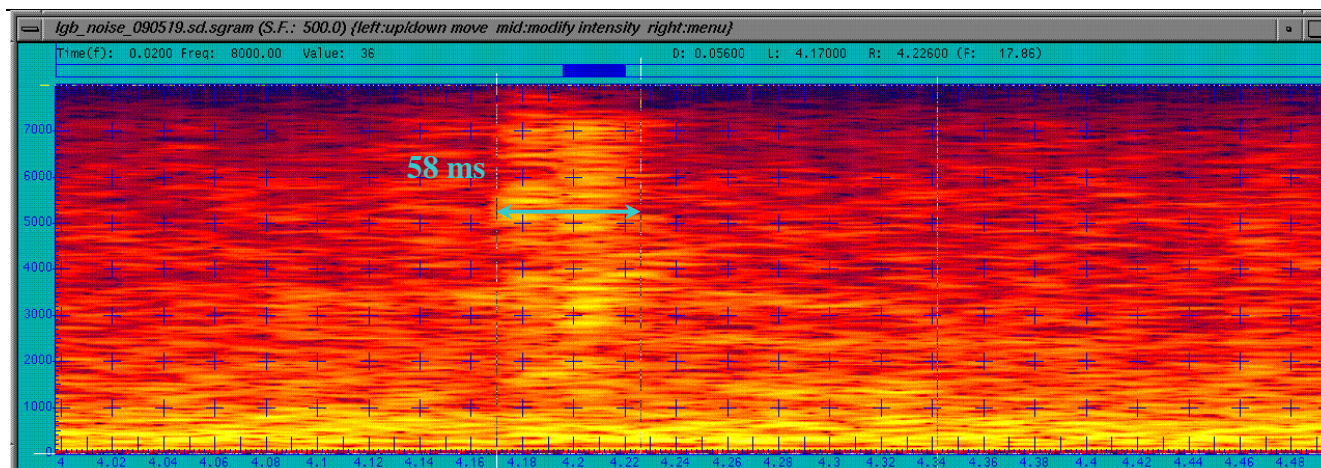
09 h 05 min 19 s : "Bruit" / "Noise"

Fig. 16: *Représentation Temps - Fréquence du bruit à identifier). Time Frequency representation of the noise to be identified.*

This noise can be decomposed temporally in two parts corresponding with two separate but adjacent noises. Its total duration is 58 ms.

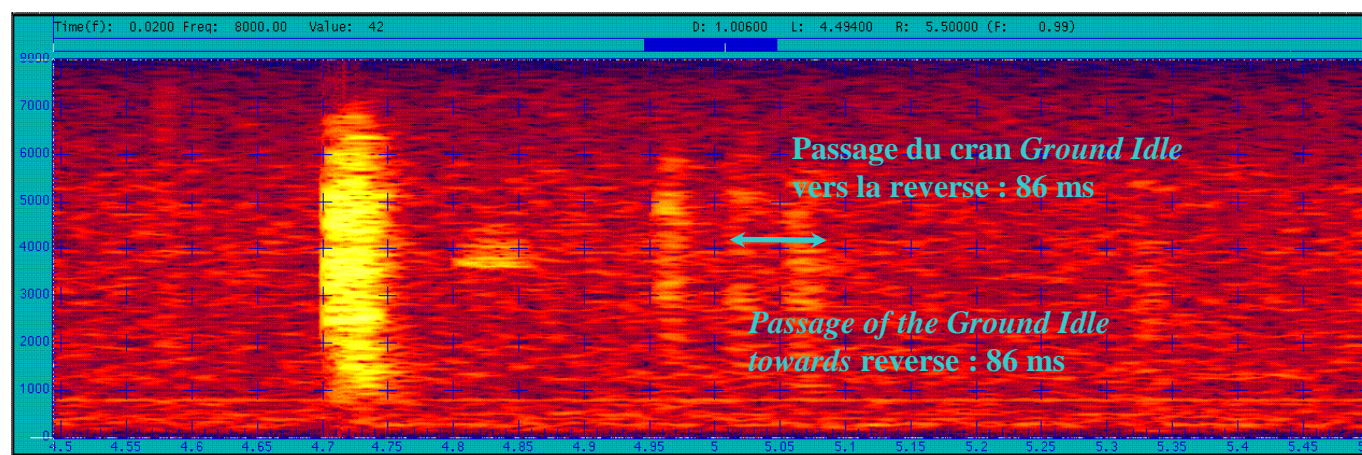
A second comparison of the transcribed noise with another lever movement gives comparable results. By moving the throttle levers to the "Reverse" position, the following results are obtained:

Fig. 19: Représentation Temps - Fréquence issue du mouvement de la manette des gaz mise en position « Reverse » depuis la position *Flight Idle*.
Time Frequency representation of the movement of the throttle from the Flight Idle position to the « Reverse » position.
