# Investigation Report

AX001-1-2/02  
May 2004

Kind of occurrence: Accident  
Date: 1 July 2002  
Location: (near) Ueberlingen/Lake of  
Constance/Germany  
Type of aircraft: Transport Aircraft  
Manufacturer/Model: 1. Boeing B757-200  
2. Tupolev TU154M  
Injuries to persons: 71 fatalities  
Damage to aircraft: Both aircraft destroyed  
Other damage: Damage to open field and forest  
Source of Information: BFU Investigation

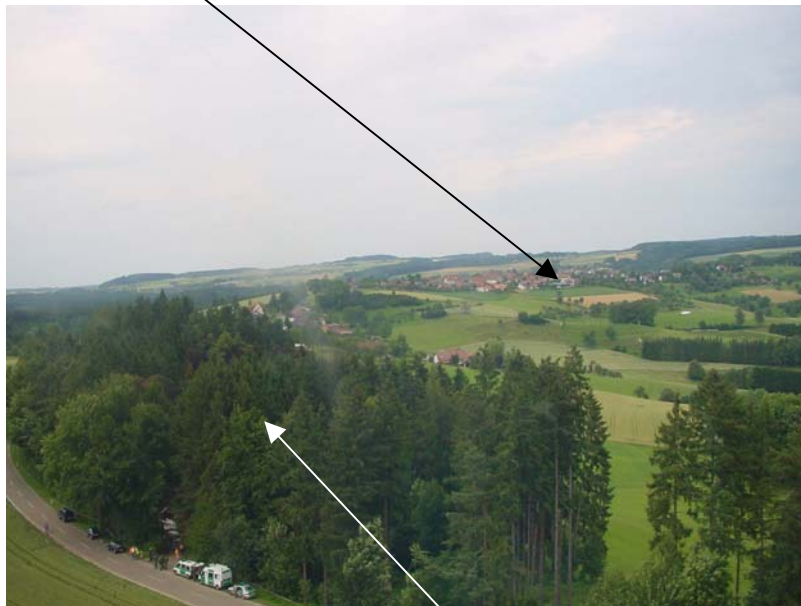
Main wreckage

The main wreckage of the B757-200 was found approximately 1 km west-south-west of the village of Taisersdorf, eastward of the street K 7788 in a mixed forest. The accident site covered an area of 110 m x 30 m.

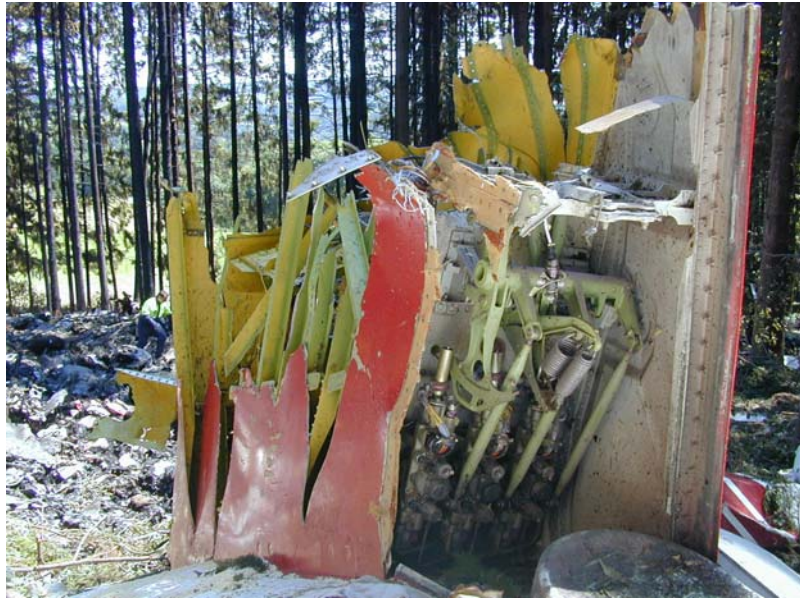
The left side of the skin was torn off in several pieces to the rear left.

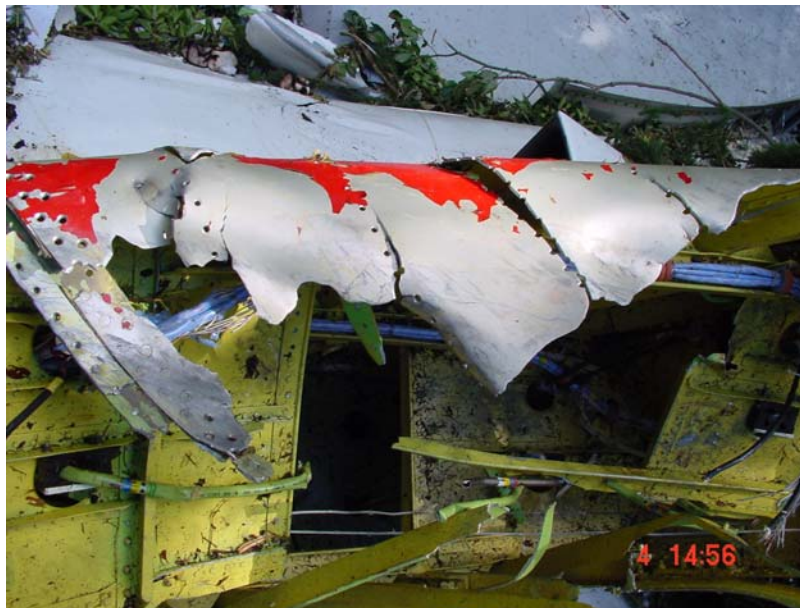
The top of the right side was bent to the rear left.

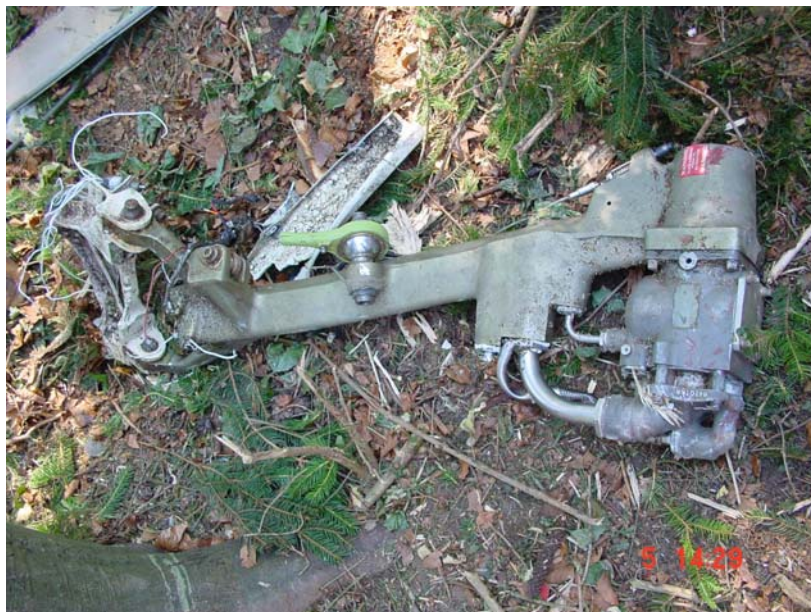
ram air turbine without propeller

The ram air turbine (RAT) was found almost undamaged and without any traces of fire.

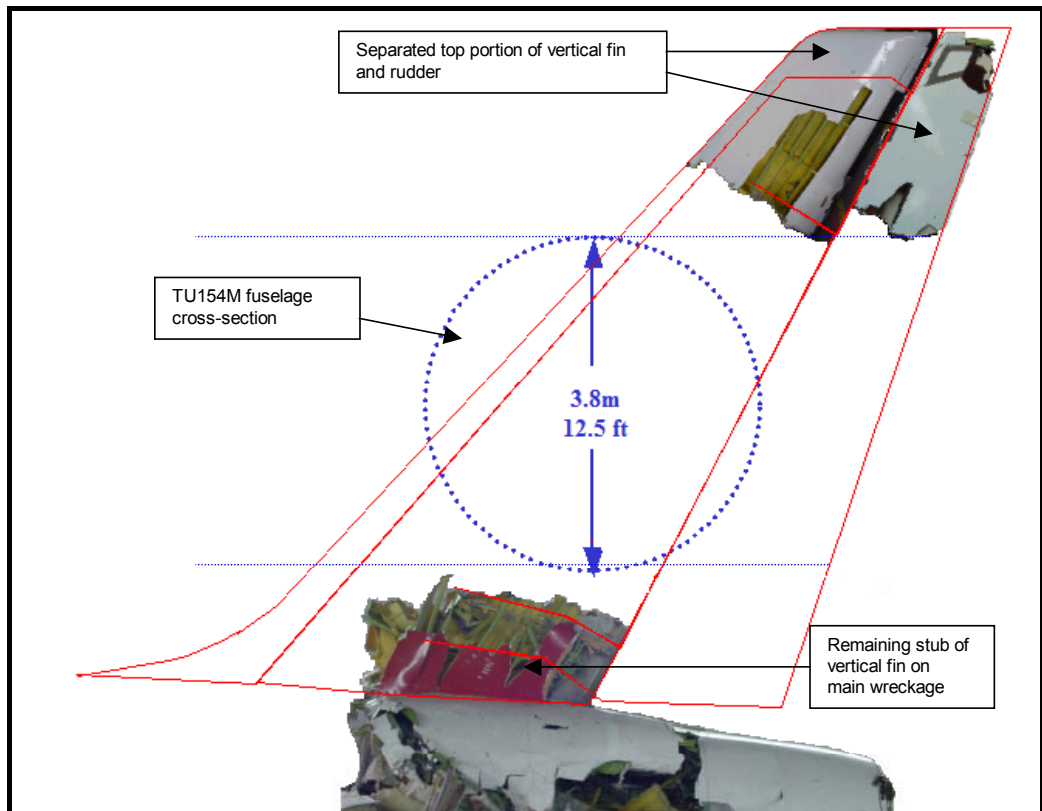
**B757-200 damage on vertical tail in relation to cross-section of TU154M**

- On collision, the airplane lost about 80% of the vertical tail. The manufacturer stated that the loss caused the airplane to become aerodynamically unstable in the yaw axis.

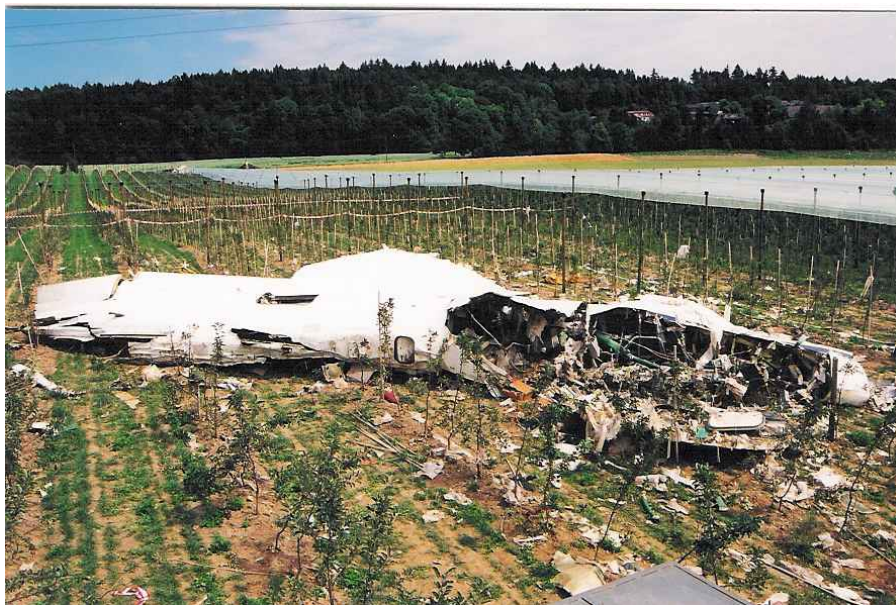
overall view – forward section of the aircraft fuselage

The forward fuselage section had crashed in the area of Brachenreuthe in level terrain (apple plantation) immediately south of a power line running in a direction of 290° and 20 m north of a paved field path. The wreckage part with a total length of about 19 m was lying on its left side. It had been separated in the area of the 41<sup>st</sup> frame of a total of 83 frames and pointed in the direction of 127°. The fuselage frames were broken. The skin on the bottom was torn open over a length of 9 m. The skin on top of the fuselage had burst open in two areas in longitudinal direction. The fuselage had been flattened to about half of its original diameter of 3.80 m.

Evidence of fire or collision evidence was not found.

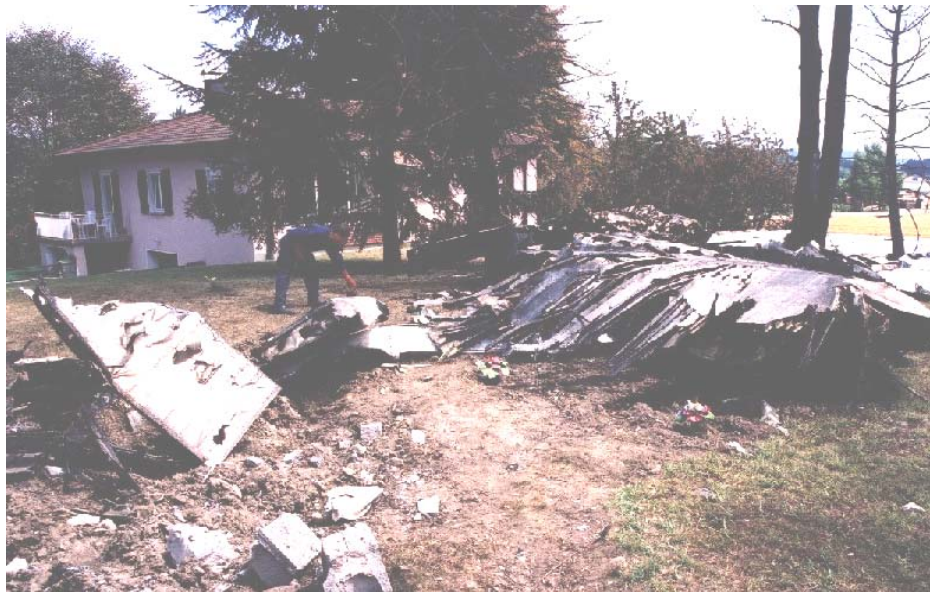
**Left wing**

The connection of left wing and centre wing section consisted of the trailing edge in the area of the inboard flap and hydraulic lines. The wing was found at a residential garden at a level higher than and at a distance of about 10 m from the house. The wing had been separated from the leading edge in a transversal line in the direction of the fuselage. The point of rupture is located between wing root and inboard slat. Some parts of this wing area were not present.

The fire melted the outer third of the wing. The completeness of the wing, however, could be told by its outlines which included the wing tip.

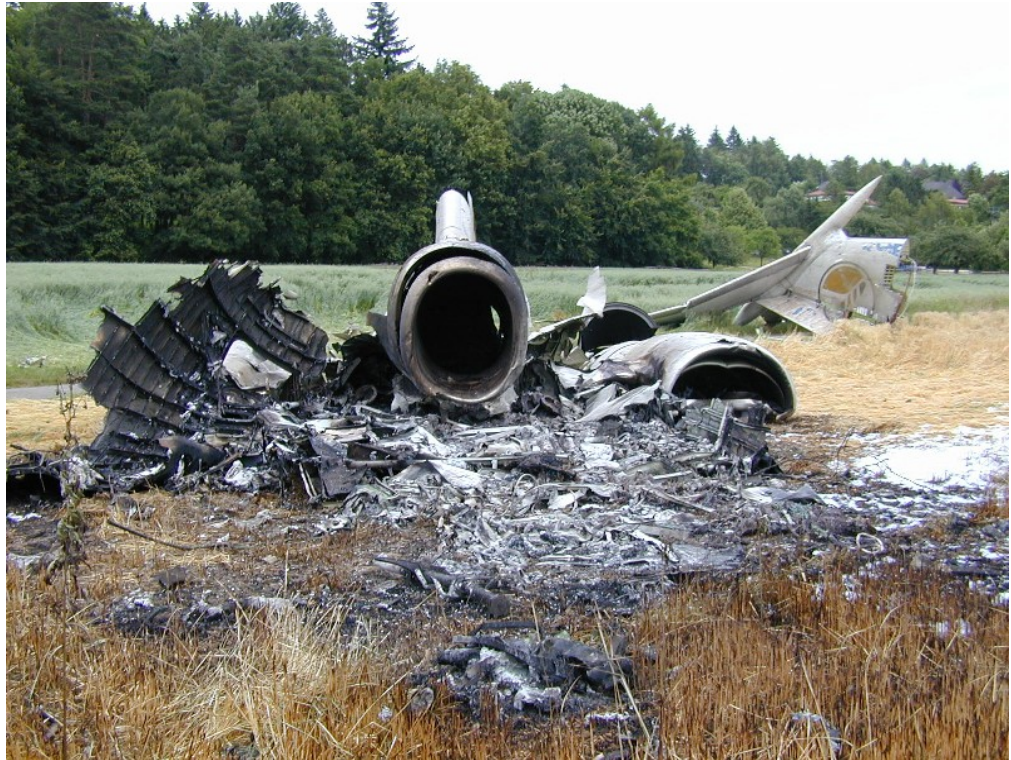
overall view – rear fuselage section/tail unit

The wreckage part had crashed, with no horizontal velocity, on a field some 300 m north of the forward fuselage section at the access road to the Brachenreuthe boarding school for retarded children. At impact, the vertical fin had broken off below the rudder. The T-tail was found about 15 m east of the rear part of the fuselage.

The rear fuselage had on the left side broken off at frame 56 and on the right side at frame 52. It was destroyed by fire and impact forces and pointed into the direction of 235°.

No collision evidence was found on the leading edges of the vertical fin and horizontal stabilizer and at the air intakes of the three engines.

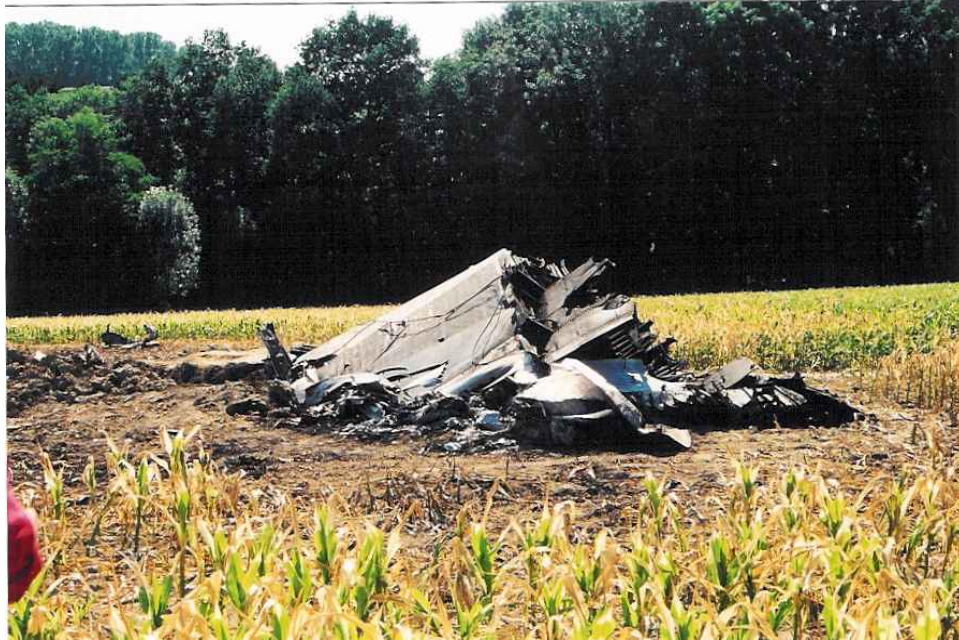
overall view – right wing

The wreckage part was found in a corn field some 800 m south of the accident site of the fuselage and some 30 m west of the district road 7786 north of the village Aufkirch. Leaking and burning fuel affected the plants in a radius of 15-20 m around the crash site. The plants showed a brownish colour.

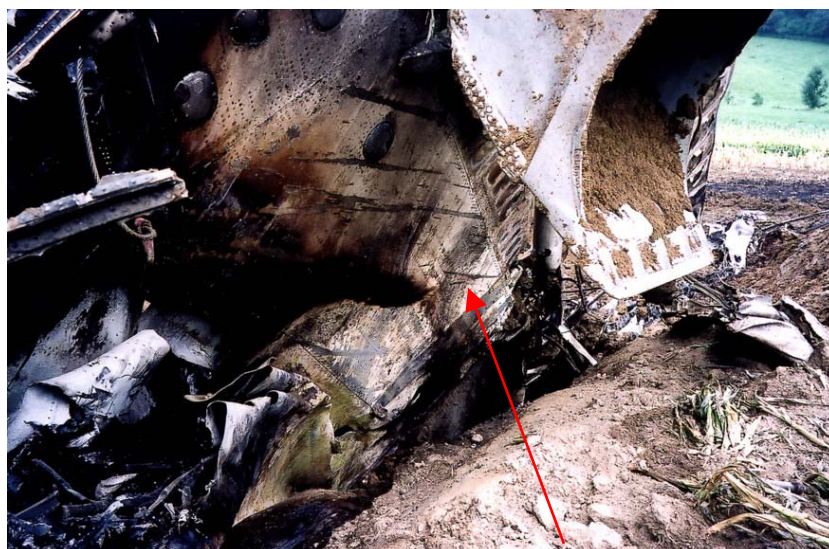
The ditch caused by the impact had a length of about 18 m and pointed into the direction of 228°. The inner section of the wing from the wing root to the main landing gear stuck 3.5 m deep in the earth. Most of the outer section of the right wing from the main landing gear to the wing tip had been destroyed by the fire except for the leading edge and the slats. A 6 m long wreckage part of the right wing's upper surface including the remains of the registration marks was found some 20 m from the wing's crash site. On the wing's lower surface between the wing root and the main landing gear scratch marks of about 3.6 m length and 0.9 m width and red paint transfer were found. The flap track and carriage of the inner flap, one landing gear door and the rear part of the main landing gear fairing were missing.

lower surface of the right wing with scratch marks

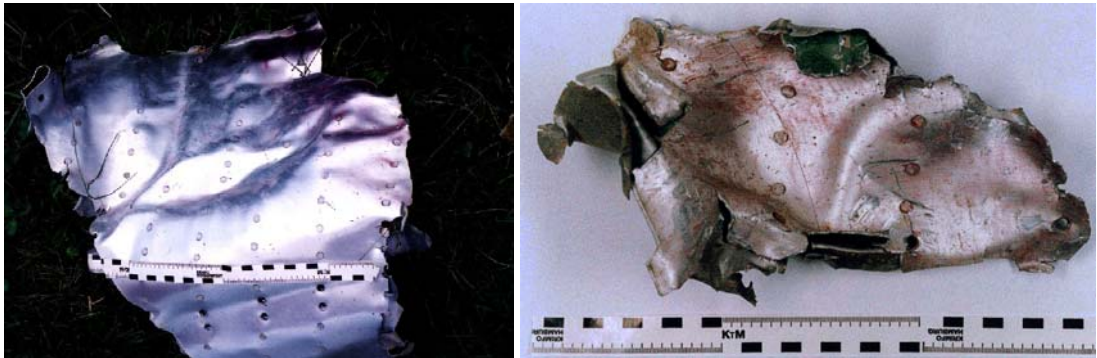
On the left wing collision traces between the wing root and the inboard slat were found. The fragments of the wing leading edge showed traces of red paint.

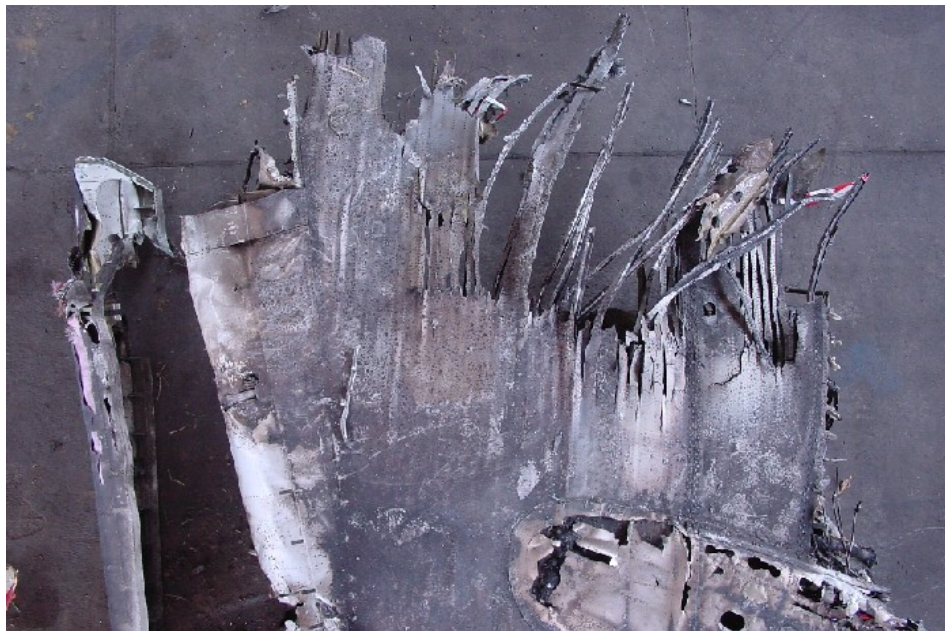
The wing including the wing spars had been severed by the collision. At the point of rupture the stringers of the wing were bent rearwards.

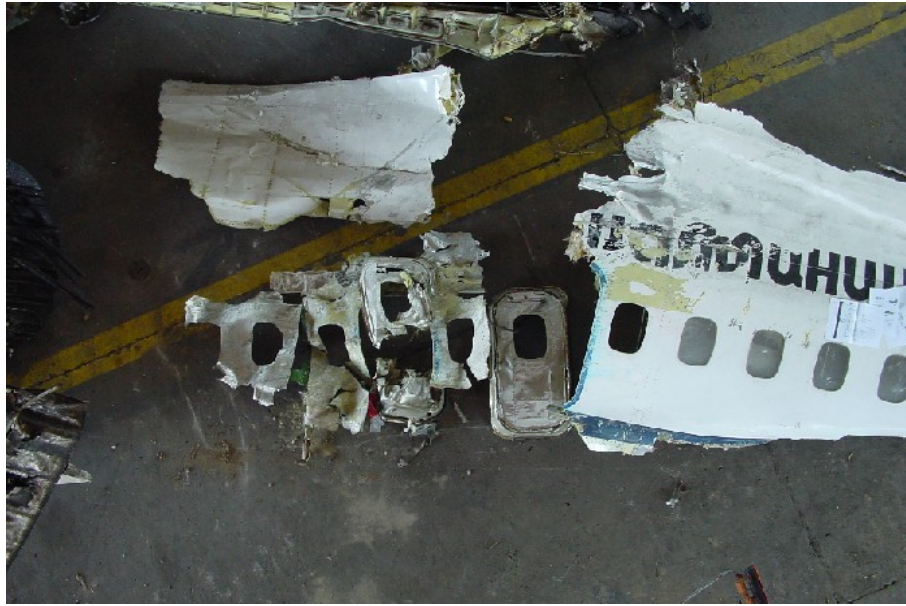
The area of both overwing emergency exits on the left side of the fuselage was smashed. Scratch marks, an extensive paint scrape-off and traces of red paint were found.

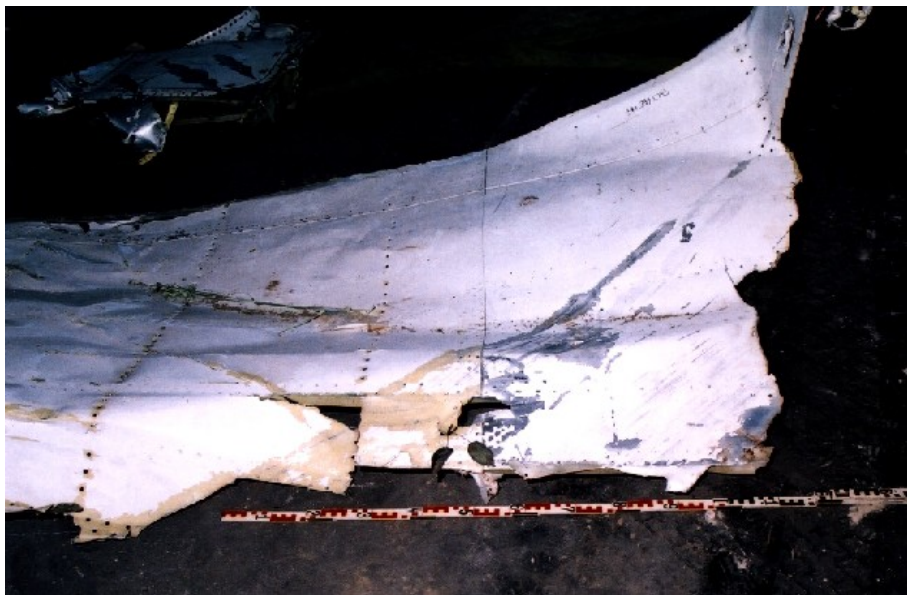
The angle between the scratch marks found on parts of the fuselage roof and the TU154M's longitudinal axis was 46°.

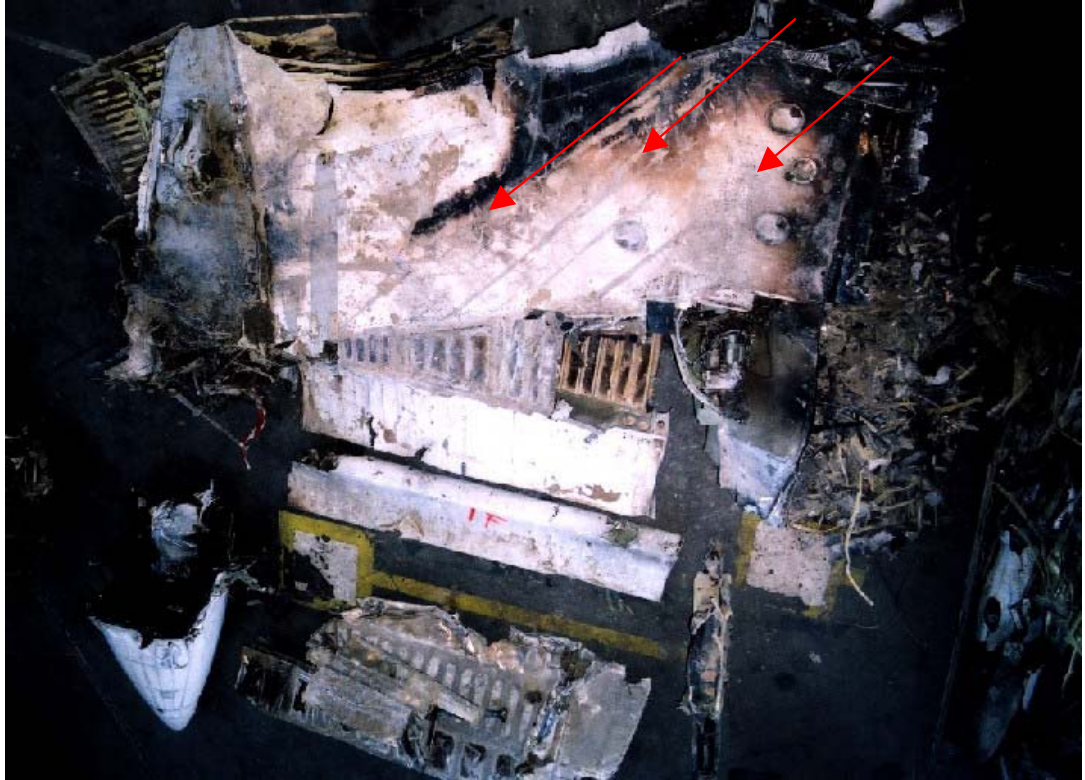
On the right wing's lower surface several parallel scratch marks of 3.60 m maximum length and 0,90 m width were found. They ran at an angle of 46° to the airplane's longitudinal axis into the direction of the right main landing gear. Traces of red paint were also found in this area.

right wing lower surface with traces of the collision

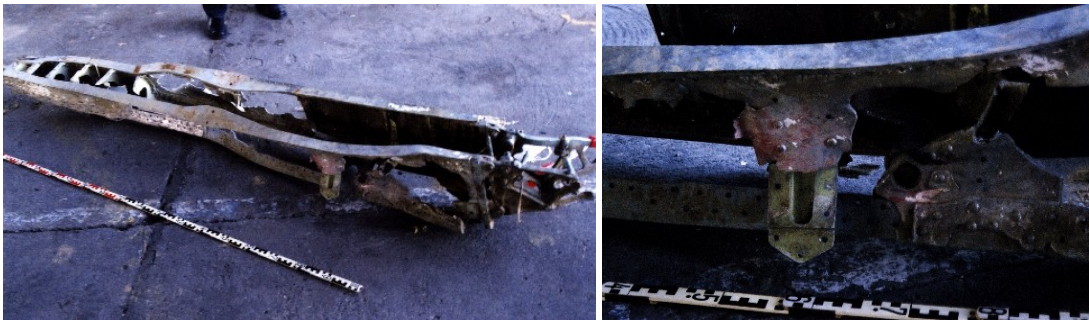
On the inboard side of the flap trap and carriage originating from the right wing, mechanical deformations and traces of red paint were found.

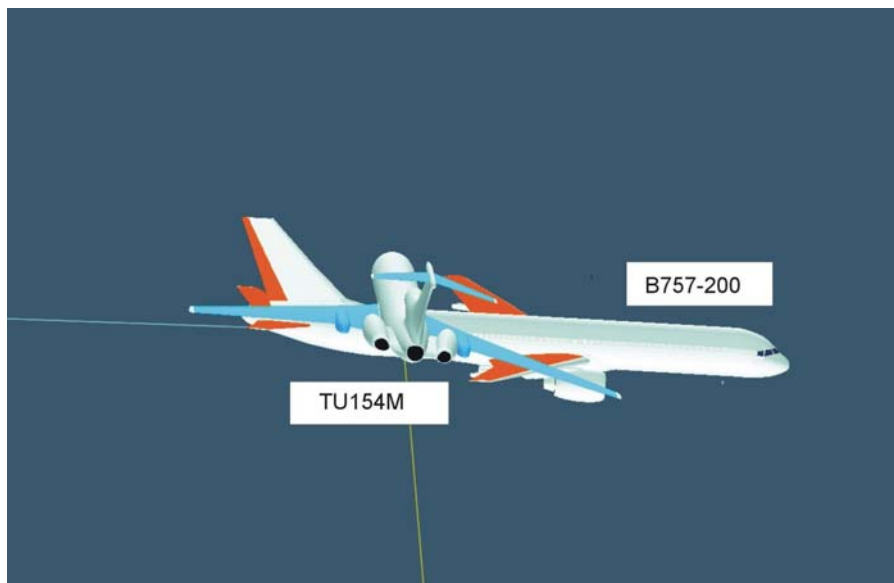
Reconstruction of the collision according to FDR data and collision evidence

FDR data shows that the TU154M had a MH of  $274^\circ$ , a pitch angle of  $0^\circ$  and a bank angle of  $10^\circ$  right at the time of the collision. The B757-200 flew a MH of  $004^\circ$ , with a pitch of approximately  $-2^\circ$  and a bank angle of  $0^\circ$ .
