App K - Crashworthiness Analysis by Cranfield Impact Centre (CIC)

Eighteen Safety Recommendations have been made.

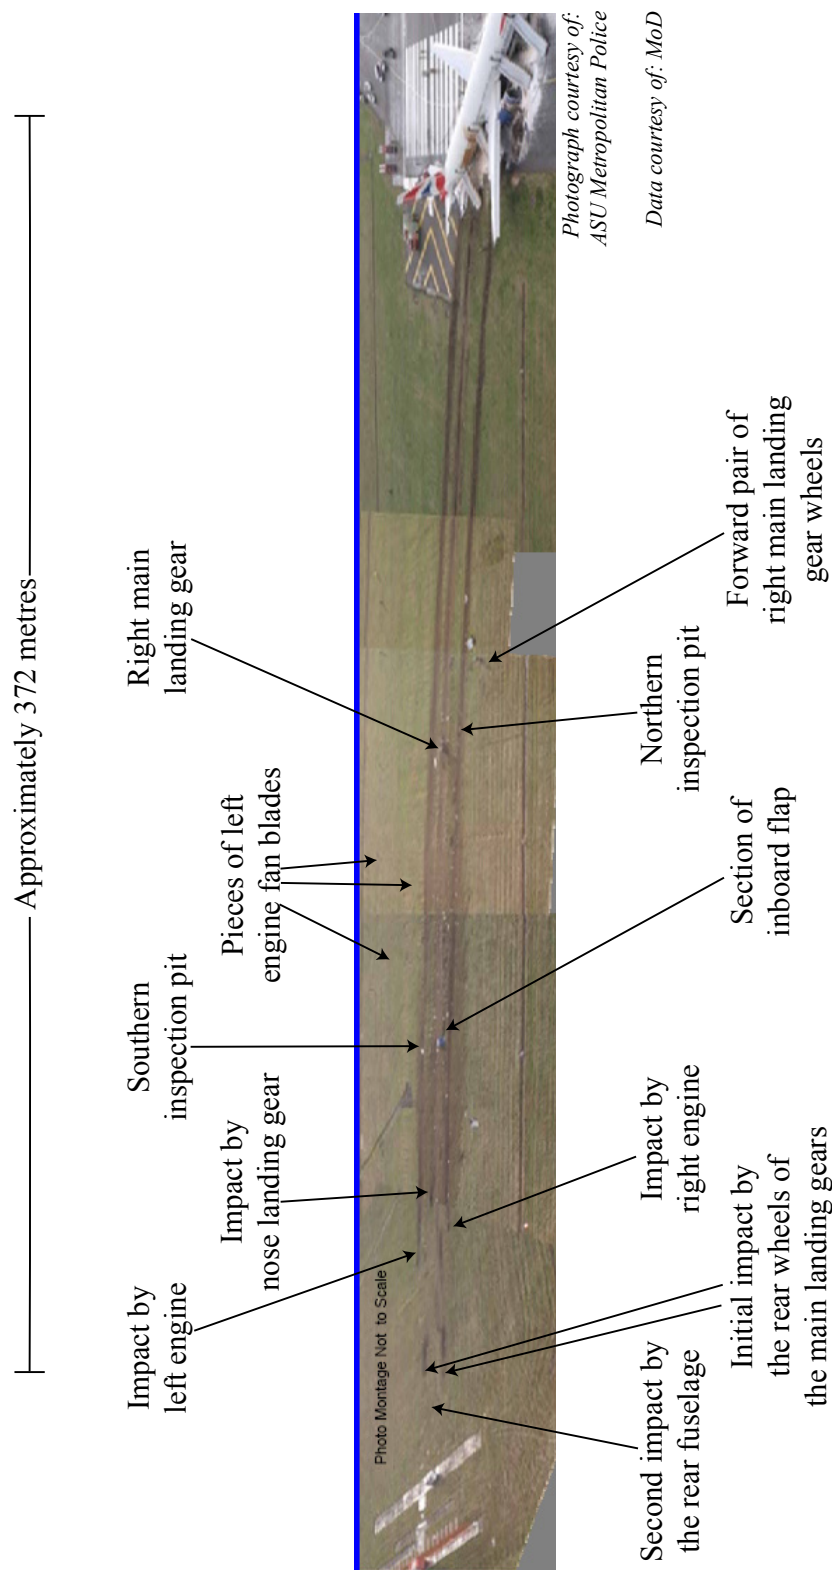
Figure 23

This caused damage to the lower part of the engine and assisted the deviation of the aircraft's ground slide to the right.

The aircraft came to rest on the tarmac area just to the north of the threshold of Runway 27L, approximately 372 m from the first impact point.

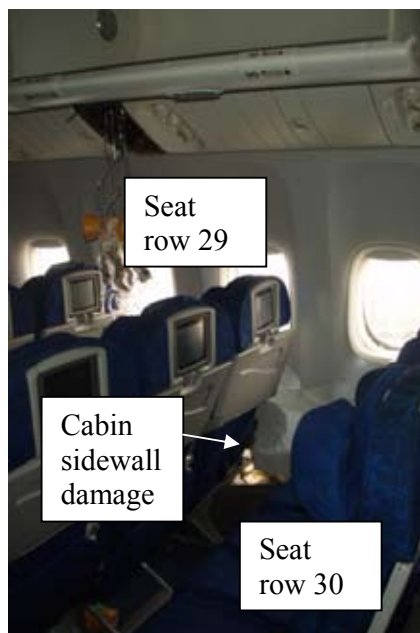
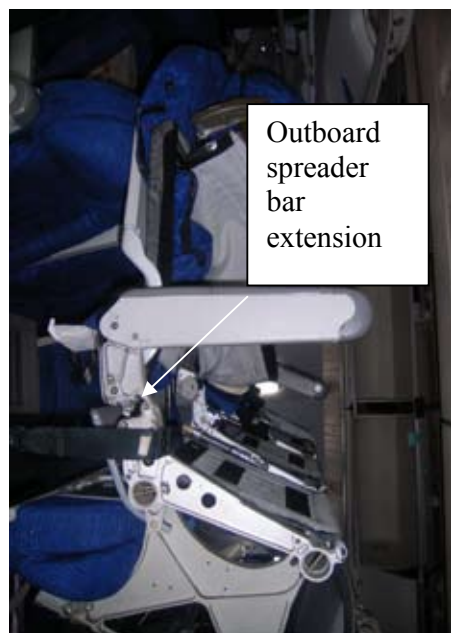
The right MLG forward truck beam and its wheels had punctured the right side of the fuselage adjacent to seat rows 29-30, at the height of the seat armrest (Figures 33 and 34). This had breached the fuselage outer skin, insulation blankets and the cabin lining panel. The sidewall lining had been pushed into the cabin, resulting in the injury to the passenger seated in 30K and the failure of the outboard spreader bar extension of seat 29K.

Cabin damage at rows 29/30

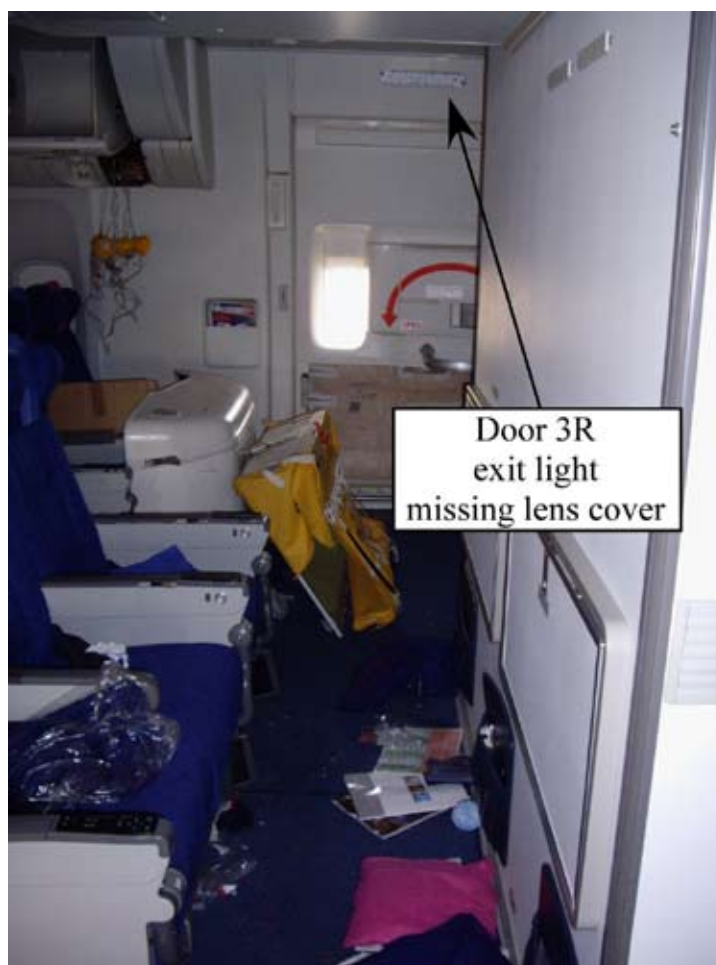
Figure 38

The exit signs light lenses were found to have detached from Door 3L and 3R (Figure 38) and it was evident that any misalignment of the plastic door mouldings resulted in difficulty in engaging all four of the mounting clips.

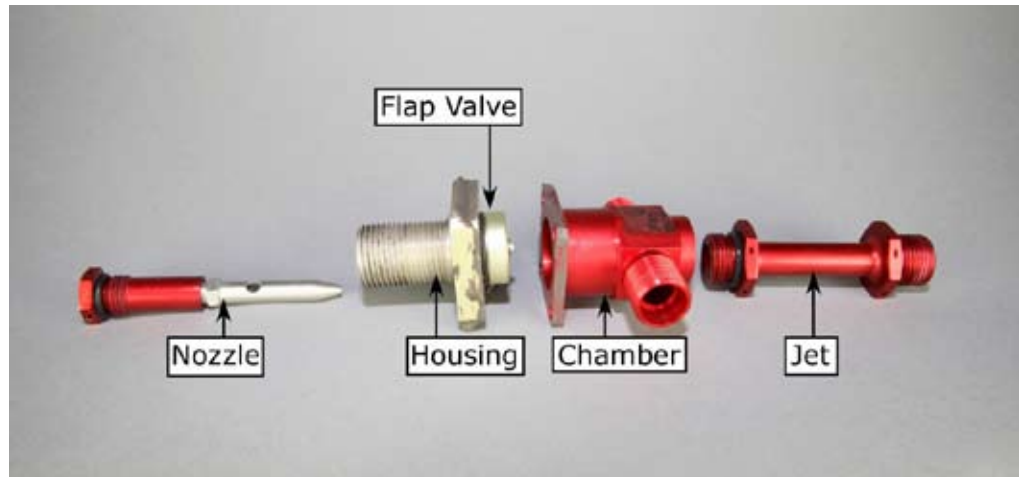
Figure 44

When the nozzle from the right main scavenge jet pump was removed from its housing half a teaspoon of a 'jelly-like' substance, later identified in a laboratory as "water", was found in the housing. It is not known if this water was originally lodged in the nozzle and was pulled through the flap valve into the housing, or whether the water had been introduced into the housing during a previous maintenance activity. The water was tested for microbiological contamination and the quantity of contamination was assessed as negligible.

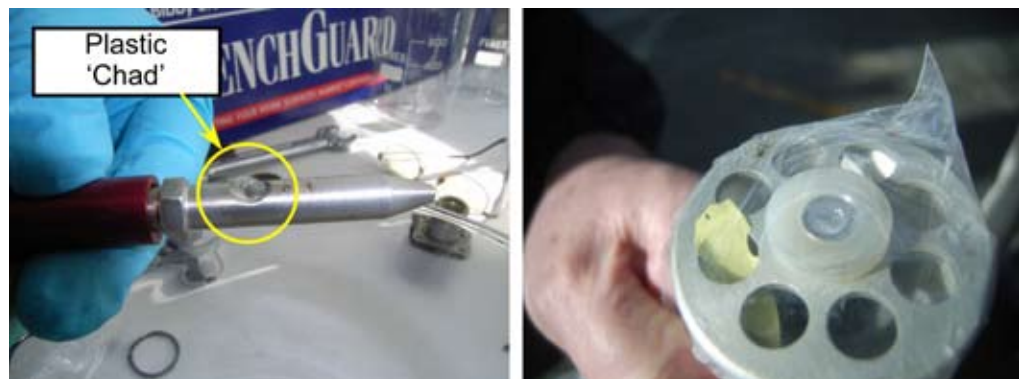
Figure 45

A 6 mm plastic disc (chad) was found in the chamber of the right main scavenge jet pump, which was large enough to block one of the ports in the nozzle, Figure 45. A flake of paint was found trapped in the pipe between the scavenge inlet and the chamber (Figure 45). From a swab taken from the inside of the chamber, it was established that there was a moderate amount of microbiological contamination on the internal surfaces of the chamber.

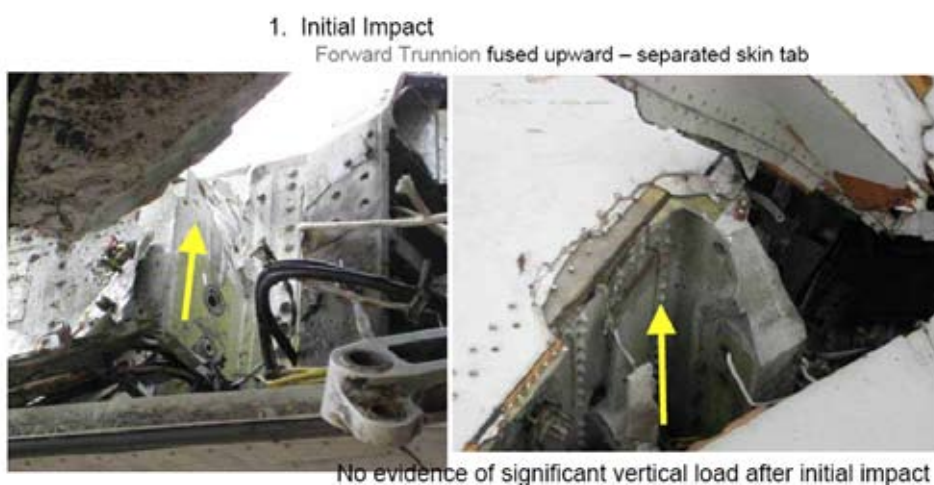
1. Initial impact: Gear beam outboard attachment fuse pins failed
Forward trunnion upper and lower housing fuse pins failed
Drag brace fuse pin 'crankshafted'

Note the piece of upper wing skin removed by the separation of the upper and lower housings. This impact had pried open the wing tank.
