## AIRCRAFT ACCIDENT REPORT AND EXECUTIVE SUMMARY

**AIRCRAFT ACCIDENT INTERIM REPORT**

**Name of Owner** : British Airways PLC  
**Name of Operator** : British Airways  
**Manufacturer** : Boeing Company  
**Model** : B747- 400  
**Nationality** : United Kingdom  
**Registration Marks** : G-BNLL  
**Place** : OR Tambo International Airport (FAOR)  
**Date** : 22 December 2013  
**Time** : 2043Z

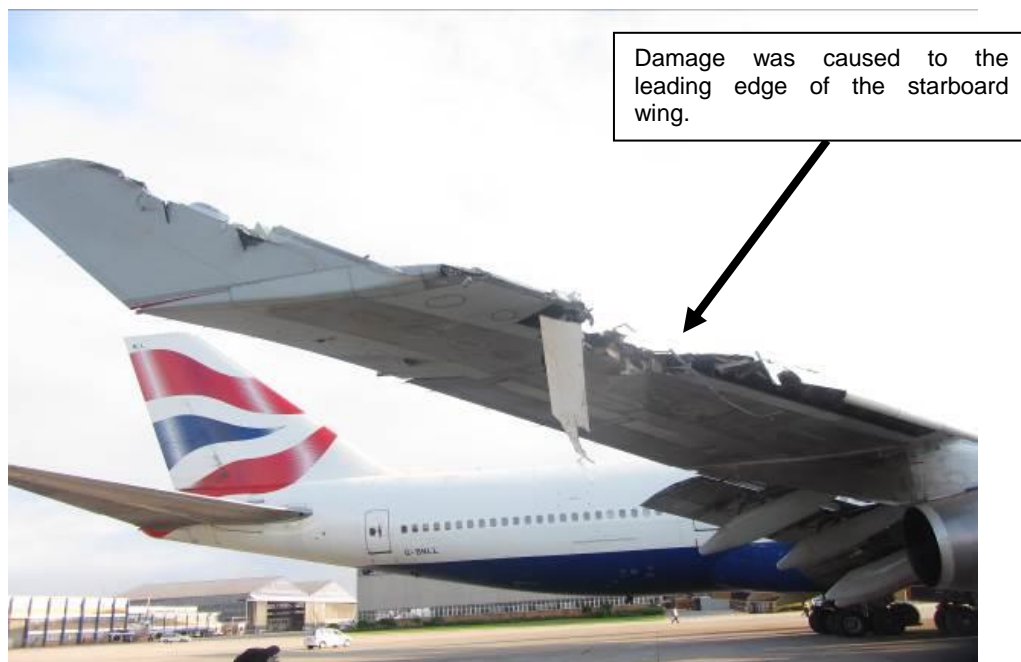
#### 1.3.1 The aircraft sustained substantial damage in the accident.

Figure 4 Damage caused to the starboard wing of the BA034 aircraft

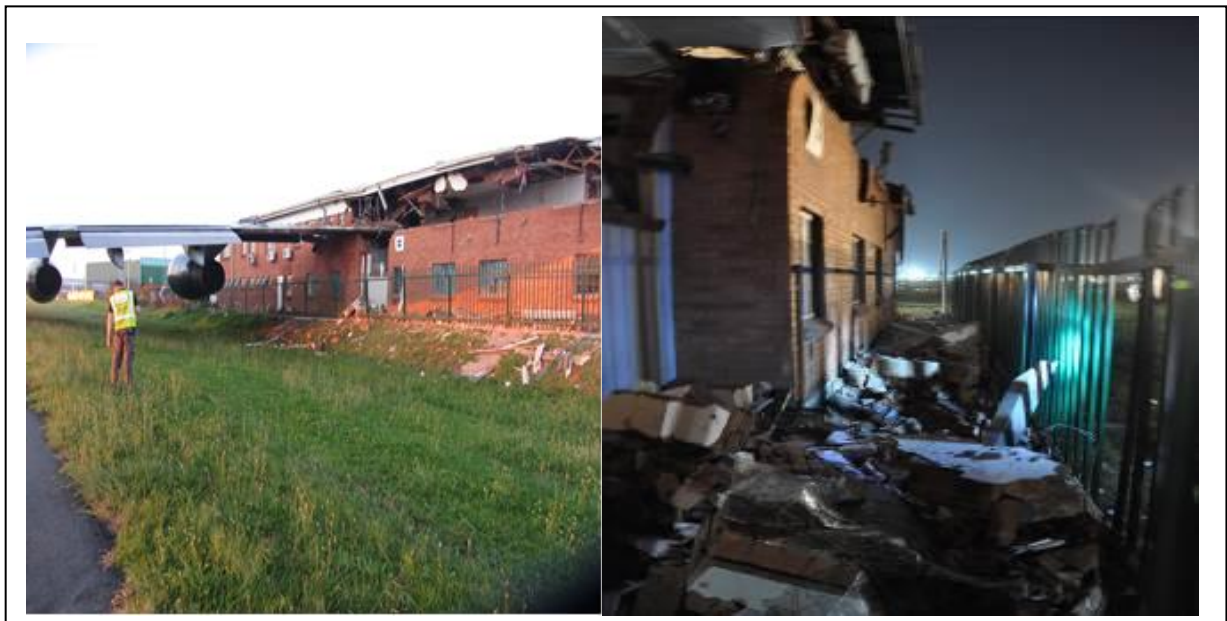
- 1.4.1.2.3 The debris of the building and light mast was found scattered on the premises. The starboard wing was visibly wedged in the building halls.

Figures 8 and 9 BA034 wing wedged in the building halls and debris of building material

- 1.4.1.2.4 It was observed that a substantial amount of fuel from the wing was spilled inside and outside the building. The building was subsequently declared unsafe for use as a result of the accident.
- 1.4.1.2.5 There were several BidAir Services vehicles in the parking area around the premises of the building. There is no evidence of information that any of the vehicles sustained damage. However, due to the fuel spillage and fire risk, all the vehicles were removed to safety immediately.

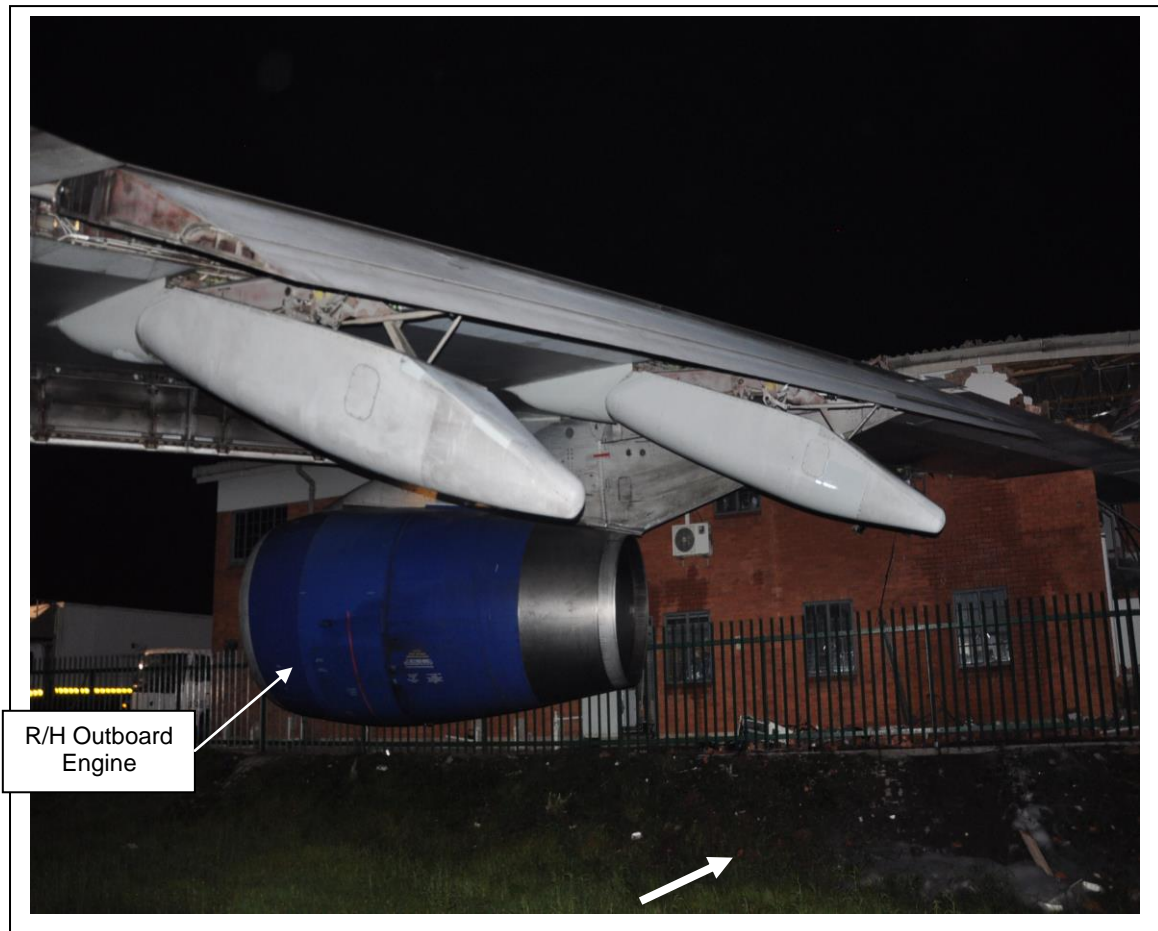
1.4.2.1 Owing to the collision with the BidAir Services building, a large quantity (kilograms) of fuel was spilled, which caused extensive environmental damage.

Figure 10 Fuel spillage and fire fighting agent (foam) stains on building hall and grass below the point where the wing came to a stop.

1.4.2.2 The evidence was that the large quantity of fuel spillage filtered through the grass into the soil off the parameter fence of the building. In order to correctly determine the extent and nature of environment damage, the Operator (British Airways) in consultation with ACSA immediately contacted a locally based service provider, namely HazRisk Solutions. The service provider had to carry out an environmental damage assessment. The result of the assessment was that a jet-fuel spillage soil remediation was required.

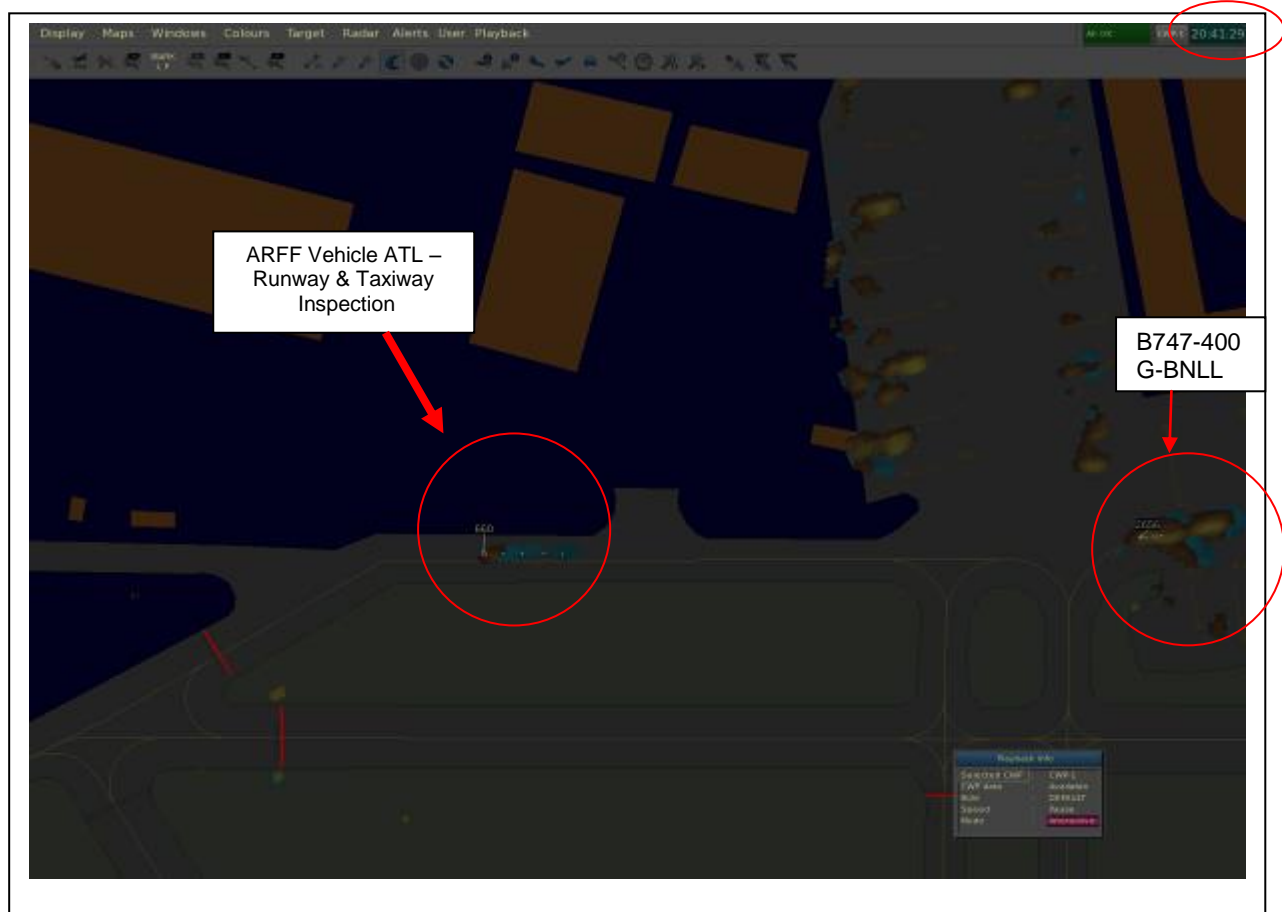
1.11.5.2 Below the A-SMGCS shows the ARFF vehicle (FTL) heading toward the intersection/junction of Bravo and Mike, which is where the two green centreline lights were found not illuminating and not reported.

Figure 38 A-SMGCS image of ARFF vehicle (FTL) near intersection of Bravo and Mike
