**UNITED STATES AIR FORCE**  
**AIRCRAFT ACCIDENT INVESTIGATION**  
**BOARD REPORT**

**B-52H, T/N 60-0047**  
**69TH EXPEDITIONARY BOMB SQUADRON**  
**5TH BOMB WING**  
**ANDERSEN AIR FORCE BASE, GUAM**

**LOCATION: DEPARTURE END OF RUNWAY 06L, ANDERSEN AIR FORCE BASE,  
GUAM**

**DATE OF ACCIDENT: 19 MAY 2016**

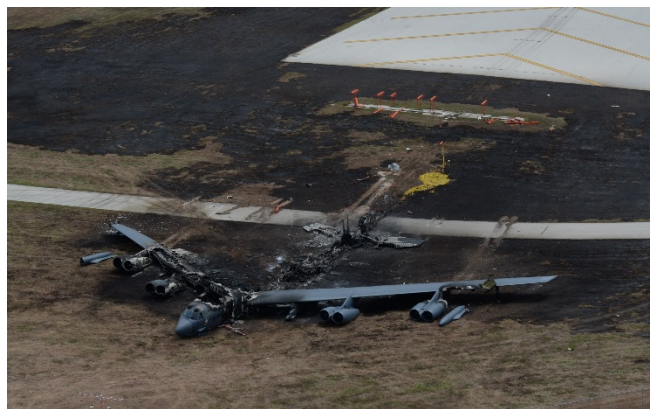
Figure 1. MA after mishap (Tab Z-3).

from the end of the runway, which sheared a portion of the main landing gear from the aircraft (Tabs S-6 and R-56). The right main tip gear also sheared from the aircraft. The MA came to rest in an upright position, slightly right wing low and caught fire (Figure 1).

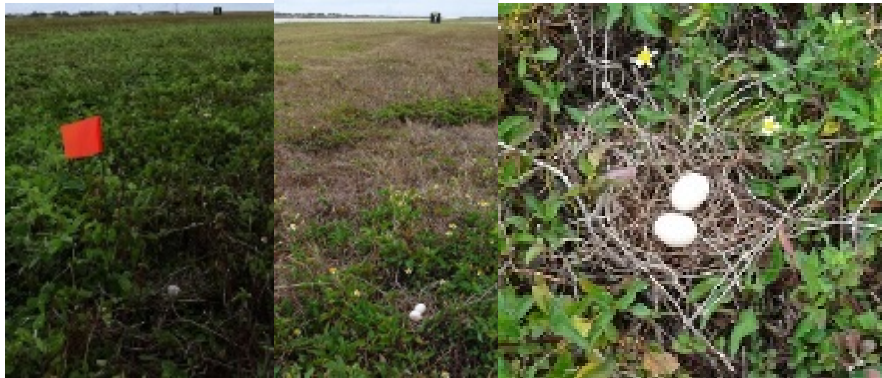
Figure 4 displays an area near runway 06L where grass management, though not considered contributory, did contain small areas in violation of AFI 91-202 requiring attention with regard to mowing operations (Tab FF-10, W-12 and W-29). Though the investigation cannot correlate scheduled mowing and grass-height deviations directly to the mishap, post mishap investigation revealed a single, Yellow Bittern nest just off the right side of runway 06L (Figure 4).

Figure 4: Bird Nest Near Runway 06L

The BHWG implemented a three-phased approach to address these areas of concern. The first one is currently implemented to identify areas in violation requiring attention and notifying the airfield mowers of those locations. The second, short-term objective is to pursue a waiver to cut grass well below the 7” minimum requirement to prevent weed seeding. This will be followed by an overspray of weed control targeting the over-abundant weed population throughout the airfield. The final, long-term objective is to implement weed control measures until only grass persists on the airfield to then revert back to the 7-14” grass height requirement (Tab FF-10).

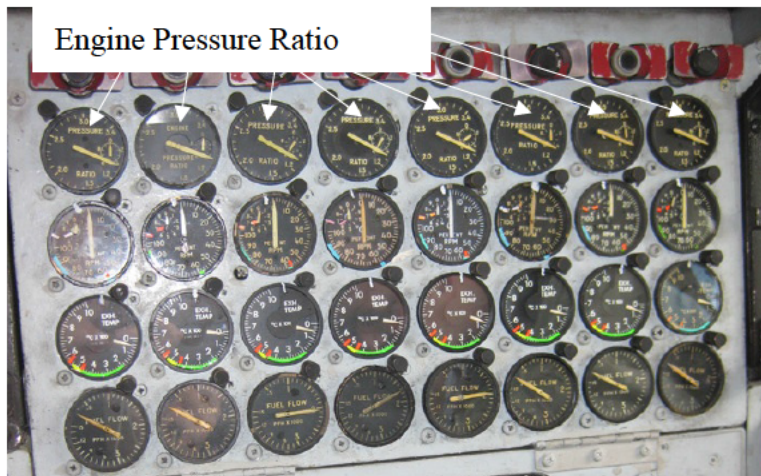
Figure 5. Engine Stack

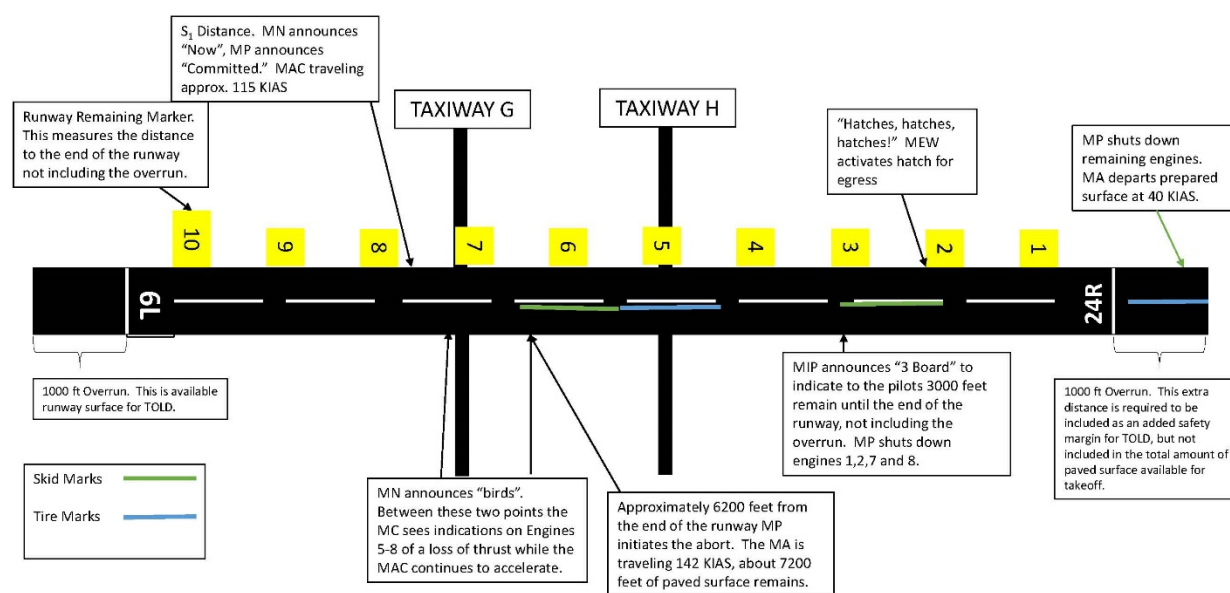
Figure 6: Mishap Sequence of Events

Referring to Figure 6, the skid marks followed by the tire marks on the runway are consistent with proper anti-skid system operations. Additionally, the lack of tire marks from approximately 2,000 feet remaining until the end of the runway suggests the brakes absorbed the maximum prescribed energy during the abort and were no longer effective (Figure 6). All brakes show signs of heat stress and fire (Figure 9).

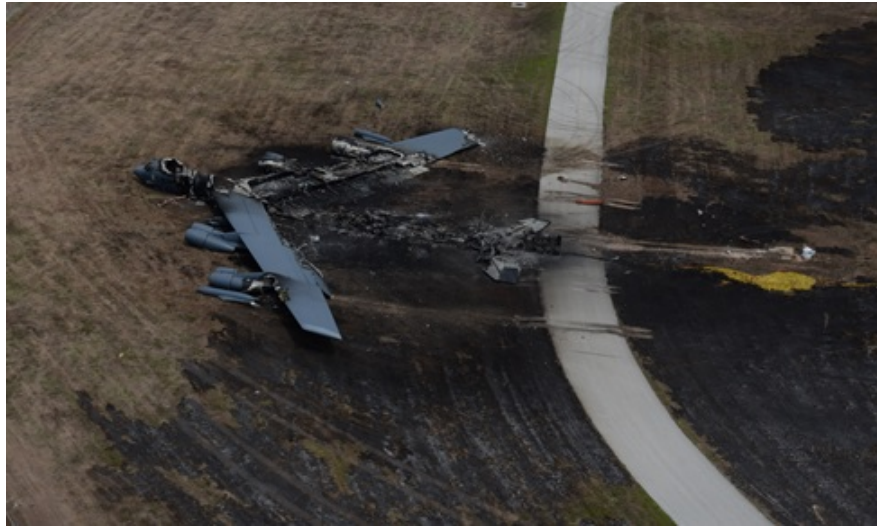
The MA departed the prepared surface by approximately 300 feet and sheared the front main landing gear and the right tip gear resulting in the number 5, 6, 7, and 8 engines dragging into the ground (Tab U-172, U-174, and U-177). The main part of the fuselage from the cockpit back to the tail just in front of the drag chute door, to include the vertical and horizontal stabilizer, was completely destroyed by fire (Figure 3). All four main landing gear tires and brakes burned with the fuselage (Figure 4). The number 3 and 4 main fuel tanks were damaged by fire along with engines #5, #6, and #7 (Tab U-170 to U-172, U-174 to U-178, and U-182). The right external fuel tank was also damaged and detached from the right wing of the aircraft during the departure from the prepared surface (Tab U-182 to U-183). Also, most of the right wing was damaged by the fire along with the flaps and flap wells (Tab U-183 to U-184). The left wing had damage to both engine pods and fire damage to the number 1 and 2 main fuel tanks (Tab U-176 to U-177). Both engine pods had damage as did the number 1, 2, 3, and 4 aircraft engines and the inboard, and part of the outboard flaps (Tab U-176 to U-177). There was also fire damage to the left side of the leading edge of the wing between the number 1 engine and the external tank (Tab U-176 to U-177). The left external fuel tank was also damaged and detached from the left wing of the aircraft.

Figure 7. Aircraft Wreckage

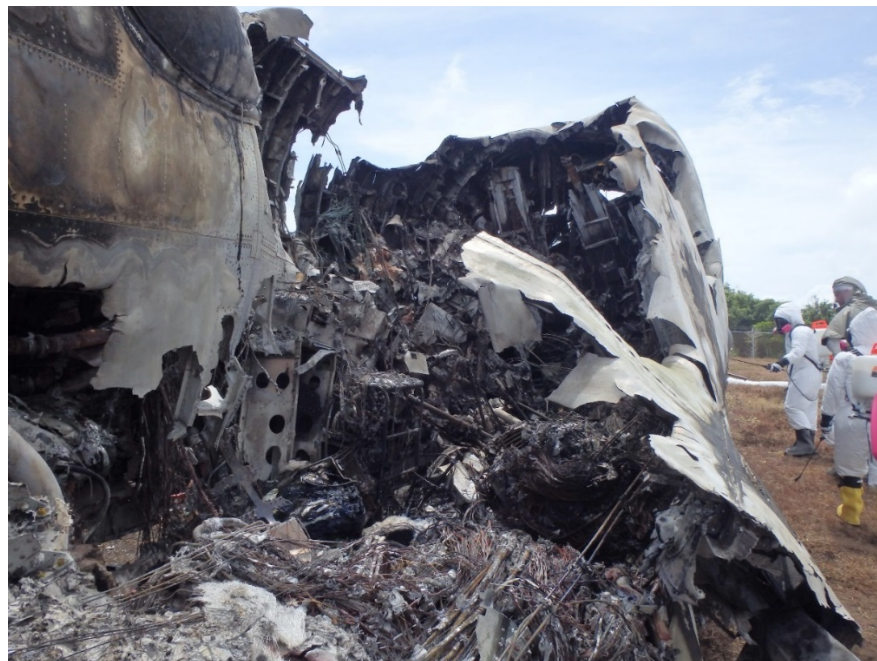
Figure 8. Cockpit Remains

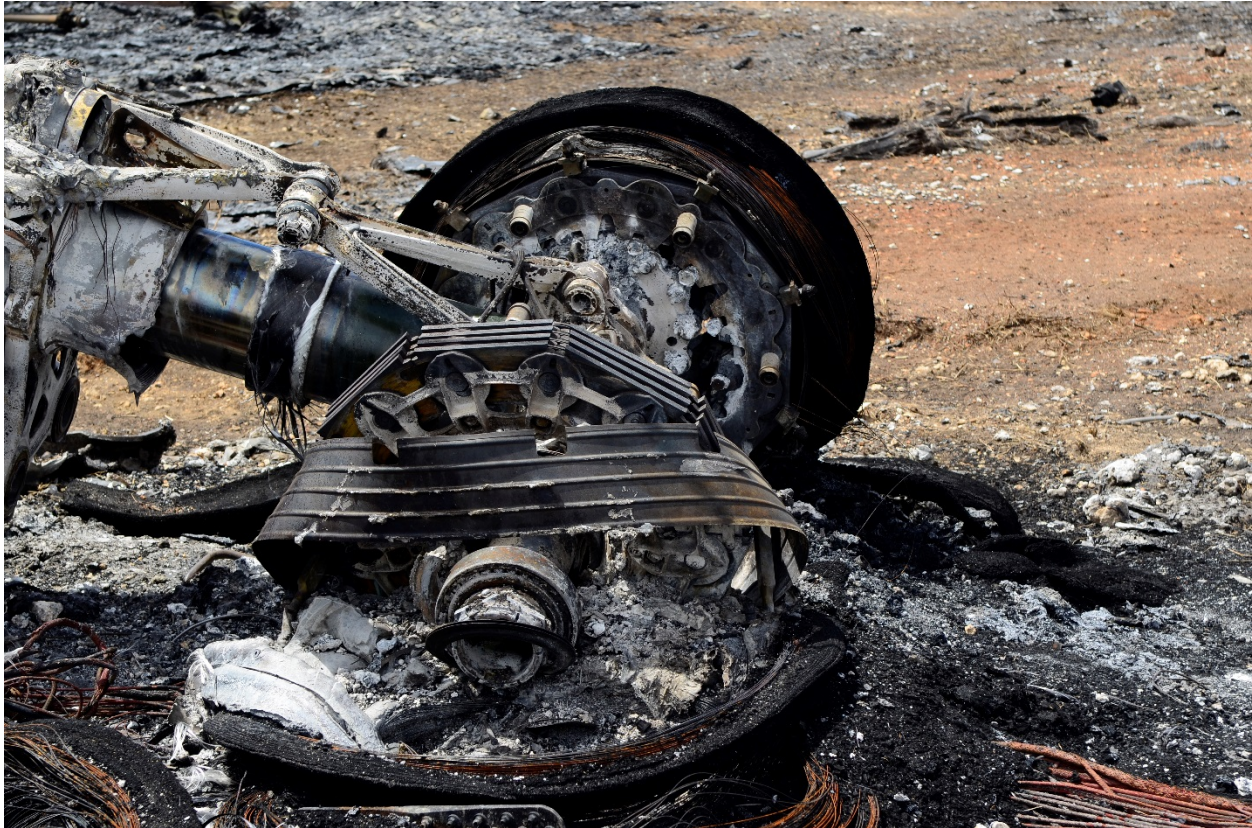
Using charts provided in T.O. 1-B-52H-1-1, the braking energy absorbed by the MA can be calculated. By applying the aircraft gross weight, airspeed at brake application, pressure altitude, and runway temperature, the braking energy calculated on the MA exceeds the capabilities of the supplied chart. Interpolating "off the chart," a value of approximately 335 million foot-pounds can be estimated, above the maximum limit of brake failure (Tab BB-15). If the drag chute worked as designed, a value of 295 million foot-pounds can be estimated, providing some validation of the simulator crew's ability to stop before the end of the runway surface when the drag chute was effective (Tabs BB-15 and EE-3).

Figure 9. Brakes and tires showing evidence of overheating and fire

The B-52H brake-energy limit is 298 million foot-pounds total for all eight brakes. This is the maximum energy the brakes can absorb before becoming ineffective and is the stopping capability limit. Above 230 million foot-pounds accumulation, fire and tire explosion are imminent. According to technical data, the brake-energy charts are the best possible estimate to assess heat-energy absorption. Using the MA gross weight, speed at brake application without drag chute, weather conditions, and adjustments for runway slope, the MA brake-energy accumulation exceeded charted technical data of 325 million foot-pounds. Interpolation off the chart suggests upwards of 335 million foot-pounds accumulation of brake energy for the MA. Evidence of the termination of rolling skid prior to the end of the runway, the extreme brake energy absorbed under the abort conditions, and the speed at which the MA crossed the end of the runway and then the end of the prepared surface, I conclude the brake energy limits on the MA were exceeded and the MA brakes were ineffective even though the MP continued brake pressure throughout the entire abort. Because the MA exceeded the stopping capability limits of its brakes with runway remaining, and still moving at approximately 40 kts airspeed, the MA departed the prepared surface. This resultant failure substantially contributed to the MP's inability to stop the MA within the confines of the runway.
