**KOMITE NASIONAL KESELAMATAN TRANSPORTASI  
REPUBLIC OF INDONESIA**

**Aircraft Accident Investigation Report**

**PT. Trigana Air Service**

**ATR 42-300; PK-YRN**

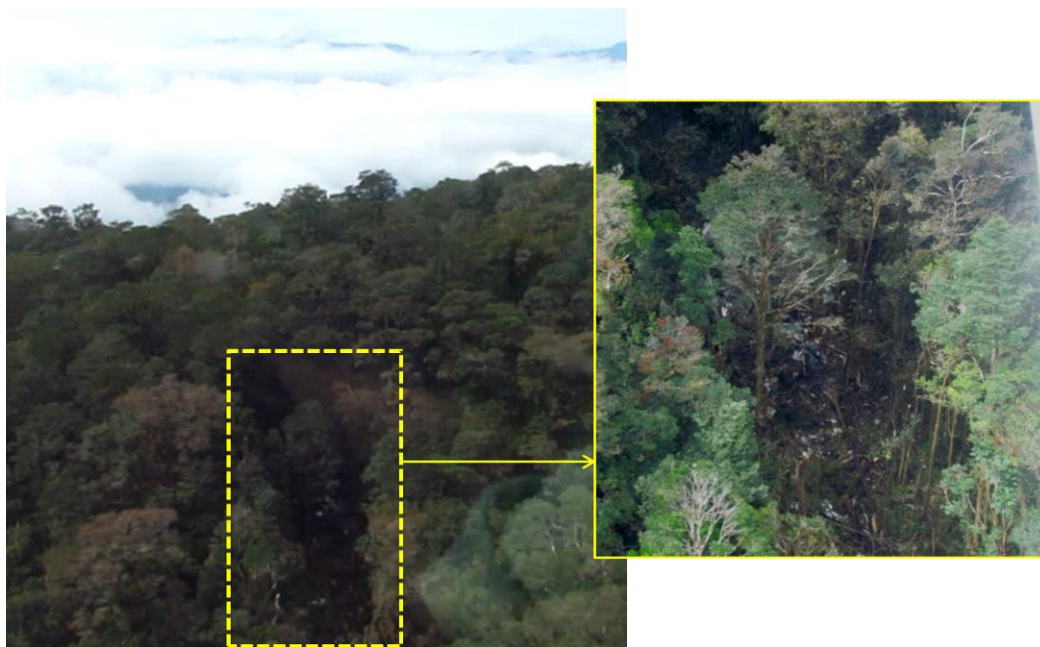
**Figure 2: The accident site pictures taken during search and rescue**

The aircraft wreckage was found on a ridge of Tanggo Mountain, Okbape District, Oksibil at approximately 8,300 feet Above Mean Sea Level (AMSL) at coordinates of 04°49'17.34" S, 140°29'51.18" E, approximately 10 Nm from Oksibil Aerodrome on a bearing of 306°.

All occupants were fatally injured and the aircraft was destroyed by impact force and post-impact fire.

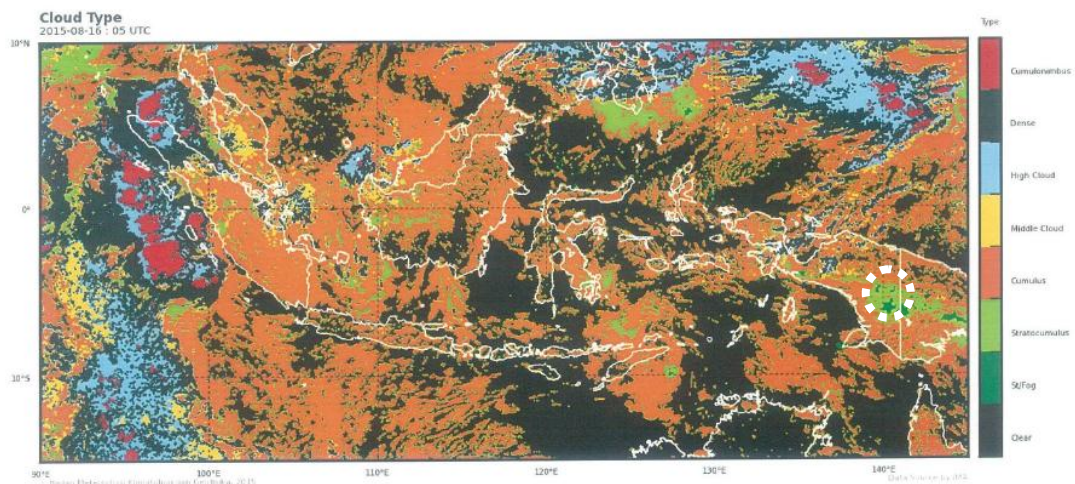
**Figure 3: The satellite weather image at 0500 UTC**

According to the weather satellite image provided by Badan Meteorologi, Klimatologi dan Geofisika (BMKG - Bureau of Meteorology, Climatology and Geophysics), indicated that over Oksibil area was covered by stratocumulus clouds.

The investigation could not determine the weather differences between the previous and the accident flight. The weather information of Oksibil at the time of occurrence was the visibility between 4,000 m – 5,000 m and the cloud base was at 8,000 feet or 4,000 feet AGL and covering more than half of the sky (BKN/broken). The witnesses stated that the cloud covered the area of final approach path. This information was supported by the weather satellite image issued by BMKG.

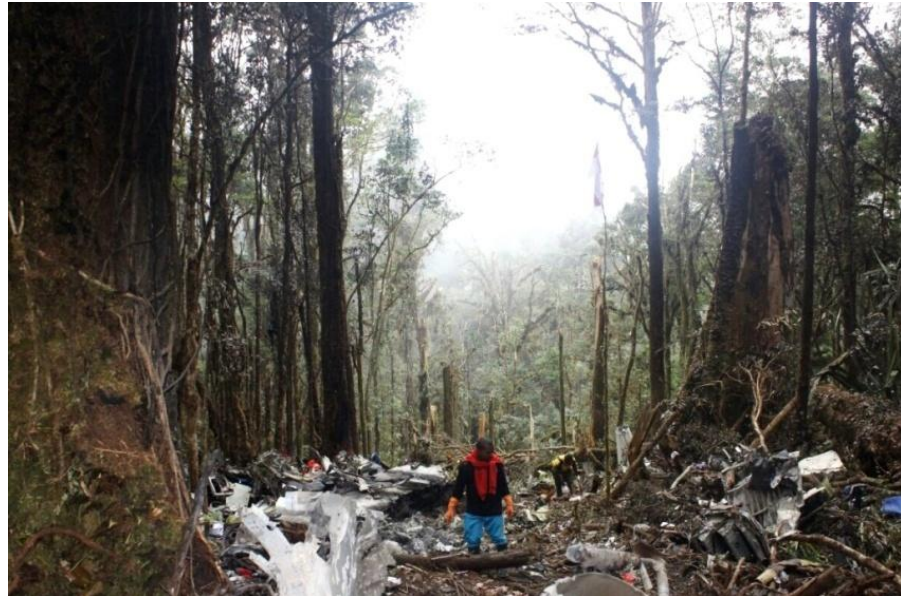
**Figure 7: The view from the accident side toward the aircraft flight path showed opening forest trees that likely caused by impact to the aircraft**

The requirement of VFR flight below 10,000 feet stated that the visibility minimum of 5 km and distance from clouds minimum is 1,000 feet above or below. The opening on the forest indicated that the aircraft flew straight to the final position and the CVR did not record any pilot conversation related to the terrain condition. These indicated that the visibility was limited and the pilot could not see the surrounding terrain.

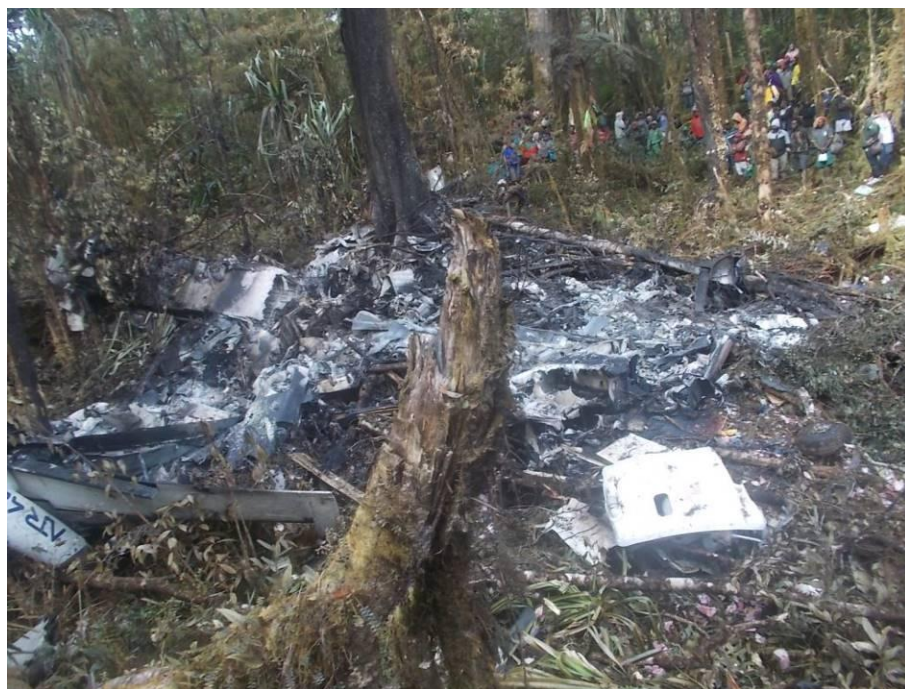
The area of the aircraft fuselage debris was destroyed by post-impact fire.

**Figure 8: The wreckage of the fuselage damaged by post-impact fire**

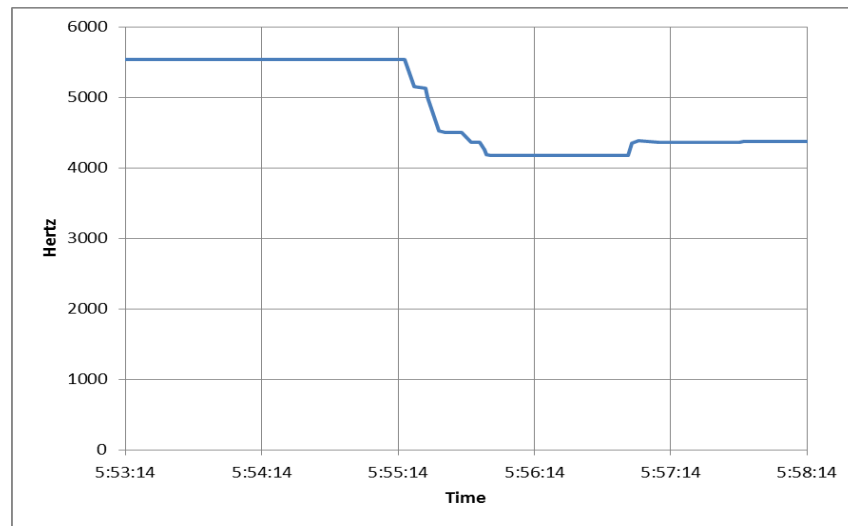
**Figure 10: Torque trends versus time extracted at last five minutes of the flight**

The graph above showed the torque was maintained and at 5:55:17 UTC the torque started stepping down until reached the minimum value recorded for approximately one minute. Subsequently at 5:56:57 UTC the torque slightly increase and maintained until the end of recording.

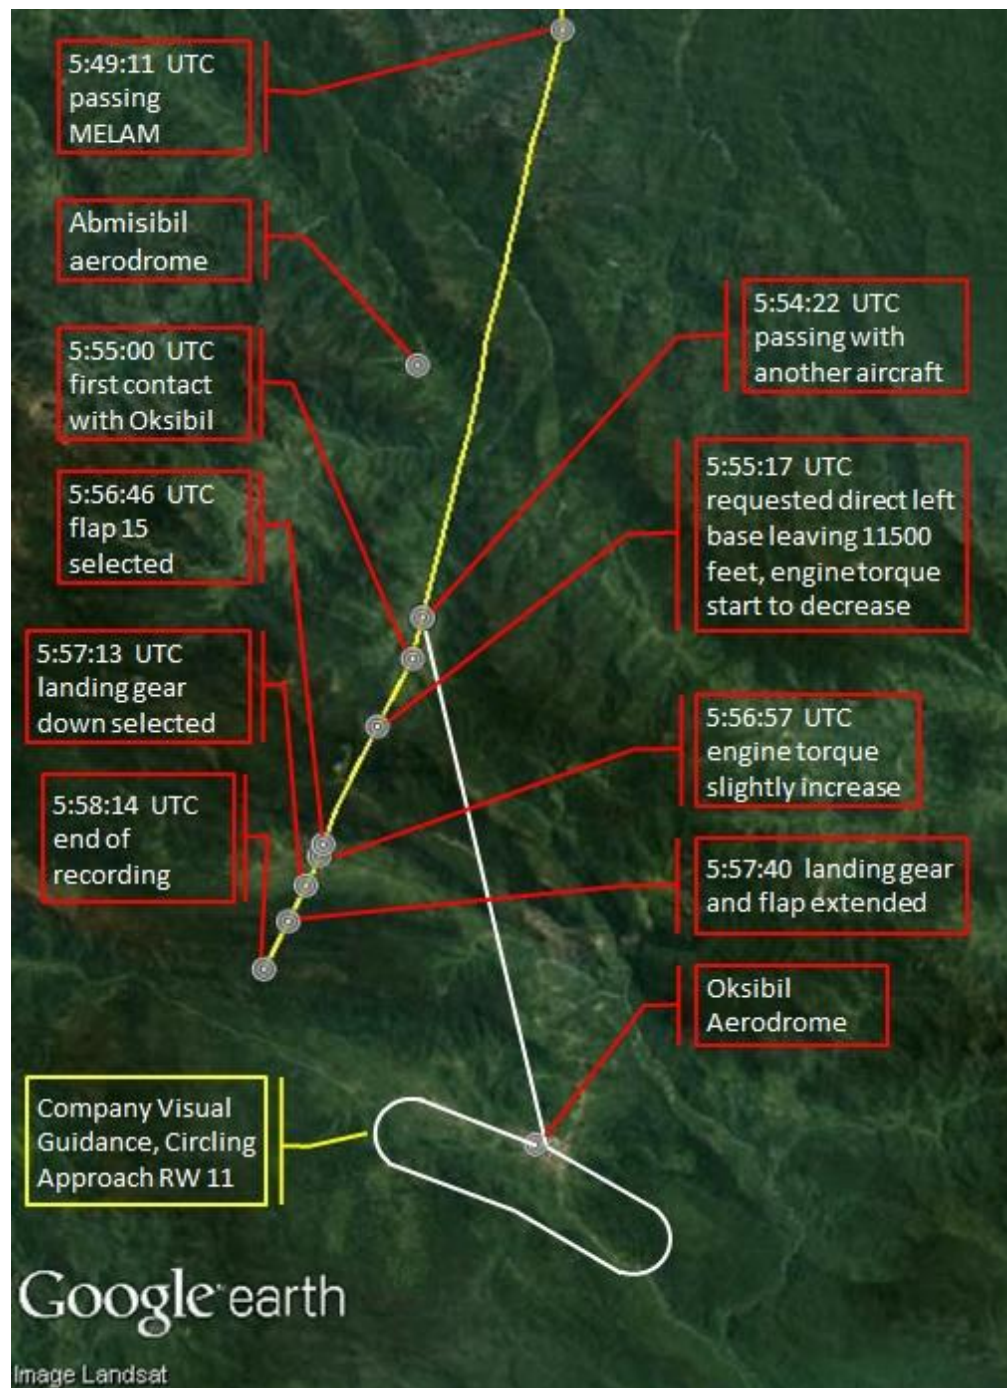
**Figure 16: The predicted aircraft flight track after passing point MELAM**

At 5:56:46, CVR recorded the pilot selected flap 15. Refer to ATR42-300 FCOM the maximum speed of flap and landing gear extension was 160 knots. Therefore, in 60 seconds, the aircraft would have travelled approximately 2.5 Nm.

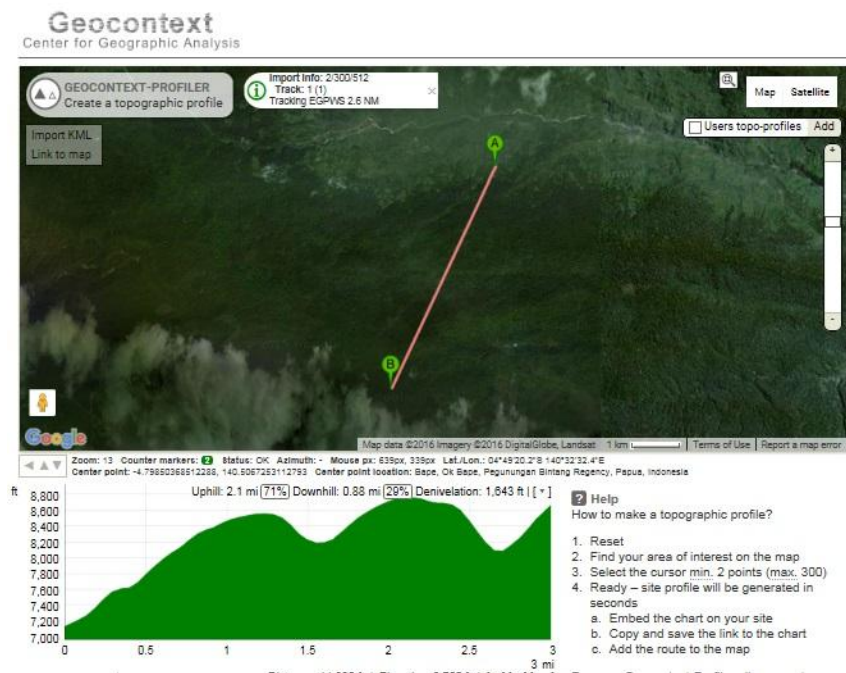
**Figure 17: The estimated terrain utilized Geocontext profiler**

The point A in the Geocontext profiler was the time at 5:57:40 UTC where the flap 15 and landing gear down was confirmed and the point B was the impact point at 5:58:14 UTC.

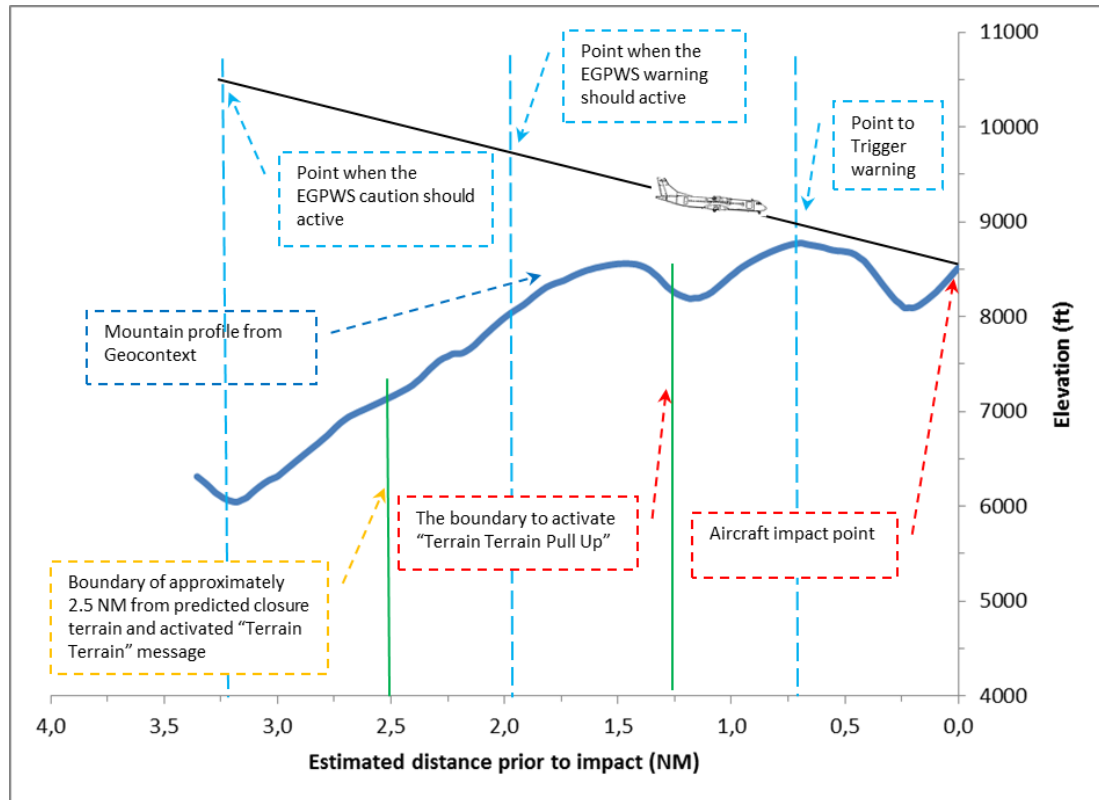
**Figure 18: Approximation of descent profile prior to impact**

Assuming that the aircraft speed was 160 knot or 2.5 Nm per minute, at 5:57:13 UTC the aircraft should have been entered the EGPWS caution envelope and call out “TERRAIN TERRAIN” activated.

Based on the rebuilt of predicted flight track and the terrain condition refer to the Geocontext profiler, there were possibly two points that might trigger the EGPWS to provide terrain caution and warning. The terrain caution should active 2.5 Nm from the trigger points and the terrain warning should active at 1.2 Nm from the trigger points.
