National Transportation Safety Board

Aviation Accident Final Report

Location:	Chignik Lake, Alaska	Accident Number:	ANC17FA021
Date & Time:	May 1, 2017, 13:50 Local	Registration:	N803TH
Aircraft:	Cessna 208B	Aircraft Damage:	Substantial
Defining Event:	VFR encounter with IMC	Injuries:	1 Fatal
Flight Conducted Under:	Part 135: Air taxi & commuter - Non-scheduled

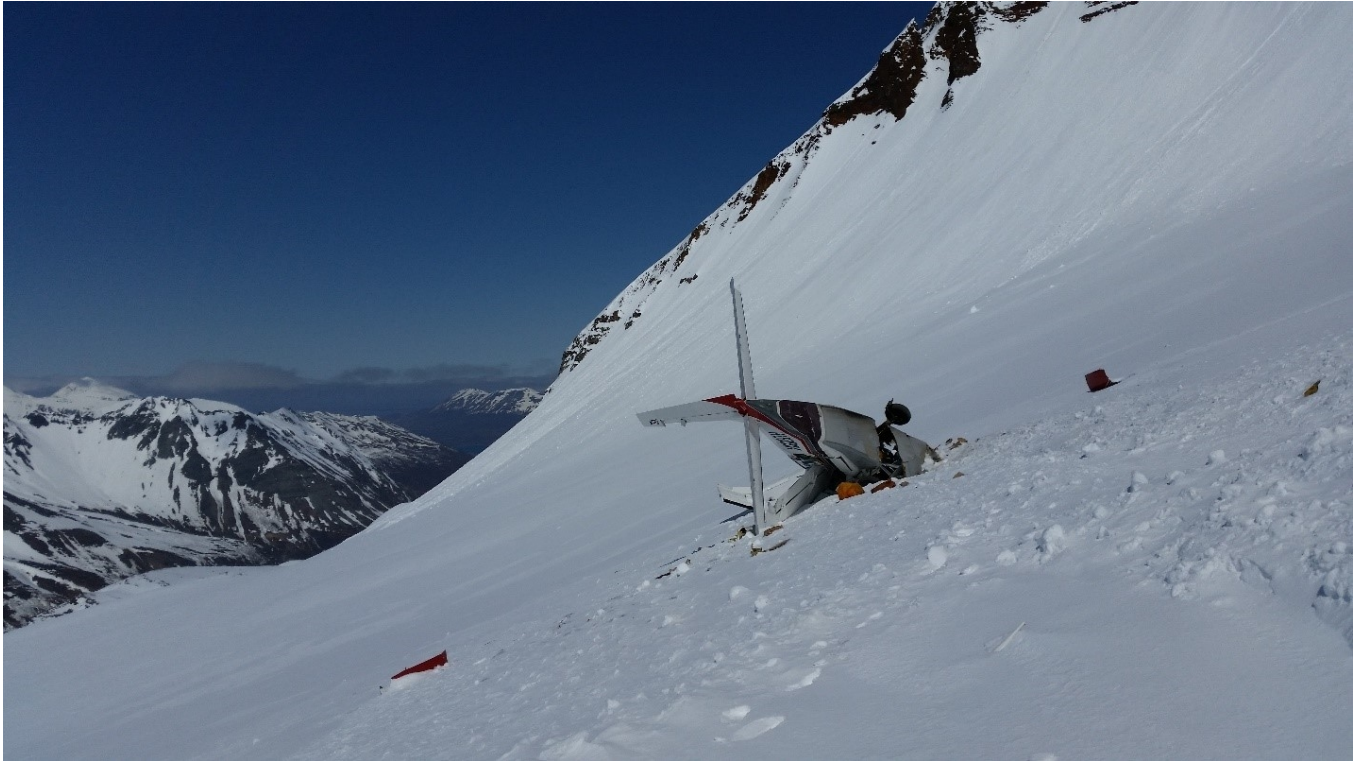
The wreckage was located at 1730 about 24 miles northeast of PAPE on a steep, snow-covered mountain. A rescue crewman was hoisted down to the site and determined that the pilot, who was inside the cockpit and strapped in his seat, had received fatal injuries. See figures 1 and 2.

Figure 2. Accident site.

According to information and photographs provided by the recovery crew, the wreckage came to rest in deep snow about 2,993 ft msl on the west face of a steep, featureless mountain in the Alaska Peninsula National Wildlife Refuge. It was located about 500 ft from the top of the mountain ridge and partially submerged in the snow on its left side with the nose section under the snowpack (see figure 4). The fragmented wreckage was contained in an area about 100 ft long by 35 ft wide, on a heading of about 031° true, with the right wing separated and located about 40 ft forward of the main wreckage and a trail of debris about 30 ft behind the empennage. The initial impact area was indicated by a narrow, 30-ft-long curved indentation in the snow about 65 ft behind the wreckage, indicative of a wing tip strike.

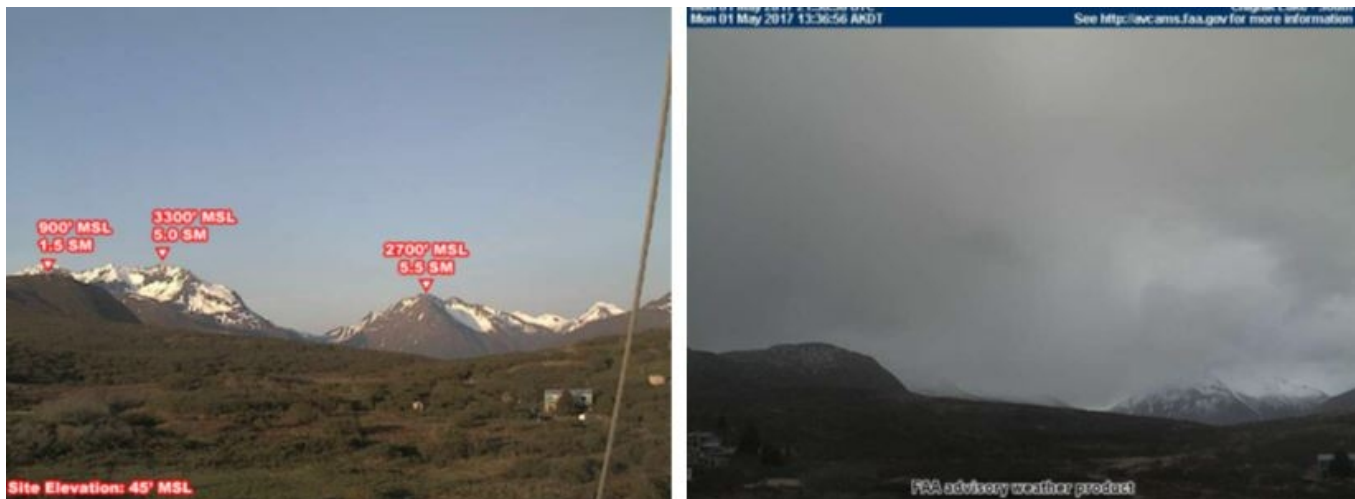
FAA weather camera images from Chignik Lake, about 7 miles north-northeast of the accident site at an elevation of 45 ft, revealed ceilings between 900 ft mean sea level (msl) and 2,700 ft msl, with forward visibilities between 1.5 and 5 miles in the vicinity of the accident site around the accident time (see figure 3). The images further suggest that mountain obscuration conditions prevailed with likely rain shower activity.

Figure 3. South-facing Chignik Lake FAA weather camera image on a clear day (left) and before the accident at 1347 (right).

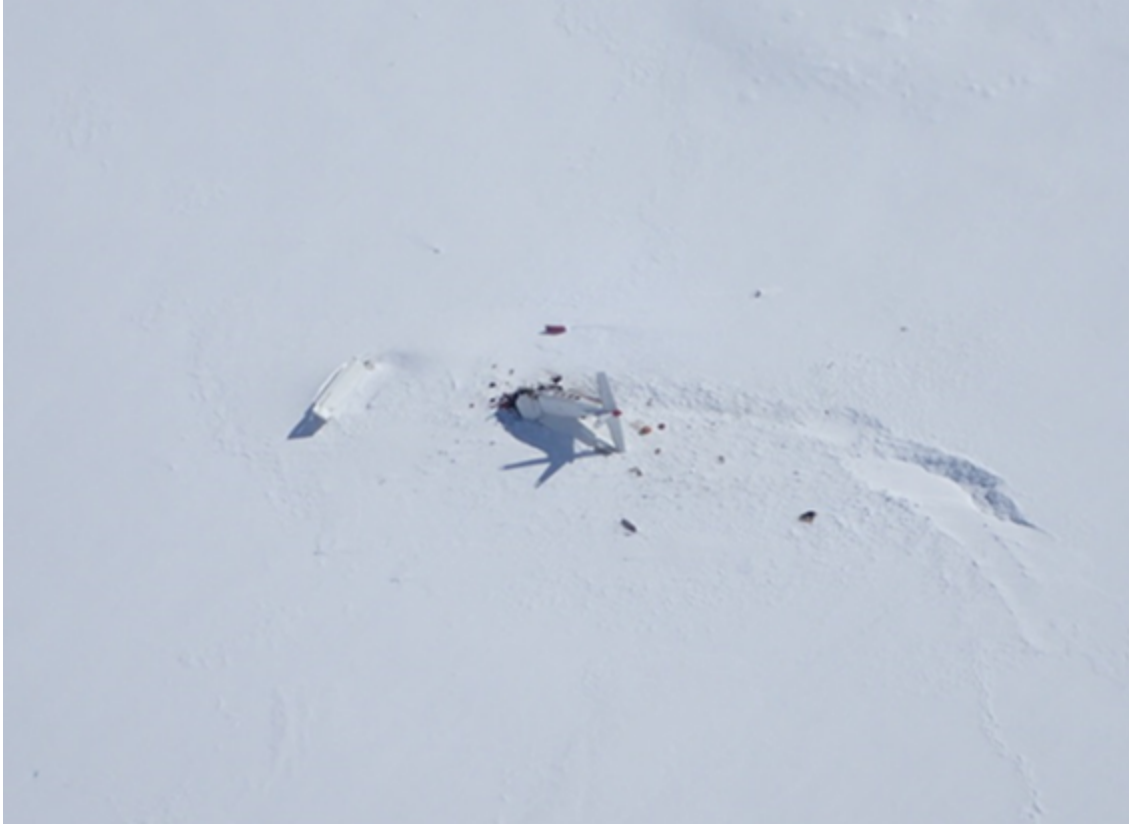
Figure 4. Aerial photograph of N803TH wreckage resting on left side of fuselage with nose under the snow pack (courtesy of the Alaska Mountain Rescue Group)

A postrecovery examination revealed structural damage to the area of the fuselage between the wing spar connections, a large hole and extensive buckling on the left side of the fuselage cabin and buckling on the left rear fuselage. The forward fuselage and cockpit were separated during recovery and exhibited fractures and inward compression deformations in the structure.

The right wing separated from the fuselage inboard of the wing attachment points with a section of the fuselage attached and spar deformation in a forward direction. The left wing exhibited separation at the forward attachment point with rearward overload tension signatures and compression buckling at the inboard trailing edge. The empennage was intact.
