National Transportation Safety Board

Aviation Accident Final Report

Location:	Fullerton, California	Accident Number:	WPR19FA115
Date & Time:	April 18, 2019, 19:51 Local	Registration:	N65MY
Aircraft:	Beech 60	Aircraft Damage:	Destroyed
Defining Event:	Ground handling event	Injuries:	1 Fatal
Flight Conducted Under:	Part 91: General aviation - Personal

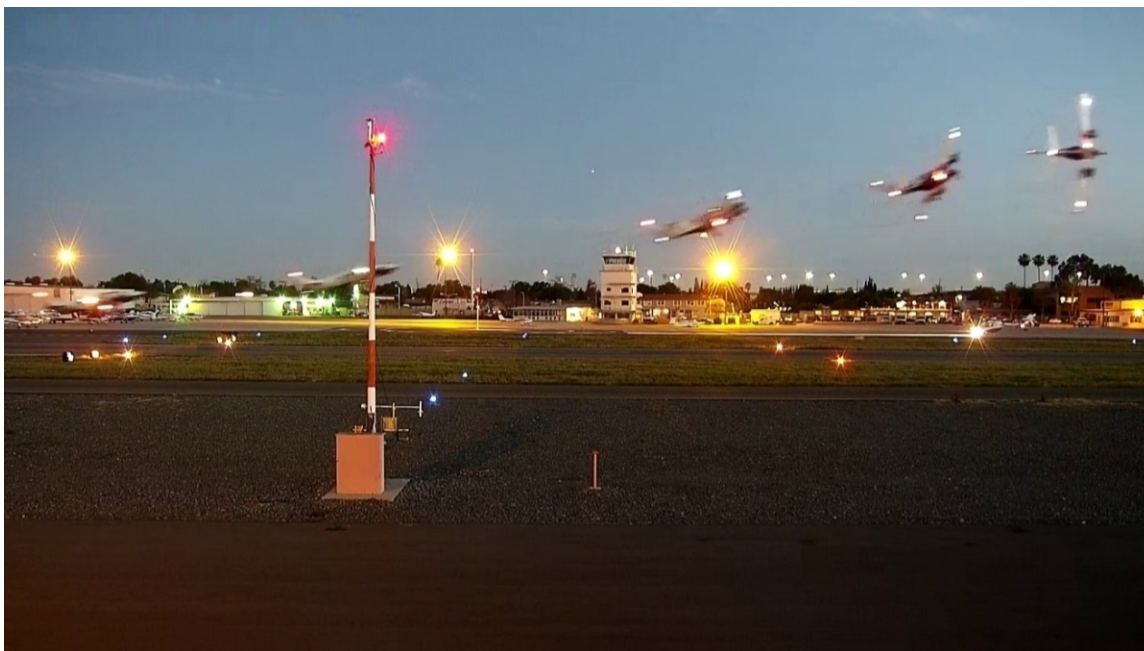
After the pilot was given the takeoff clearance, the airplane began the takeoff roll. The airplane was airborne after traveling about 1,300 ft down the runway, and about 2 seconds after rotation, it began to roll to the left. Three seconds later, the airplane had reached an altitude of about 80 ft above ground level and was in a 90° left bank (figure 1). The nose then dropped as the airplane rolled inverted and struck the southern side of taxiway E in a right-wing-low, nose-down attitude.

Figure 1. Composite video surveillance image of takeoff as viewed from the north.

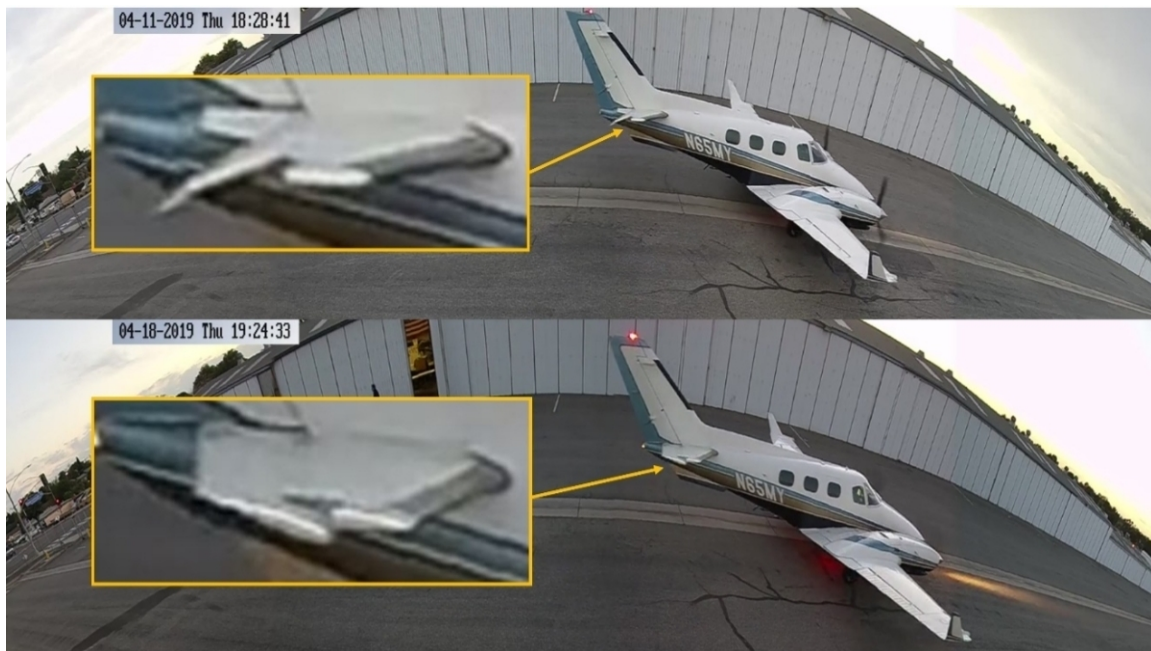
One of the surveillance cameras was positioned above the pilot's hangar and captured the airplane as it was being moved inside that night. Review of the footage revealed that, as the airplane was first being maneuvered, the elevator was hanging at about the 15° trailing edge down position, consistent with the pilot's friend's observation. The following evening, as the pilot pulled the airplane back out of the hangar for the accident flight, the elevator was at about the 15° trailing edge up position such that the elevator balance weight hung below the lower skin of the horizontal stabilizer trailing edge.

The video footage on the day of the accident was compared with video footage of the last time the pilot flew the airplane on April 11, 2019. On that day, the elevator was in the trailing edge down position as the airplane was maneuvered out of the hangar and remained in that position while it taxied to the runup area (figures 2 and 3). While in the runup area on April 11, the elevator moved up and down, consistent with the pilot performing a flight control check.

Figure 2 - Composite image of the elevator position outside of the hangar on April 11, 2019 (top) and April 18, 2019 (bottom). (Video timestamp, 07:07 slow)

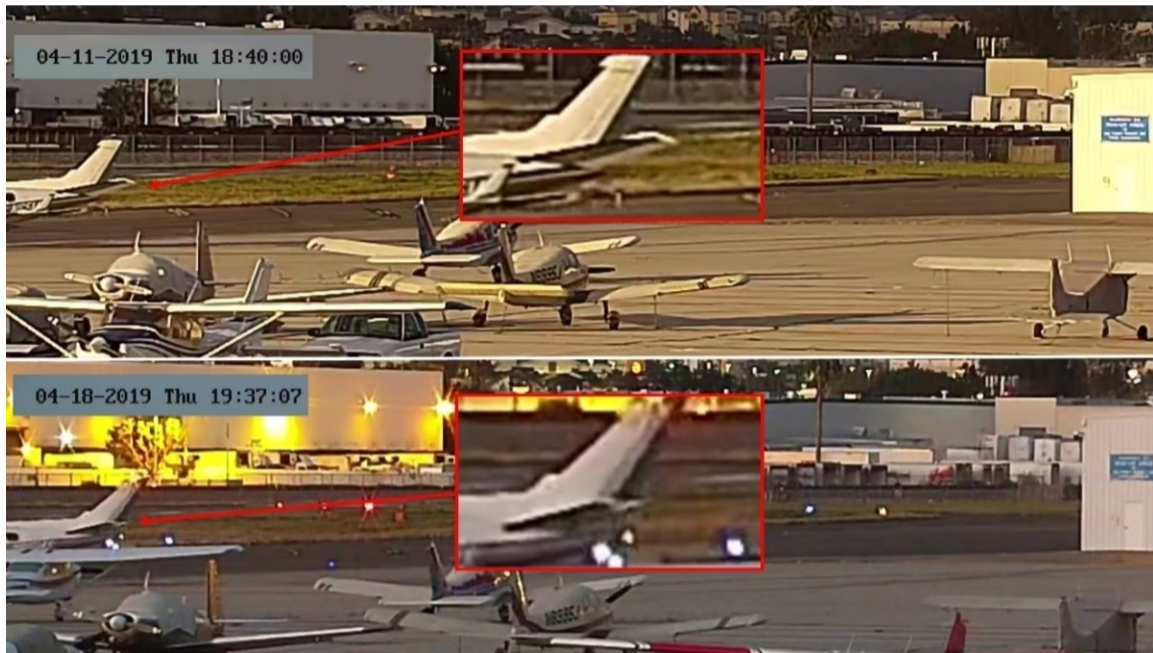
The loss of control during takeoff was likely due to the pilot's use of an unapproved elevator control lock device. Despite video evidence of the elevator locked in the trailing edge up

position before the accident, an examination revealed no evidence of an installed control lock in the cabin. Therefore, during the night before the accident, the pilot likely placed an unapproved object between the elevator balance weight and the trailing edge of the horizontal stabilizer to lock the elevator in the trailing edge up position.

Review of video footage throughout the airport revealed that the elevator remained in the same trailing edge up position throughout taxi, in the runup area, and at the runway hold short line.

Figure 3 – Composite image of the elevator position after the airplane departed the runup area on April 11 (top) and April 18 (bottom). (Video timestamp, 07:07 slow)
