# Aviation Investigation Final Report

<b>Location:</b>	Coleman, Texas	<b>Accident Number:</b>	CEN20FA093
<b>Date &amp; Time:</b>	February 20, 2020, 06:00 Local	<b>Registration:</b>	N860J
<b>Aircraft:</b>	Beech 200	<b>Aircraft Damage:</b>	Destroyed
<b>Defining Event:</b>	Loss of control in flight	<b>Injuries:</b>	3 Fatal
<b>Flight Conducted Under:</b>	Part 91: General aviation - Personal

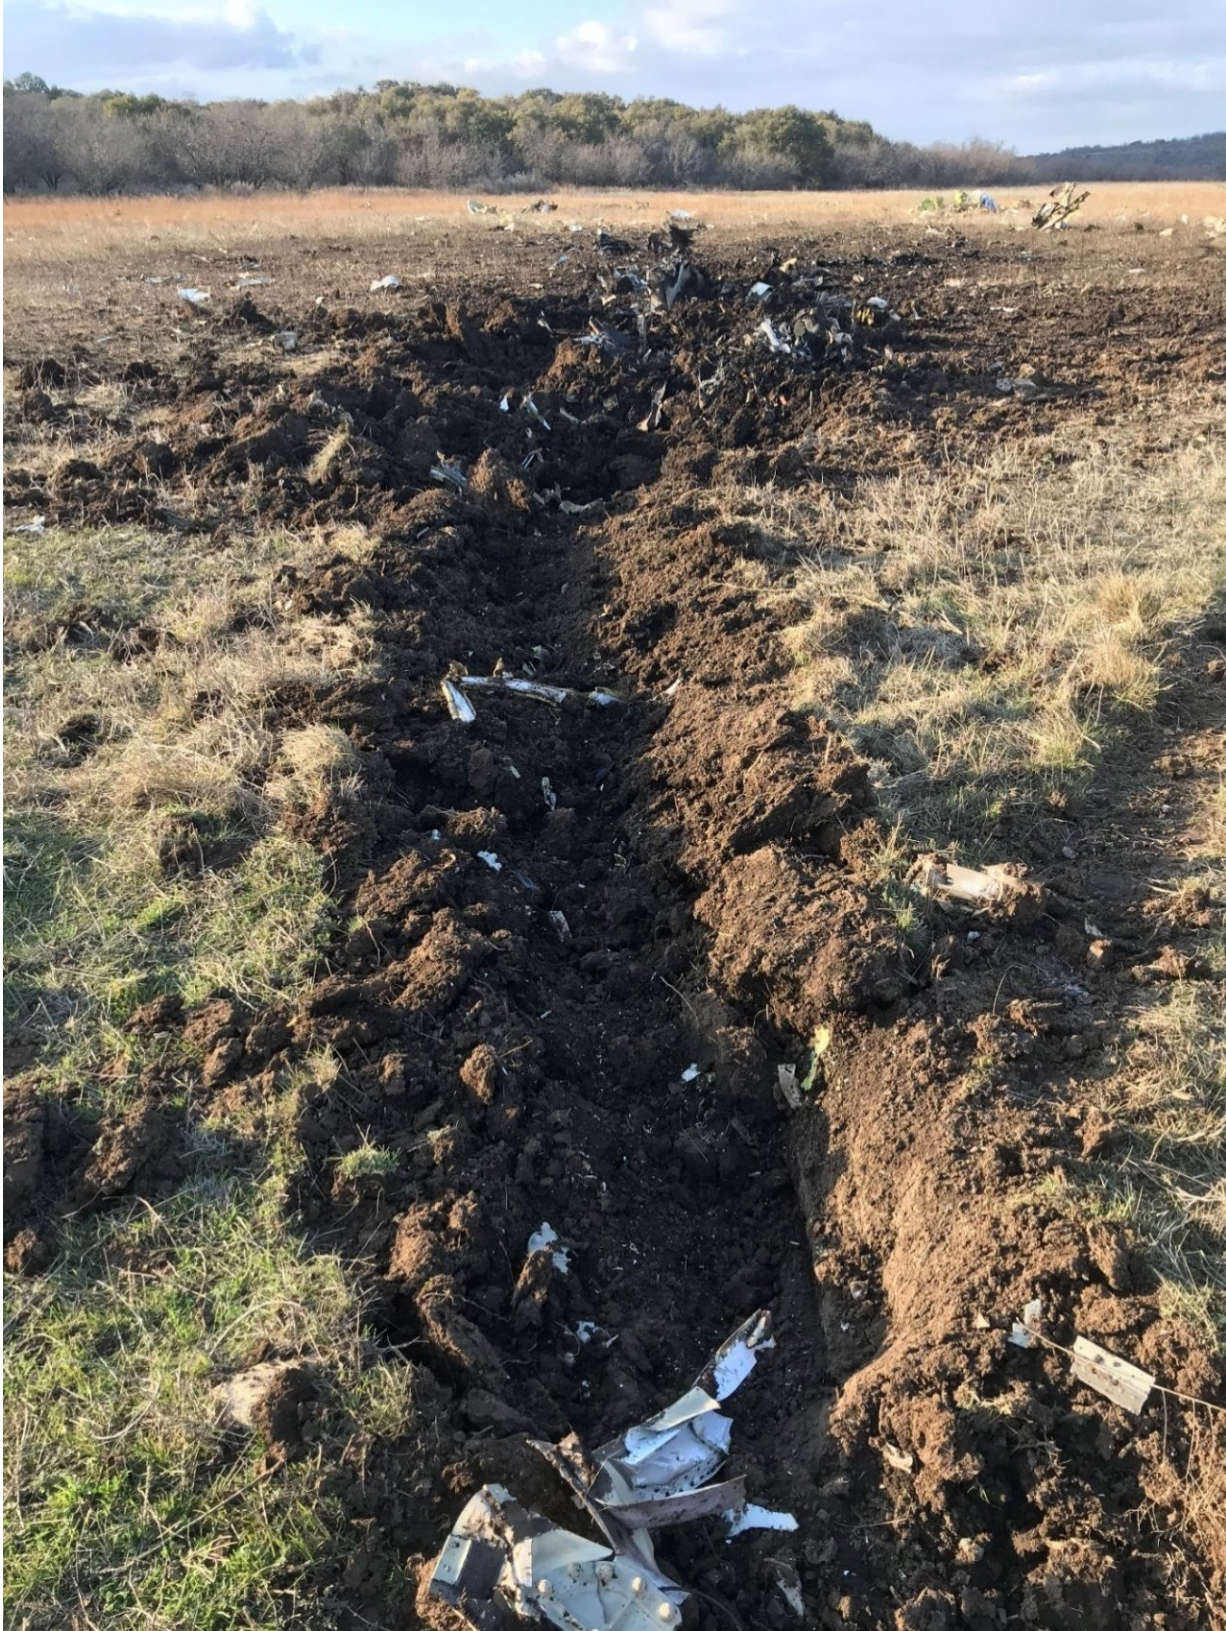
The airplane impacted terrain in a right-wing-low attitude. The wreckage path was oriented on a magnetic heading of 320° and continued for about 570 ft. The wreckage was highly fragmented along the wreckage path. There was a strong fuel odor at the site.

Figure 1: Wreckage path with fragmented wreckage

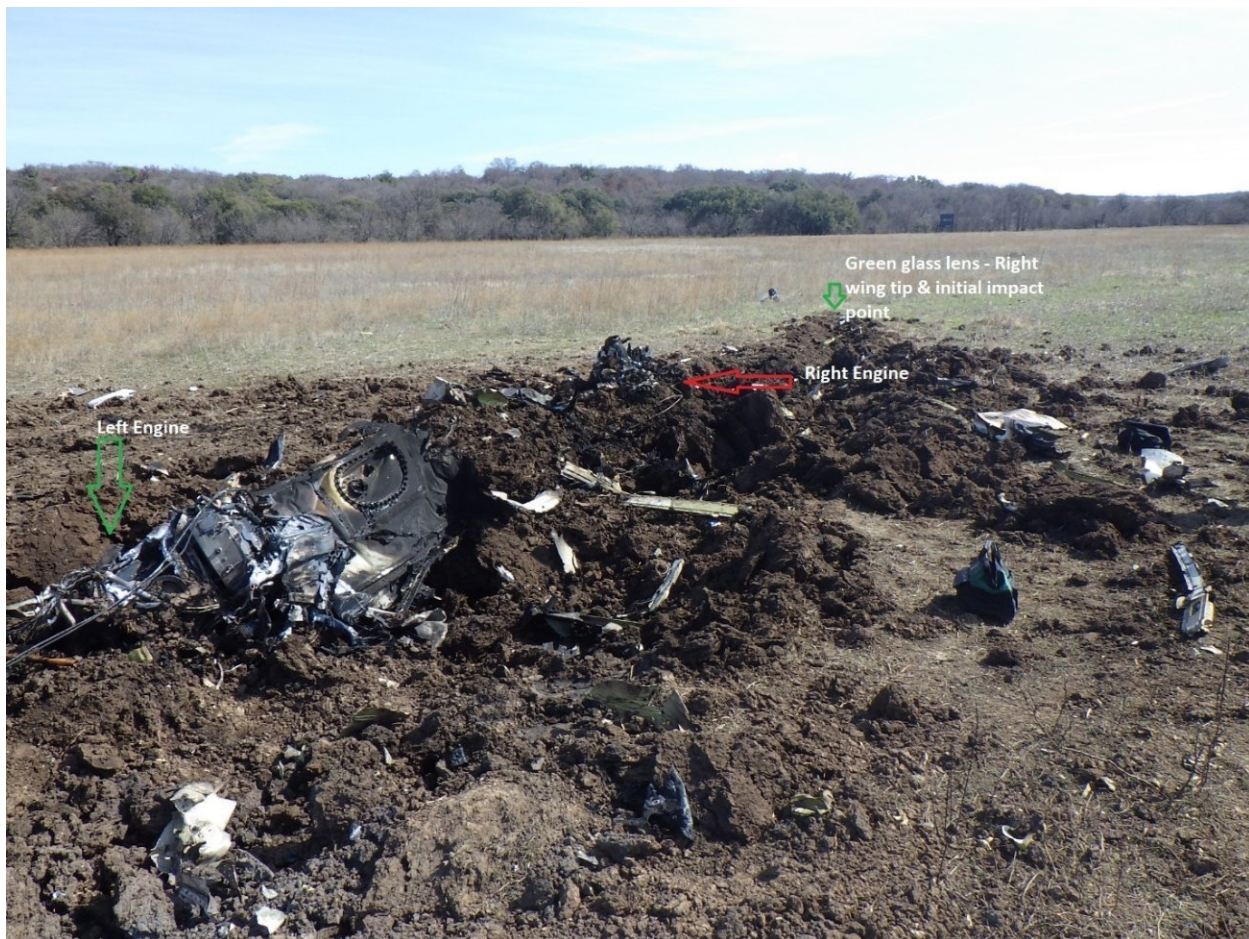
Both engines were either buried or partially buried in the ground, just beyond the initial wing impact point. The right-side engine sustained heavy impact damage: the engine case, accessory gear box, exhaust ducts were crushed, deformed, or fragmented. Disassembly of the engine was conducted in the field; examination of the compressor turbine showed circumferential rubbing wear at the disc and blade firtree serration area from contact with the pressure turbine (1<sup>st</sup> stage) vane ring. The compressor turbine disc downstream side center bore, and lugs showed rubbing wear from contact with the interstage baffle. The compressor turbine shroud segments showed circumferential rubbing wear and corresponding rubbing wear was observed on the compressor turbine blade tips. A visual examination of the 1<sup>st</sup> stage compressor rotor showed several airfoils were bent in the opposite direction of rotation with material observed on the blade tips. The 1<sup>st</sup> stage compressor rotor airfoils showed impact marks on the leading edge.

The left engine was located slightly further along the debris path. The exhaust ducts were still attached to the engine and were crushed, deformed, and folded over the engine exhaust case. The engine also displayed heavy impact damage. Disassembly of the left engine was conducted in the field; examination of the compressor turbine disc found it was fractured at the compressor rear air seal area and released from the compressor. Circumferential rubbing wear was observed on the compressor disc upstream side from contact with the compressor turbine vane ring. The downstream side of the compressor turbine disc showed circumferential rubbing wear across the entire disc face from contact with the 1<sup>st</sup> stage power turbine vane ring and interstage baffle. The compressor turbine blades were fractured and showed secondary impact damage. The fracture surfaces showed evidence of tensile overload. The compressor turbine shroud segments showed circumferential scoring. The corresponding portion of the fracture compressor turbine disc remained inside the engine. The compressor turbine vane ring airfoils showed debris, otherwise no pre-impact distress was observed.

The left and right engine examinations did not identify any pre-impact abnormalities.

Figure 2: Initial impact point and Engines

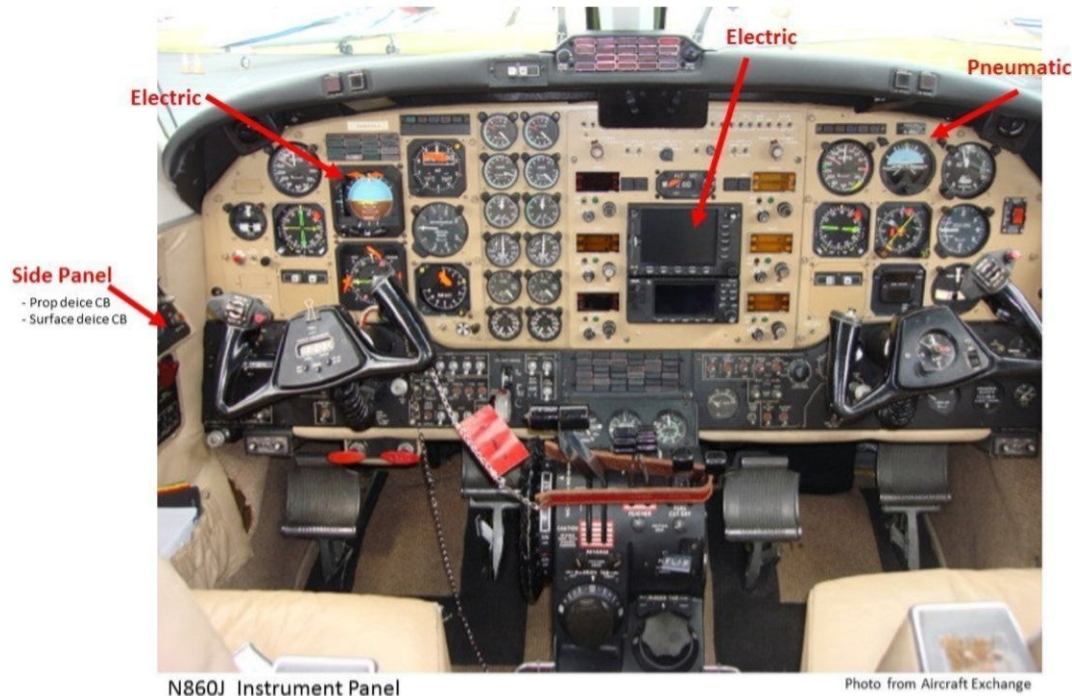
The instrument panel was highly fragmented, with pieces of instruments scattered along the wreckage path. Due to the impact damage, instrument readings and the position of switches and levers in the cockpit were not considered reliable. The right-side pneumatic attitude indicator was located; the instrument had impact separated from the panel and displayed heavy impact damage. The rotor/gyro was outside of the case; light circumferential scoring/rubbing was noted. A remote gyro unit was in the debris path. The unit also had heavy impact damage with circumferential scoring/rubbing on the rotor/gyro system.

Figure 3: N860J panel
