Aviation Investigation Final Report

| Location: | Sioux Falls, South Dakota | Accident Number: | CEN20LA215 |
| Date & Time: | June 7, 2020, 04:25 Local | Registration: | N44MX |
| Aircraft: | Mitsubishi MU2B | Aircraft Damage: | Destroyed |

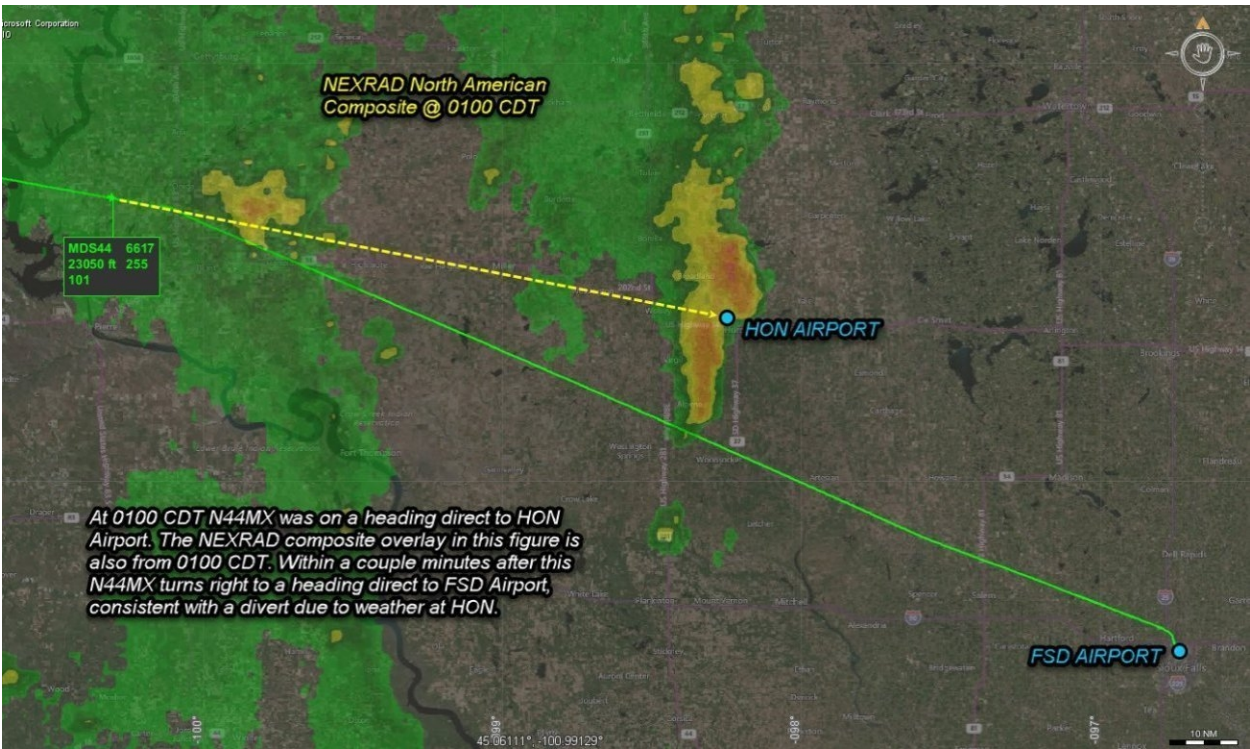
The flight, operated by McNeely Charter Service, Inc., originated at Snohomish County Airport (Paine Field) (PAE), Everett, Washington, about 2115, and was originally destined for Huron Regional Airport (HON), Huron, South Dakota, for a fuel stop. Air traffic control information and weather data was consistent with the pilot diverting to Joe Foss Field Airport (FSD), Sioux Falls, South Dakota, due to weather at HON at the time of intended arrival. The flight landed at FSD at 0140. The final destination was Kokomo Municipal Airport (OKK), Kokomo, Indiana.

Figure 1: Final segment of inbound leg that had originated from Everett, Washington.

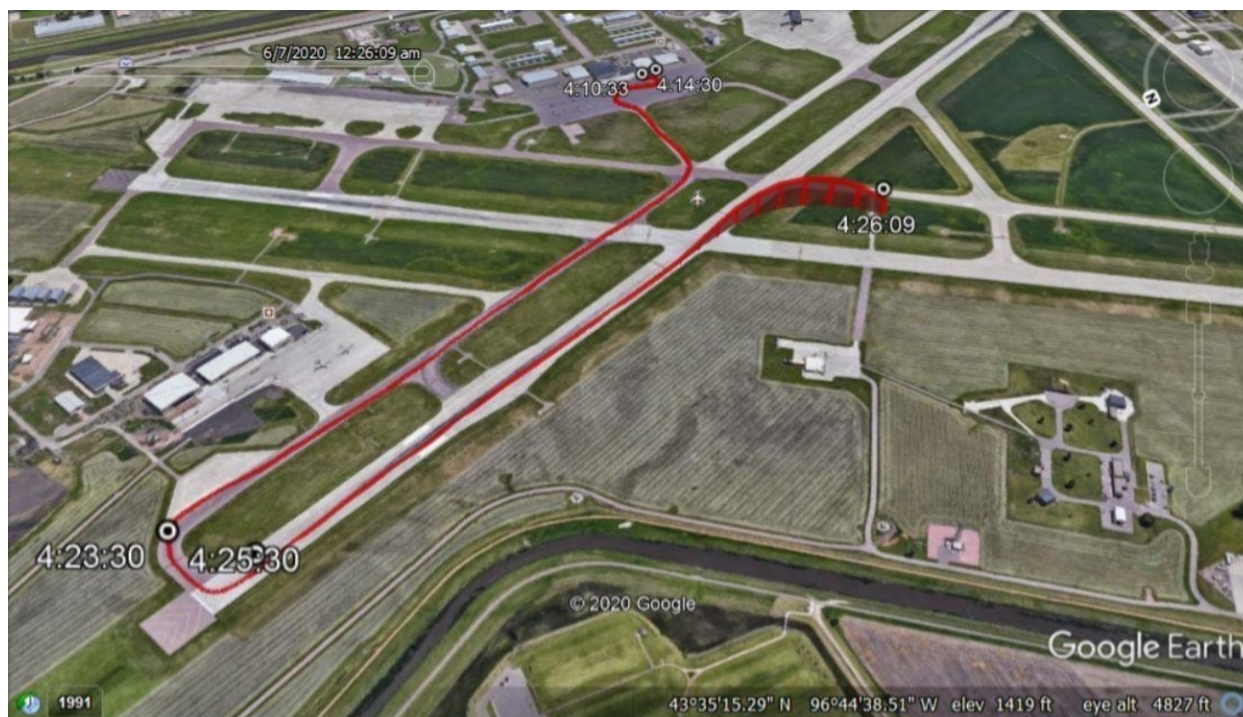
Recovered GPS data revealed that the airplane departed FSD from runway 15 at 0426. According to a video recording from FSD, the airplane appeared to have a normal takeoff roll. After rotation, a high pitch angle was established for initial climb out and the right wing began to dip. As the airplane climbed,

the right wing continued to drop, and the airplane rolled over to the right side. The airplane nosed over on the right side and continued in a nose down attitude and impacted terrain. Radar track data for the flight began when the airplane reached about 45 ft above ground level (agl) and was limited to 3 radar hits in 3 seconds.

Figure 2: A Google Earth plot showing the accident aircraft's ground track and altitude depiction.
