Aviation Investigation Final Report

Location:	Billings, Montana	Accident Number:	WPR20LA128
Date & Time:	April 20, 2020, 09:50 Local	Registration:	N926K
Aircraft:	Piper PA31T	Aircraft Damage:	Destroyed
Defining Event:	Collision during takeoff/land	Injuries:	1 Fatal
Flight Conducted Under:	Part 91: General aviation - Personal

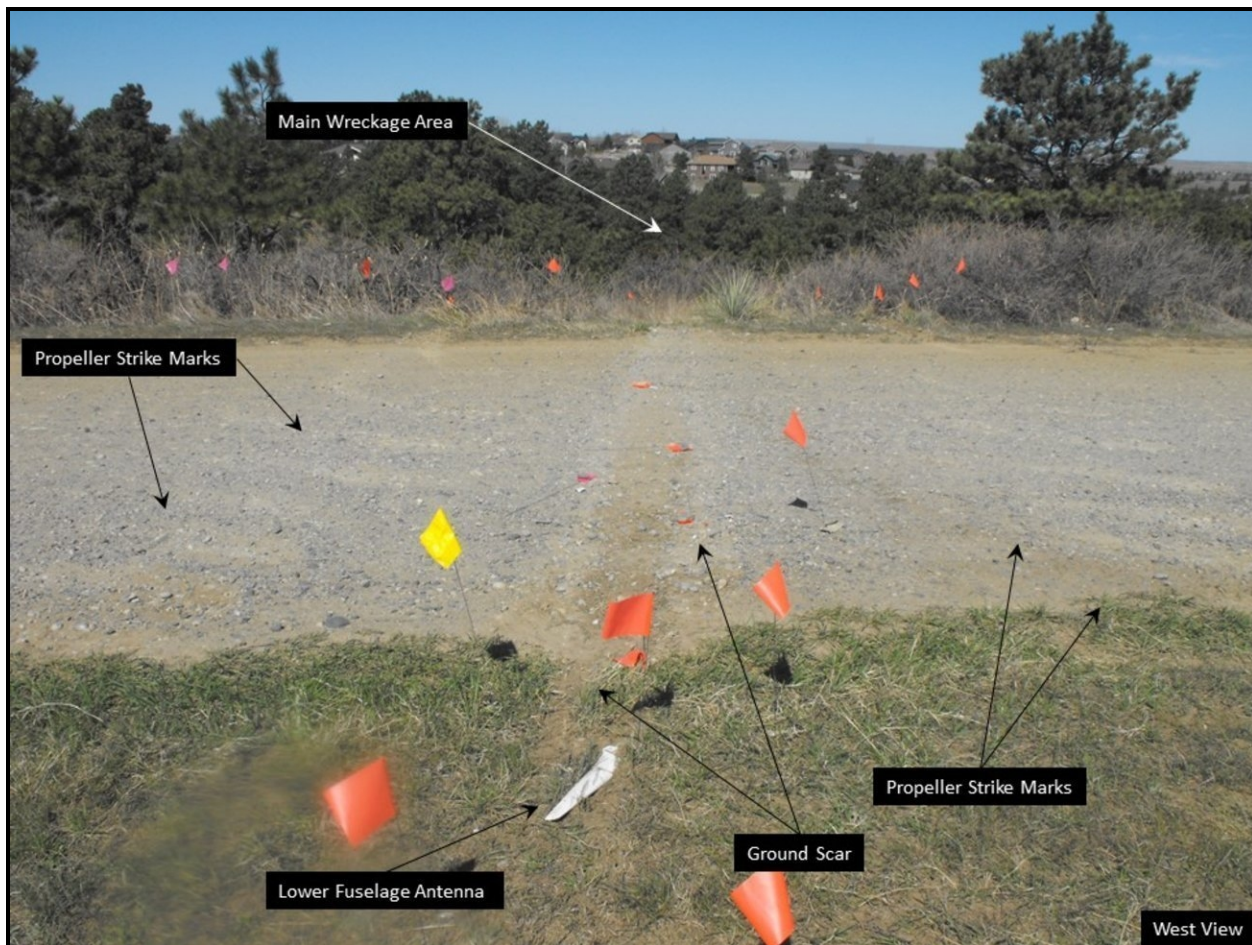
Ground scars found near the top of a coulee consisted of the airplane's fuselage impact mark and symmetrical propeller strikes consistent with the airplane impacting the ground in a shallow, nose-up, wings-level attitude. The airplane continued about 410 ft over the coulee and about 75 ft down the side before impacting the terrain where a postimpact fire ensued. All major structural components of the airplane were located within the debris field.

Figure 1-Accident site, initial ground impact marks.
