Aviation Investigation Final Report

Location:	Fairmount, Georgia	Accident Number:	ERA20FA096
Date & Time:	February 8, 2020, 10:13 Local	Registration:	N501RG
Aircraft:	Cessna 501	Aircraft Damage:	Substantial
Defining Event:	Loss of control in flight	Injuries:	4 Fatal
Flight Conducted Under:	Part 91: General aviation - Personal

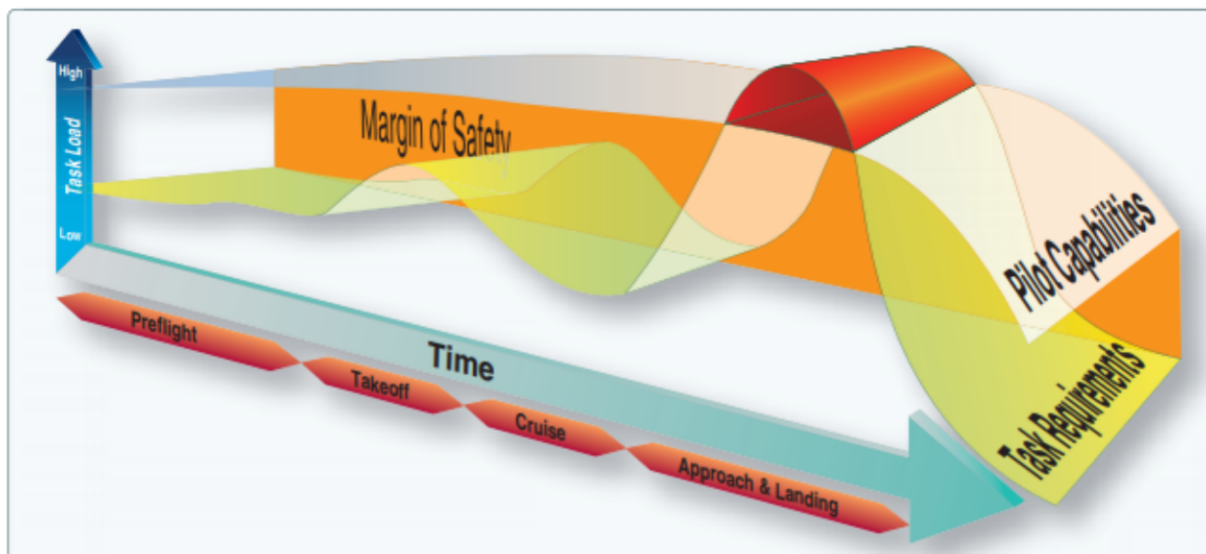
Recognizing a work overload situation is also an important component of managing workload. The first effect of high workload is that the pilot may be working harder but accomplishing less. As workload increases, attention cannot be devoted to several tasks at one time, and the pilot may begin to focus on one item. When a pilot becomes task saturated, there is no awareness of input from various sources, so decisions may be made on incomplete information and the possibility of error increases. When a work overload situation exists, a pilot needs to stop, think, slow down, and prioritize. It is important to understand how to decrease workload. For example, in the case of the cabin door that opened in VFR flight, the impact on workload should be insignificant. If the cabin door opens under IFR different conditions, its impact on workload changes. Therefore, placing a situation in the proper perspective, remaining calm, and thinking rationally are key elements in reducing stress and increasing the capacity to fly safely. This ability depends upon experience, discipline, and training.

Figure 14-1. The pilot has a limited capacity of doing work and handling tasks, meaning there is a point at which the tasking exceeds the pilot's capability. When this happens, either tasks are not done properly or some are not done at all.
