# Aviation Investigation Final Report

<b>Location:</b>	Winslow, Arizona	<b>Accident Number:</b>	WPR21FA175
<b>Date &amp; Time:</b>	April 23, 2021, 15:19 Local	<b>Registration:</b>	N59EZ
<b>Aircraft:</b>	Swearingen SA226-T(B)	<b>Aircraft Damage:</b>	Destroyed
<b>Defining Event:</b>	Loss of engine power (partial)	<b>Injuries:</b>	2 Fatal
<b>Flight Conducted Under:</b>	Part 91: General aviation - Personal

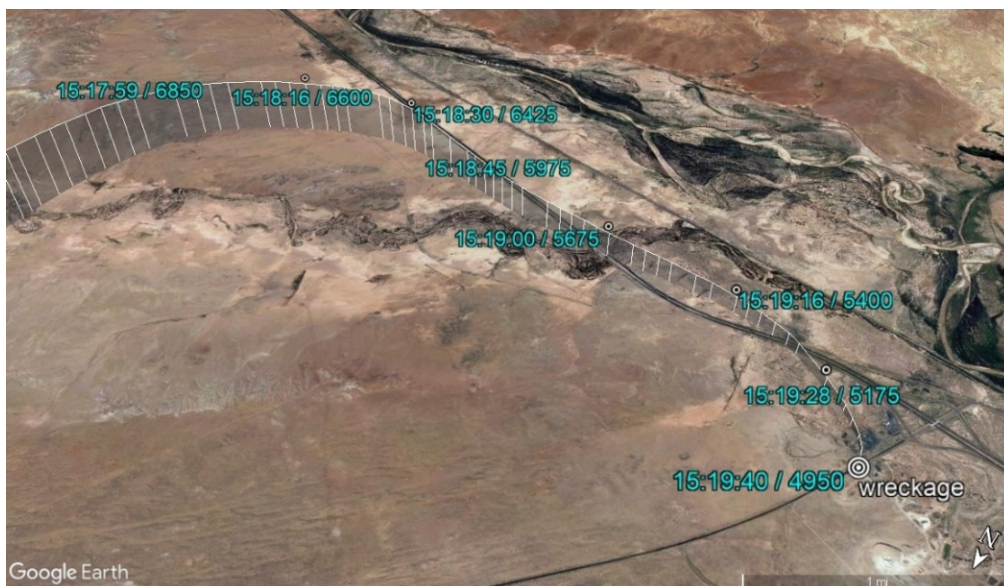
During the final 2 minutes of flight, the airplane descended steadily while slowing from 200 to about 125 knots. The airplane continued to slow while aligning with Interstate 40 (I-40). At 1519:15, the airplane began a turn to the right and away from I-40. The final ADS-B reported altitude for the airplane was 4,950 ft msl (about 80 ft above ground level). Figure 1 shows the airplane’s track.

Figure 1. ADS-B track for the accident flight.

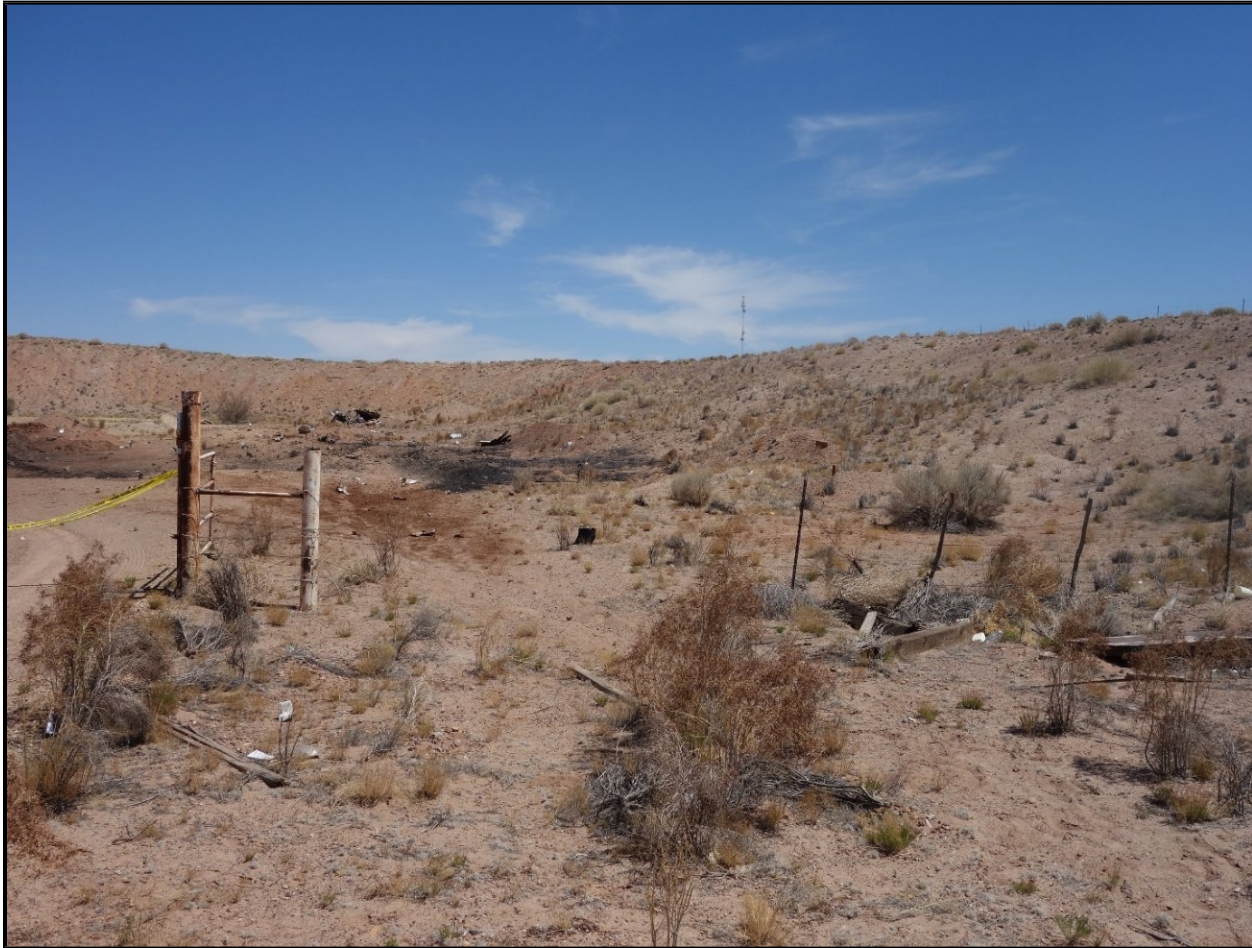
The first identified point of impact was a ground mark about 10 ft from a barbed-wire fence. Two metal fence posts, about 12 ft apart from each other, were not damaged or disturbed (see figure 2).

Figure 2. Barbed wire fence and fence posts.

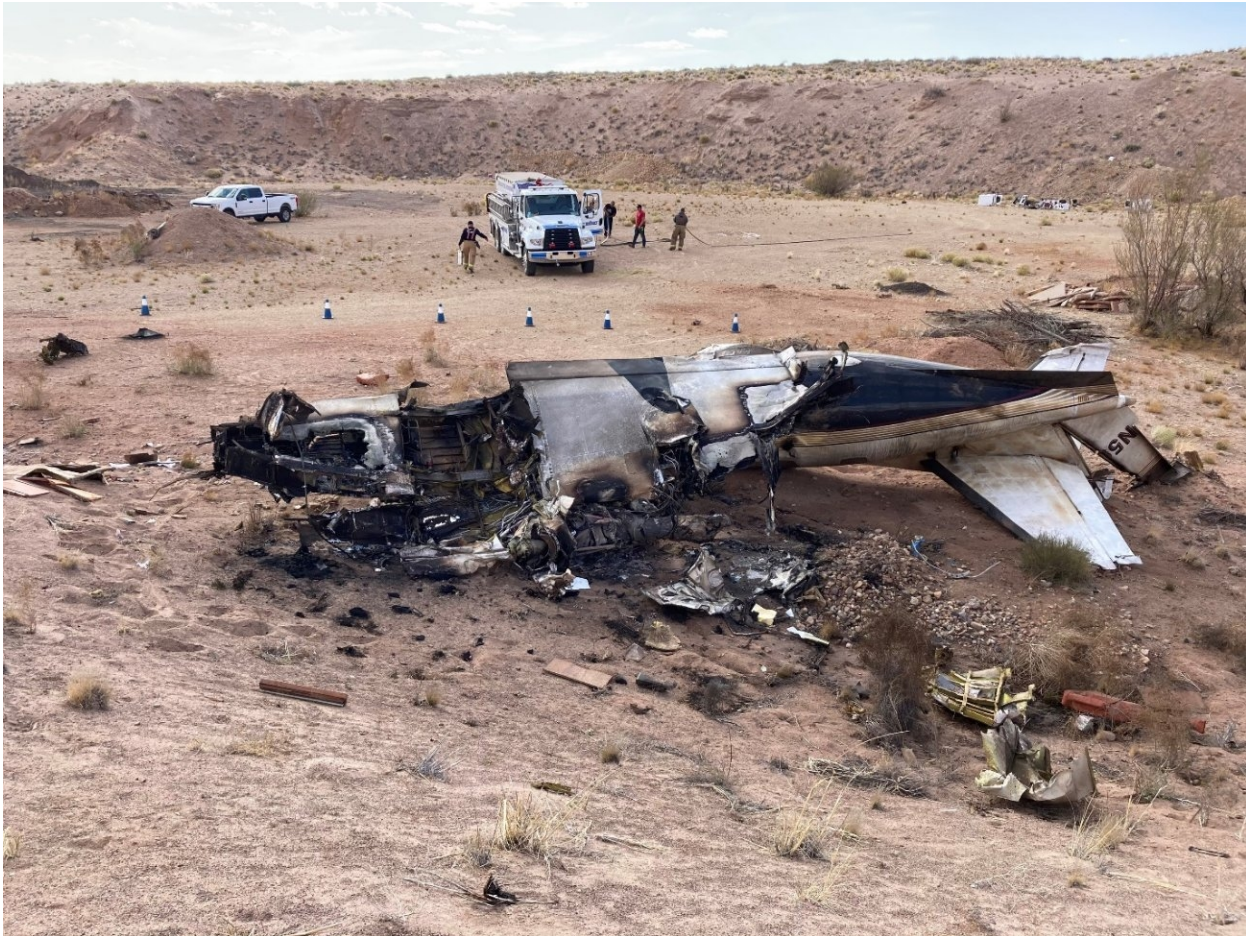
The debris path was oriented on a 028° heading that extended to the main wreckage (see figure 3), which was about 410 ft from the first identified point of impact. All major structural components of the airplane were located within the wreckage debris path. Both wings were separated from the fuselage, and both engines had separated from their respective wings. Both propeller assemblies had separated from their respective engines and were found in the debris field. Flight control continuity was established throughout the airframe. There was no evidence that indicated any pre-existing mechanical malfunction with the airframe.

Figure 3. Main wreckage (Source: Navajo County Sheriff Department).
