**FINAL REPORT**  
**A-075/CENIPA/2020**

<b>OCCURRENCE:</b>	<b>ACCIDENT</b>
<b>AIRCRAFT:</b>	<b>PT-MBV</b>
<b>MODEL:</b>	<b>EMB-121A</b>
<b>DATE:</b>	<b>14JUN2020</b>

This Final Report refers to the accident with the EMB-121A aircraft, registration PT-MBV, on 14 June 2020. The accident was typified as “[LOC-I] Loss of control in flight”.

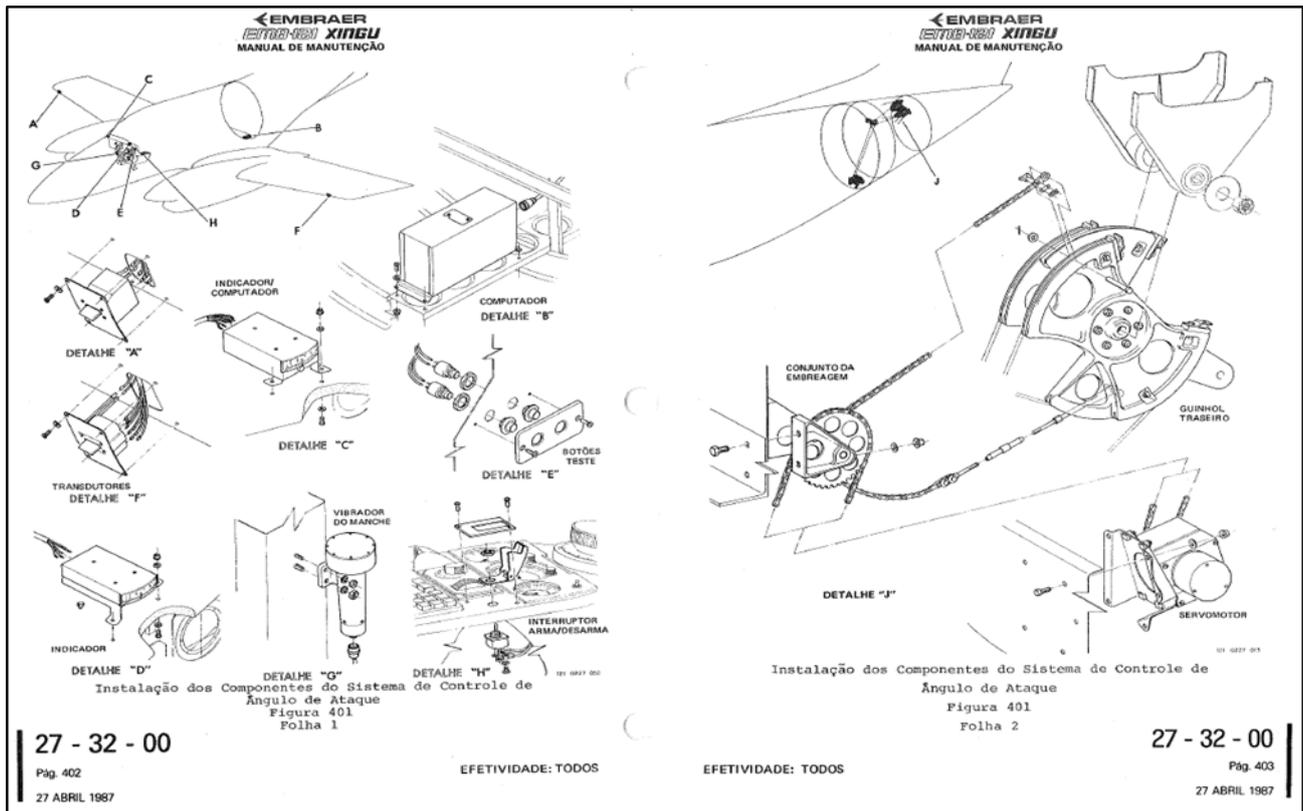
Fig. 2 - Visual description of components of the angle-of-attack control system, subsystems 1 and 2.

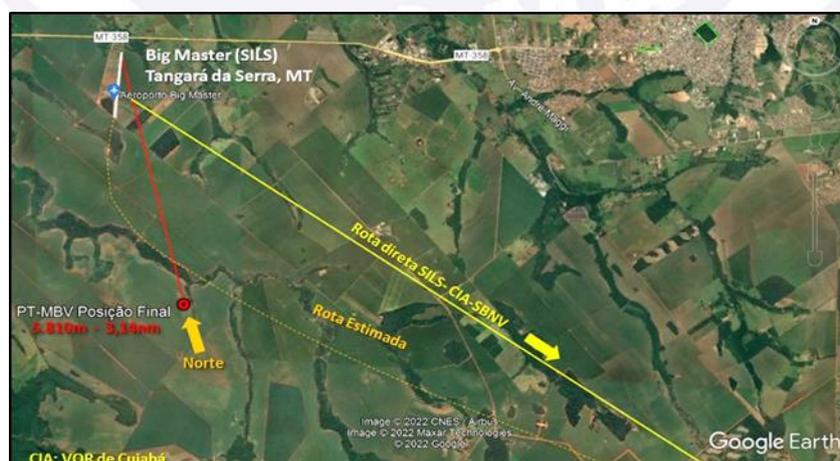
The distance between the accident site and the threshold of the takeoff runway (RWY 20) of SILS, was approximately 5,810 m (3.14 NM) along a straight line, azimuth 006° (Figure 8).

Figure 8 - Sketch of the aircraft's estimated trajectory for the intended route. Source: Adapted from Google Earth.

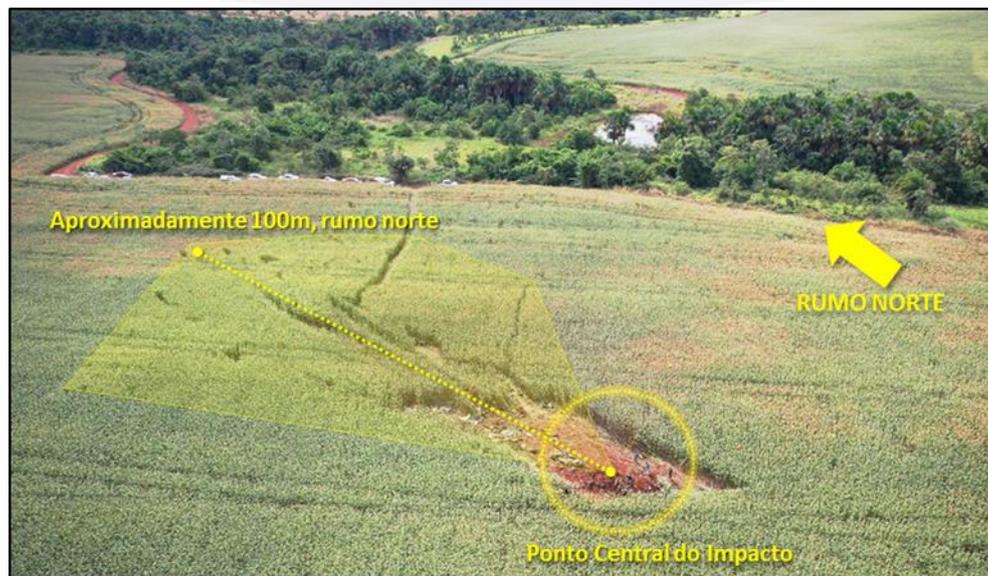
The engines had penetrated the ground at a depth between 1.5 and 2 meters, with the right-hand engine buried underneath the left-hand one.

In addition, there was no sign of ground scars before the point of impact, a factor that demonstrates the high angle of impact against the ground, as shown in the aerial view in Figure 9.

Figure 9 - Aerial view of the crash site.

Information obtained from the wreckage revealed that the engines penetrated the ground at a depth between 1.5 and 2 meters, with the right-hand engine found underneath the left-hand engine, indicating that the aircraft was in a downward turn to the right.

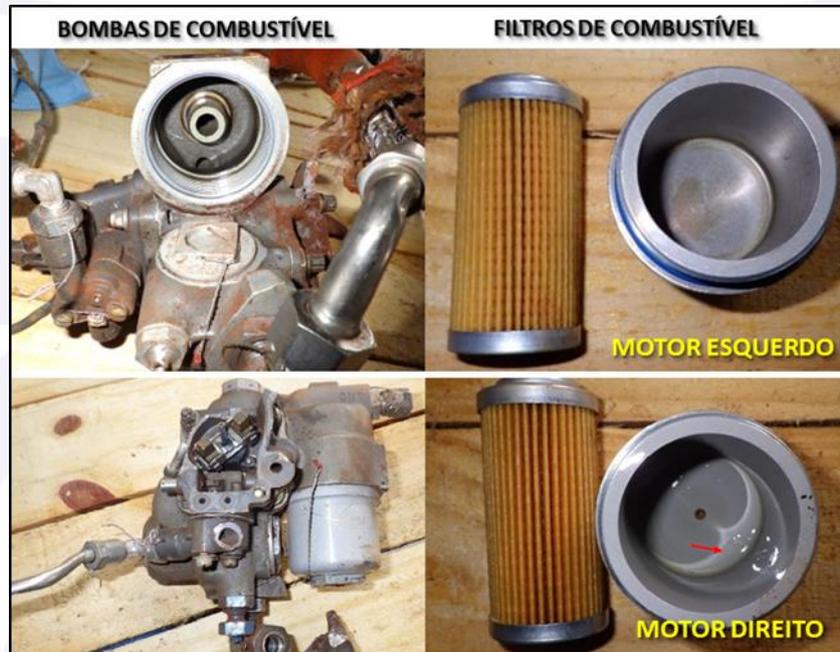
The low-pressure fuel filters had their interiors clean, with no visible indication of contamination, but with a distinct smell of fuel, as they contained residual liquid. The fuel found was light in color, without phase separation (Figure 10).

Figure 10 - General condition of the pumps, filters, and fuel.

There was no evidence that could be associated with a malfunction of the engines.
