Aviation Investigation Final Report

Location:	Bignell, Nebraska	Accident Number:	CEN23FA031
Date & Time:	November 9, 2022, 09:34 Local	Registration:	N234PM
Aircraft:	Piper PA46-500TP	Aircraft Damage:	Destroyed
Defining Event:	Loss of control in flight	Injuries:	2 Fatal
Flight Conducted Under:	Part 91: General aviation - Business

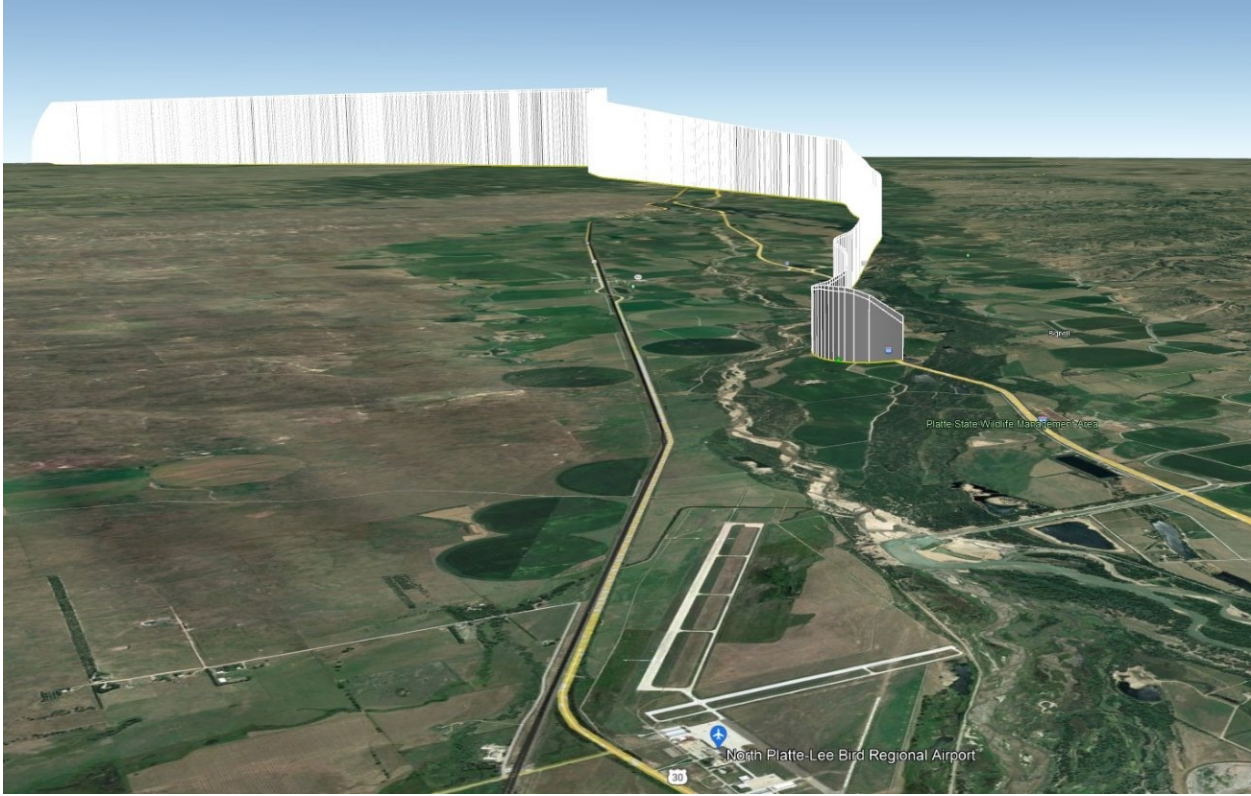
A review of the ADS-B data revealed that during the last minute of data, the airplane's vertical descent rate increased from 500 ft per minute to 3,000 ft per minute. In the last 30 seconds, the vertical rate increased to a climb of 2,000 ft per minute, and then sharply decreased to a left descending turn exceeding 5,000 ft per minute. The last data point was located about 1,000 ft west-northwest of the accident site (see Figures 1 and 2).

Figure 1. ADS-B flight track view looking east-southeast.

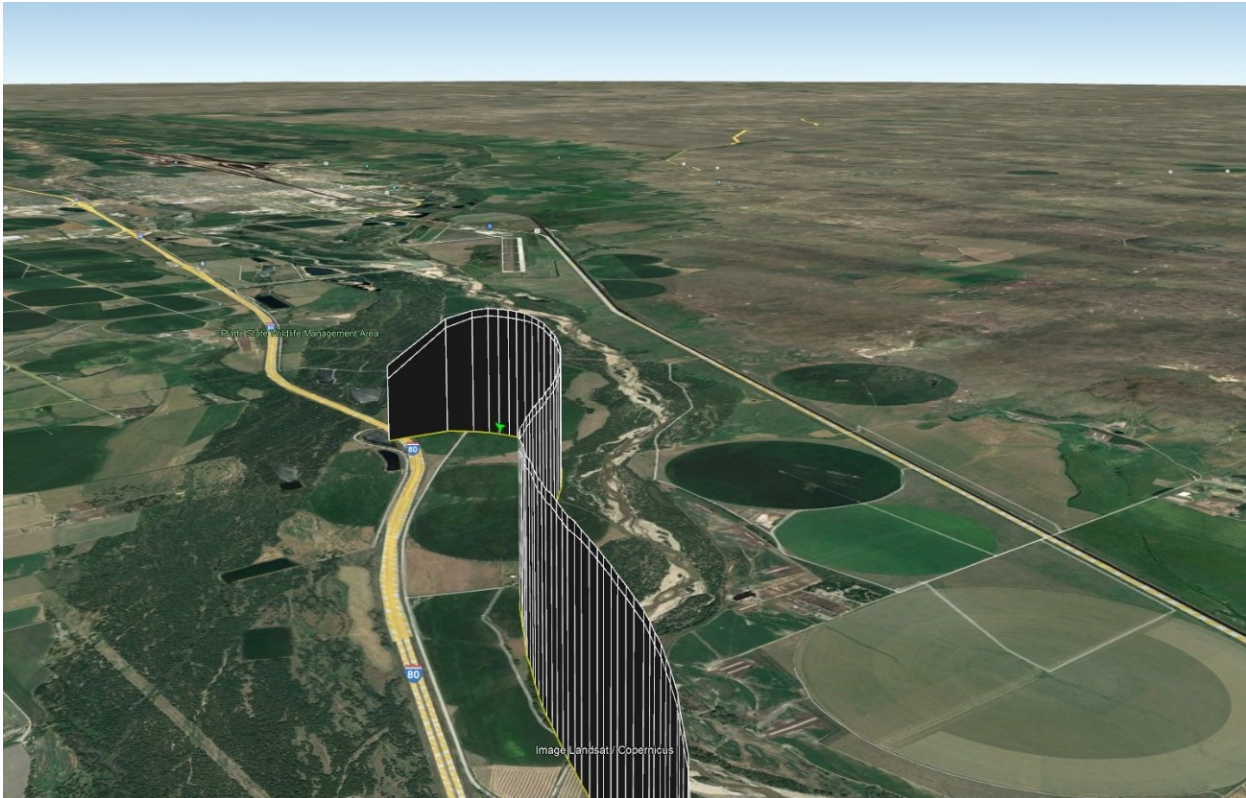
Figure 2. ADS-B flight track view looking west-northwest.

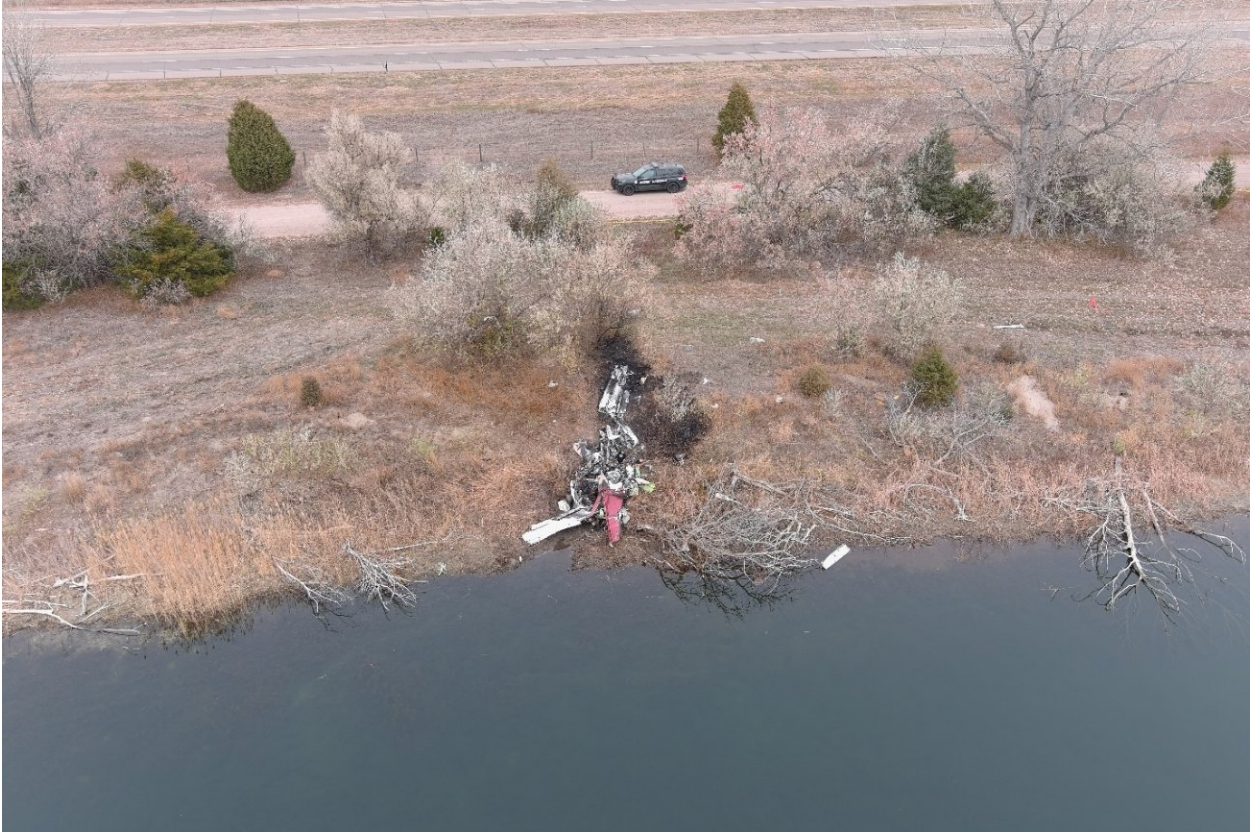
Postaccident examination of the accident site revealed the airplane impacted terrain on the bank of an irrigation reservoir. A postimpact fire partially consumed the airplane. The main wreckage, which consisted of the engine, fuselage, and empennage, came to rest within the initial impact area. Fragmented airplane structure was located within a 50 ft diameter of the main wreckage. The engine and propeller assembly were embedded in the terrain, followed by the cockpit, cabin, and empennage. The left and right wings came to rest adjacent to the main wreckage (see Figures 3 and 4). The airplane's flight instruments and avionics were destroyed by impact and thermal damage. The airplane's landing gear and flaps were in the retracted position. The airplane's fuel system was destroyed, and there was a fuel odor and fuel sheen on the water surface at the accident location.

Figure 3. Aerial view of accident location (Source: Nebraska State Patrol)

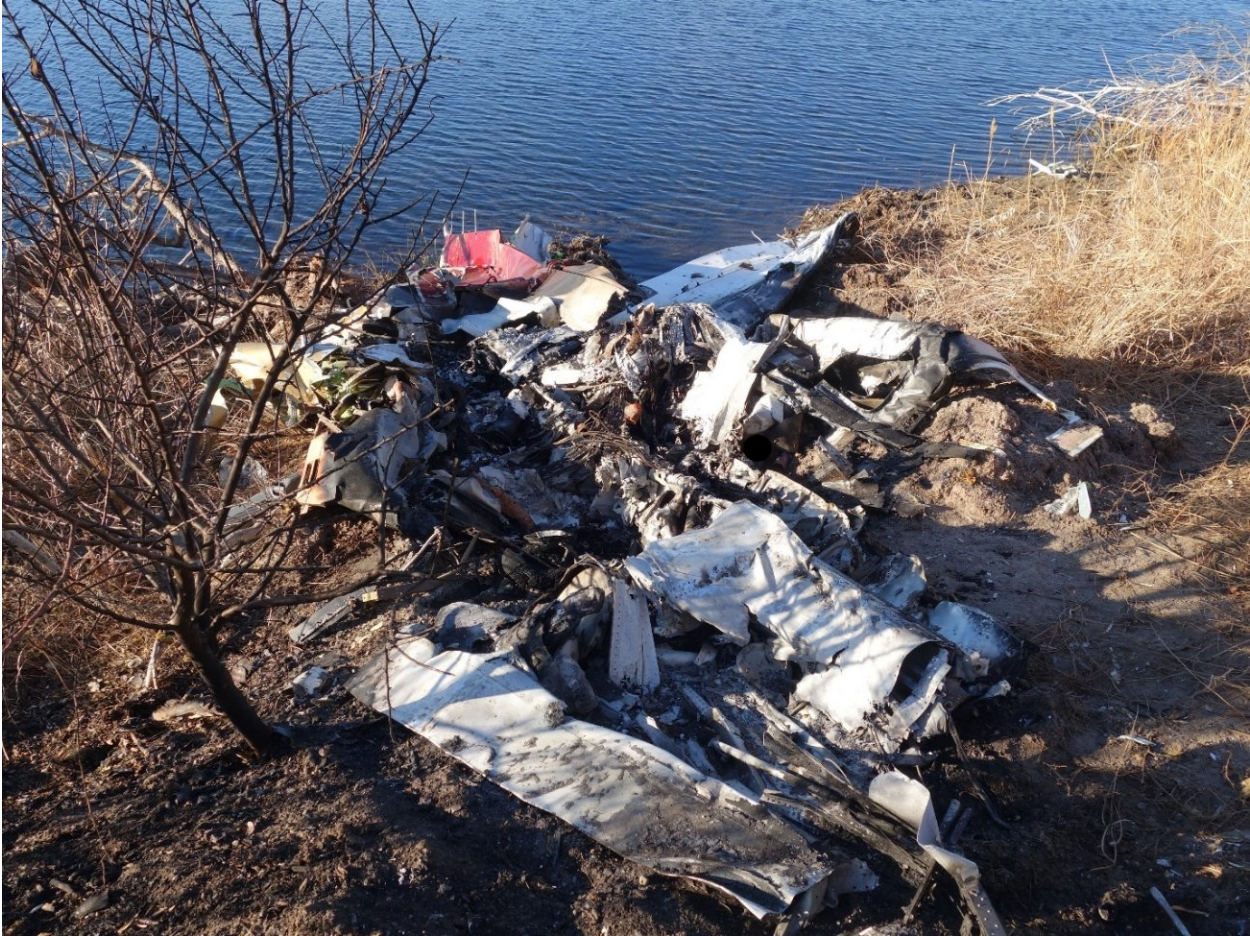
Figure 4. Accident main wreckage (Source: Piper Aircraft, Inc.)
