# Aviation Investigation Final Report

| <b>Location:</b> | Marietta, Ohio | <b>Accident Number:</b> | ERA23FA024 |
| <b>Aircraft:</b> | Beech E-90 | <b>Aircraft Damage:</b> | Substantial |

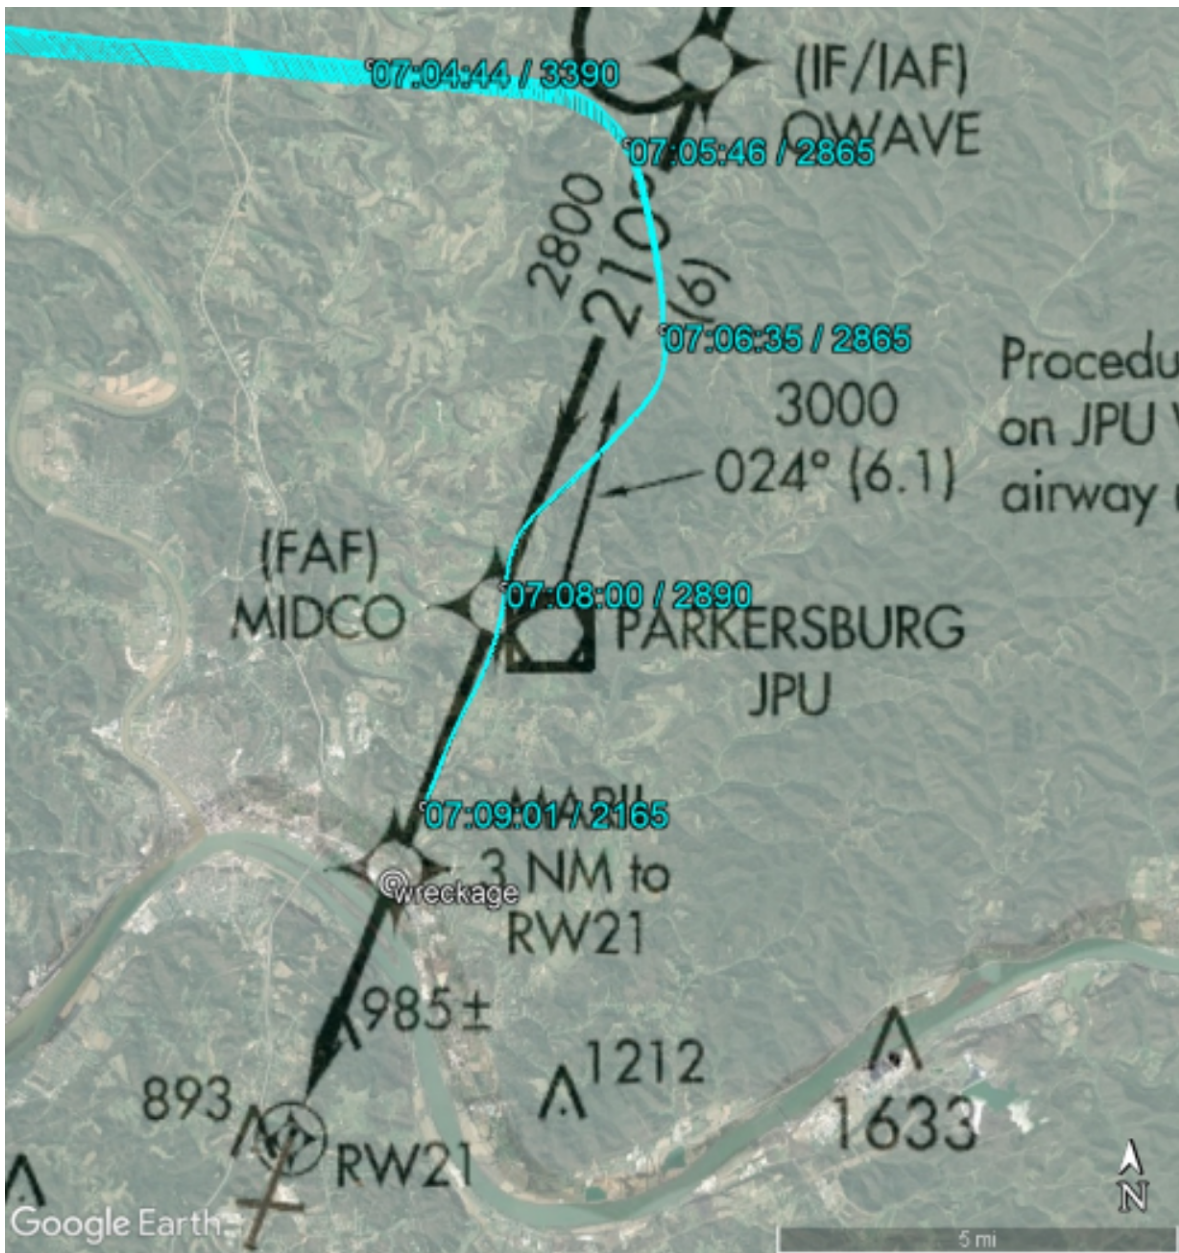
Figure 1 - Airplane flight path with selected times and altitudes annotated. A portion of the RNAV (GPS) RWY 21 instrument approach procedure has been superimposed onto aerial imagery.

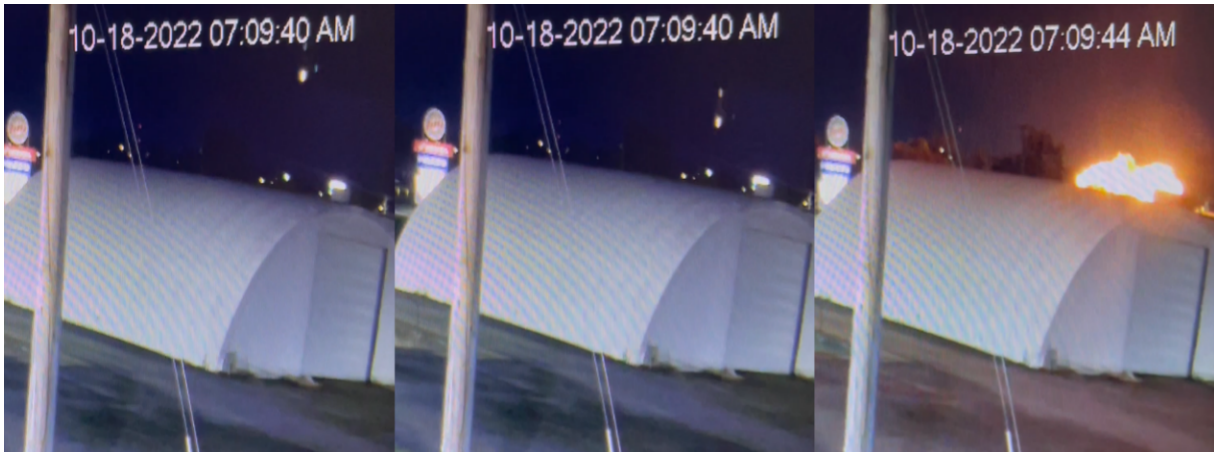
Multiple eyewitnesses located on the airport and area surrounding the accident site reported that the airplane, while flying straight and level, suddenly began a steep descent and spun near vertically to the ground. Security camera footage from multiple camera angles showed the airplane's descent through impact, which was consistent with the eyewitness's accounts (see figure 2).

*Figure 2 - Three sequential still images from the security camera video showing the airplane's near vertical descent to impact. Note landing light and position light.*

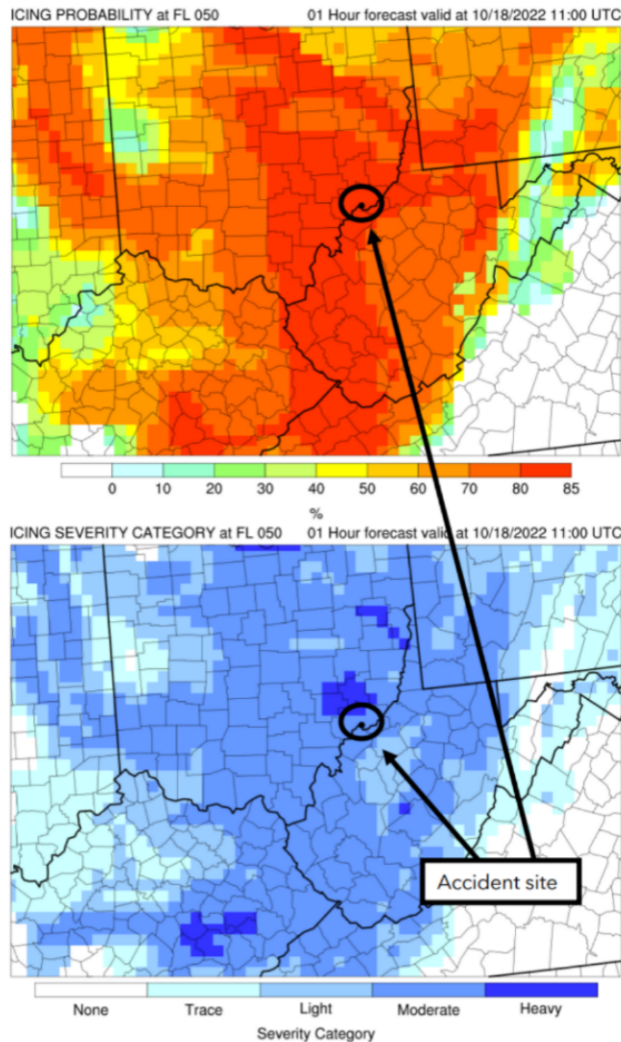
The NWS Current Icing Product (CIP) and Forecast Icing Product (FIP) were intended to supplement other icing advisories such as AIRMETs and SIGMETs. The CIP icing probabilities and severity and 1-hour forecast was valid at 0700 and showed that at 3,000, 4,000, and 5,000 ft, there was a 60 to 85% probability of icing at 3,000 to 5,000 ft surrounding the accident area (see figure 4). Furthermore, the icing intensity near the accident site ranged from “light” to “heavy,” with a 20 to 80% probability of Supercooled Large Droplets (SLD). For additional weather information see the meteorology factual report in the public docket for this investigation.

Figure 4 - Icing probability and severity charts with accident location annotated.
