# Aviation Investigation Final Report

<b>Location:</b>	Grasmere, Idaho	<b>Accident Number:</b>	WPR22FA173
<b>Date &amp; Time:</b>	May 8, 2022, 14:19 Local	<b>Registration:</b>	N801DT
<b>Aircraft:</b>	BLUE SIDE UP INC COMP AIR 8 SS52	<b>Aircraft Damage:</b>	Substantial
<b>Defining Event:</b>	Loss of control in flight	<b>Injuries:</b>	2 Fatal
<b>Flight Conducted Under:</b>	Part 91: General aviation - Personal

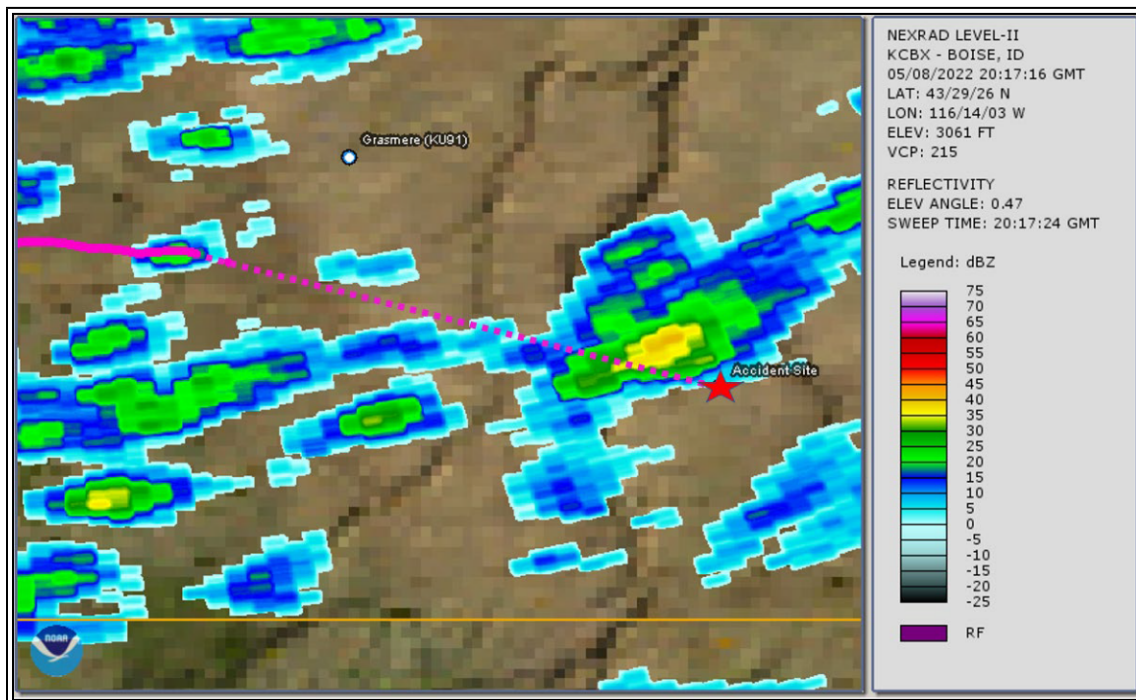
A review of radar imagery from Boise, Idaho, revealed that the airplane flew through several areas of light to moderate intensity echoes as it proceeded northward, and then after turning eastward, the airplane's flight track was through an area of moderate to heavy intensity echoes. The accident site was located on the southeast edge of the echo. Light-to-moderate icing conditions in the clouds with clear to mixed type icing below 12,000 ft msl were expected. Thus, it is likely that the airplane, which was not certified for flight in icing, encountered icing in the final portion of the flight.

ft above ground level or about 6,000 ft msl. The atmosphere was characterized as conditionally unstable and supported broken to overcast cumulus clouds capable of producing light rain from about 3,000 ft msl to 20,000 ft msl. The analysis program expected light-to-moderate icing conditions in the clouds, with clear to mixed type icing below 12,000 ft msl. A review of radar imagery from Boise, Idaho, revealed that the airplane flew through several areas of light-to-moderate intensity echoes as it proceeded northward and then turned eastward. At 1417, the airplane's flight track was through an area of moderate-to-heavy intensity echoes, with the accident site on the southeast edge of the echo.

Figure 1: Base reflectivity image for 1417 MDT with flight track.
