# Aviation Investigation Final Report

<b>Location:</b>	Heyburn, Idaho	<b>Accident Number:</b>	WPR22FA151
<b>Date &amp; Time:</b>	April 13, 2022, 08:32 Local	<b>Registration:</b>	N928JP
<b>Aircraft:</b>	Cessna 208B	<b>Aircraft Damage:</b>	Substantial
<b>Defining Event:</b>	Collision during takeoff/land	<b>Injuries:</b>	1 Fatal
<b>Flight Conducted Under:</b>	Part 135: Air taxi & commuter - Non-scheduled

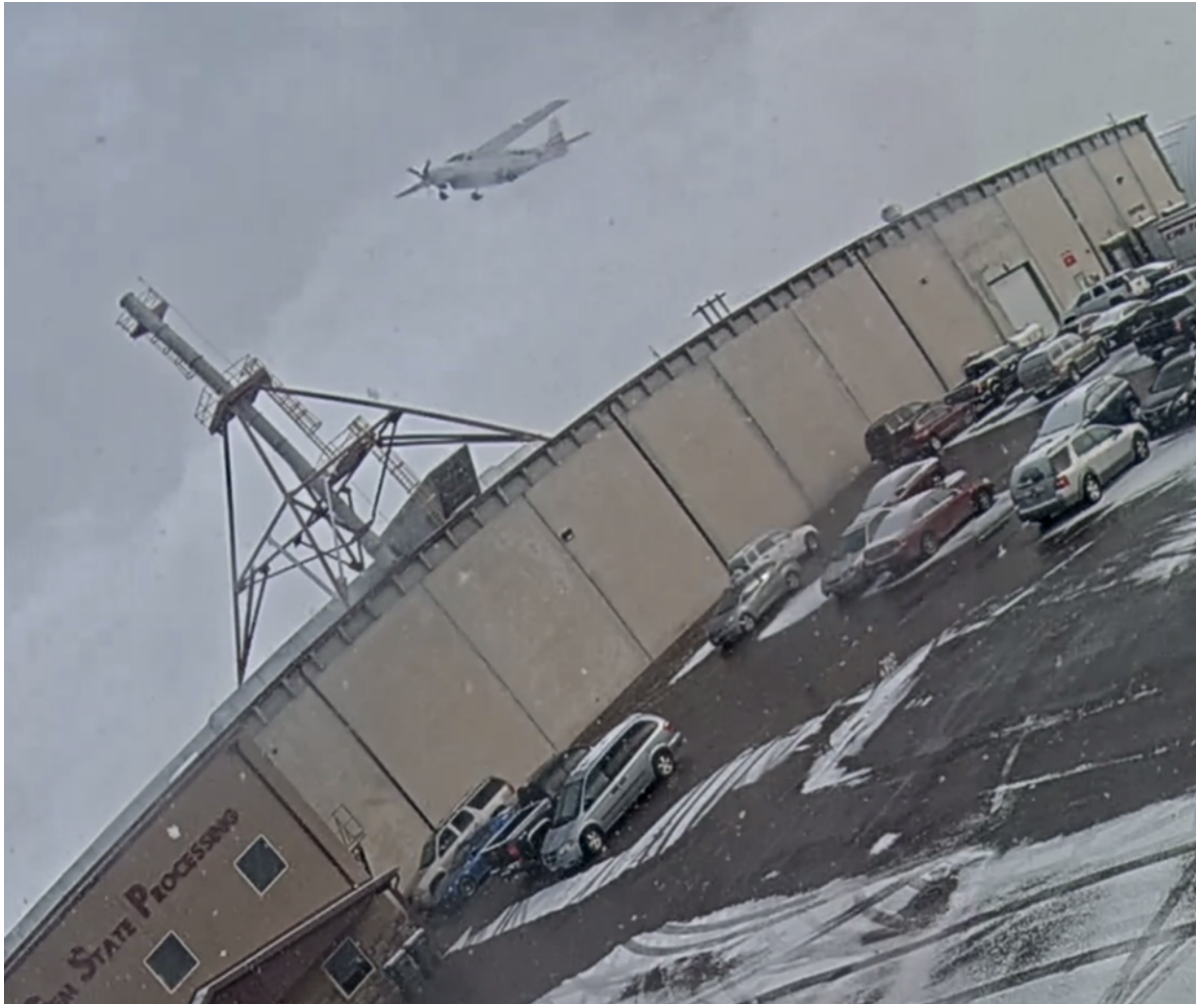
Video footage recovered from a security camera located at the processing plant along the approach to runway 20 showed a view of the rooftop of the processing plant, along with a single vent stack supported by steel framework on the roof. Snow was observed falling, and visible moisture was present in the form of billowing steam clouds emitting from other stacks

on the roof of the plant. The stack remained clearly visible in the video, with small sections periodically concealed by the steam clouds. The stack was topped by a warning light, but due to the daylight contrast, and location of the camera below, it could not be determined if it was operating. About 0832:25, the airplane came into view in a wings-level, flaps-up, nose-high descent (Figure 2). The airplane struck the vent stack and fell to the rooftop. The top of the stack was 4,256 ft msl. The airplane struck the stack about 14 ft below the top. The stack was within the lateral boundaries of the approach path, and the distance from the top of the stack to the glide path above it was calculated at 98 ft (Figure 3).

Figure 2. Image from the security camera.

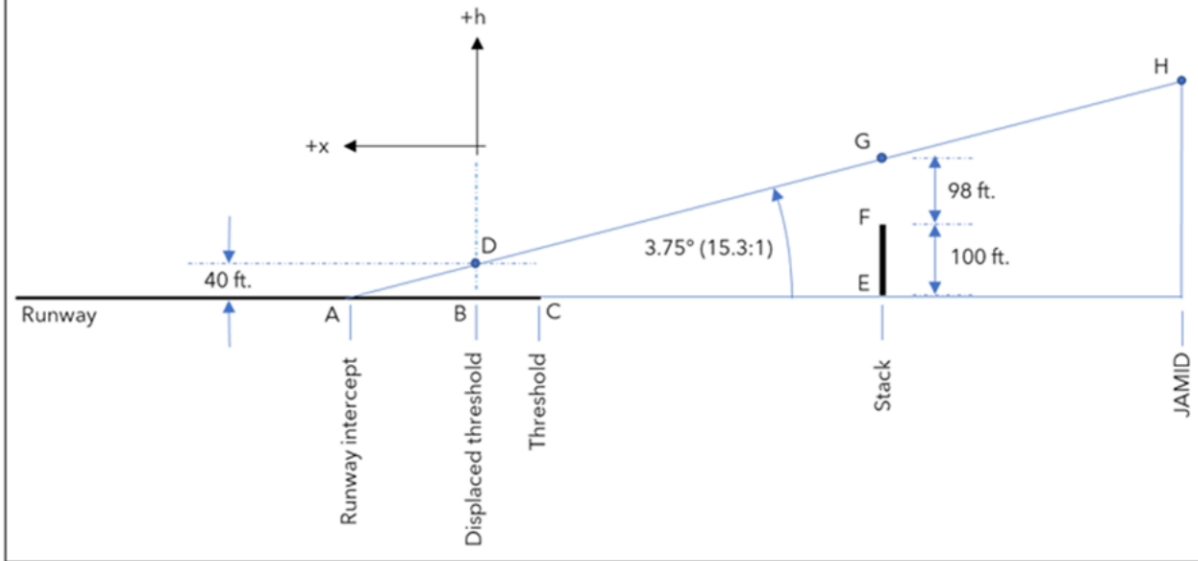
Figure 3. Illustration showing the height of the stack and distance from the glide path to runway 20.

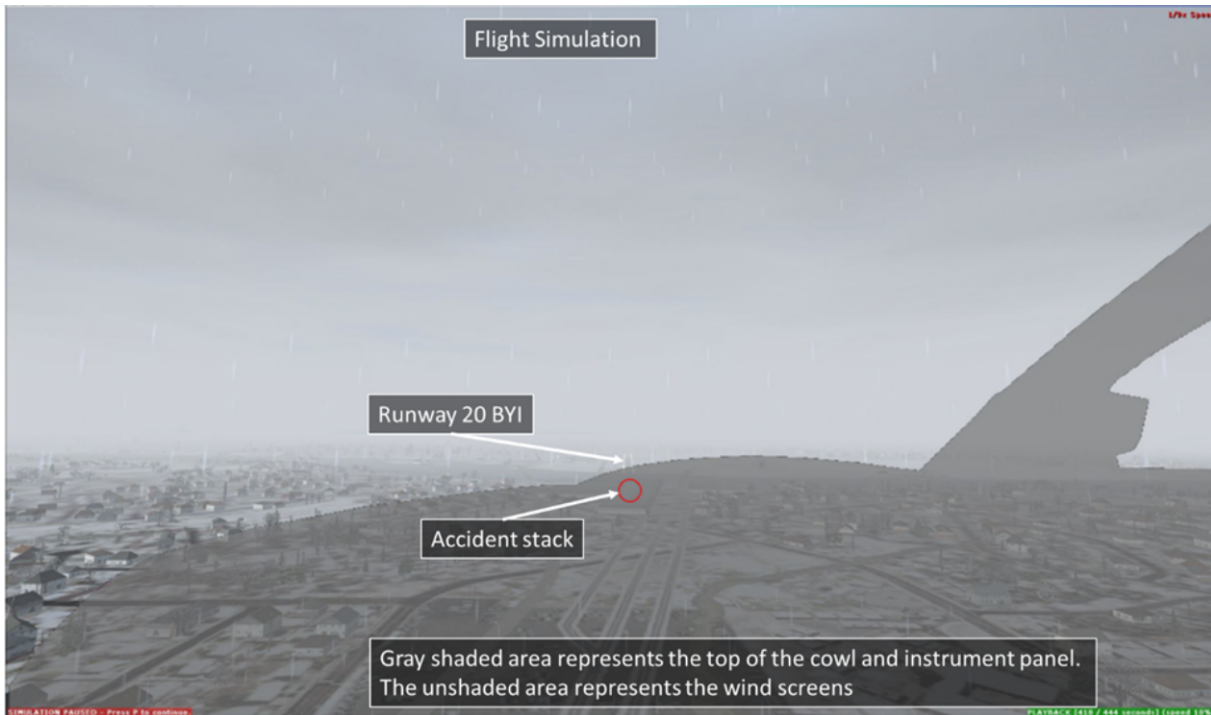
Figure 4. Flight simulation using accident weather conditions and airplane attitude, showing the airport visible above the instrument panel while the stack is concealed by the instrument panel.

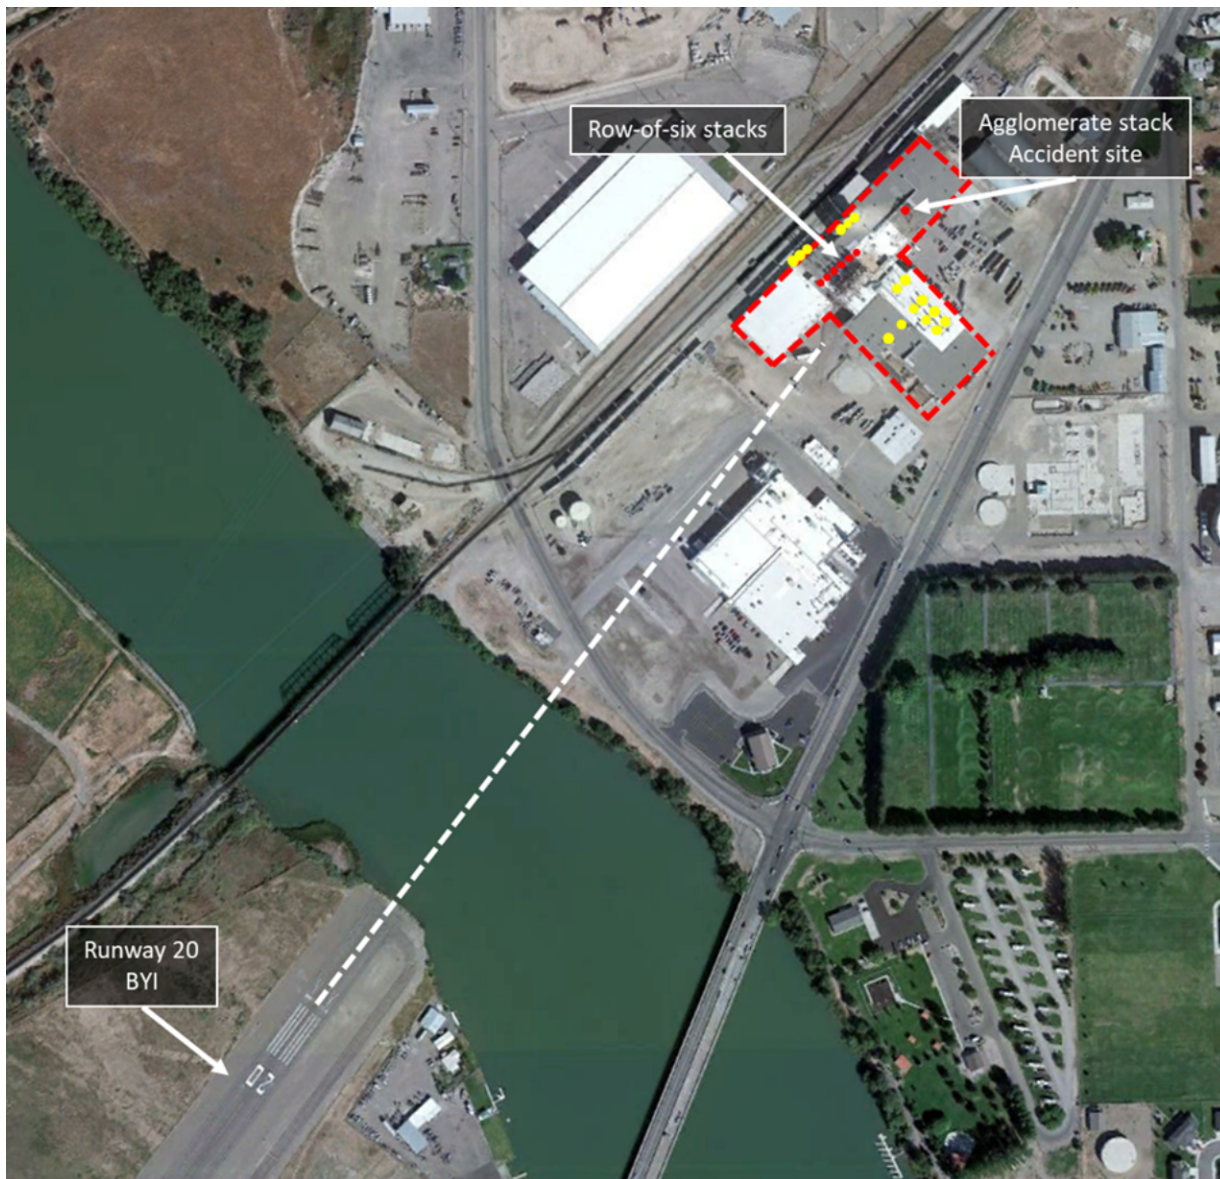
The Gem State Processing plant was located directly to the northeast of BYI, across the Snake River. The processing plant’s roof top had multiple vent stacks. The airplane impacted a 32-inch diameter vent stack known as the agglomerate stack. A group of 6 42-inch diameter drum dryer vent stacks were on the same roof, about 200 ft southwest of the agglomerate stack. The agglomerate stack and the group of six stacks were 100 ft agl and in line with the extended centerline of runway 20. Other smaller vent stacks were present on an adjacent plant building rooftop but were not in line with the runway, as shown in Figure 7.

Figure 7. Google Earth view of the Gem State Processing plant and runway 20 at BYI. The plant is outlined in red. The agglomerate and row-of-six stacks are shown in red dots and the other structures are shown in yellow dots. The white dashed line is an estimate of the extended centerline of runway 20.

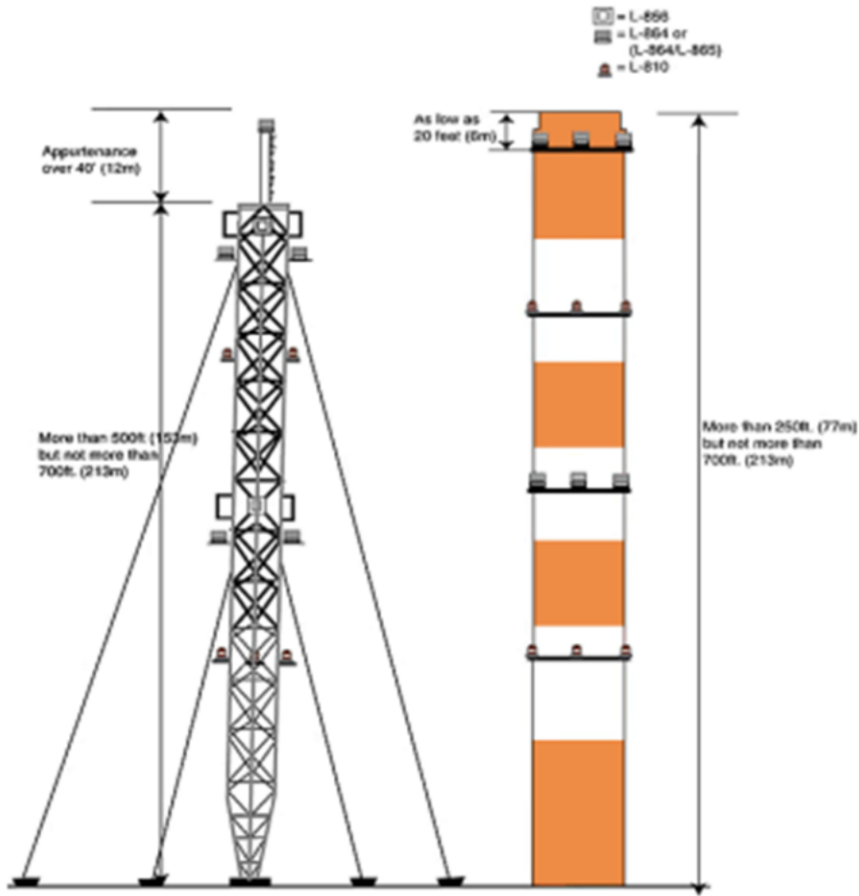
Figure 8. FAA Advisory Circular 70/7460-1K illustration showing an exhaust stack painted white and aviation orange.

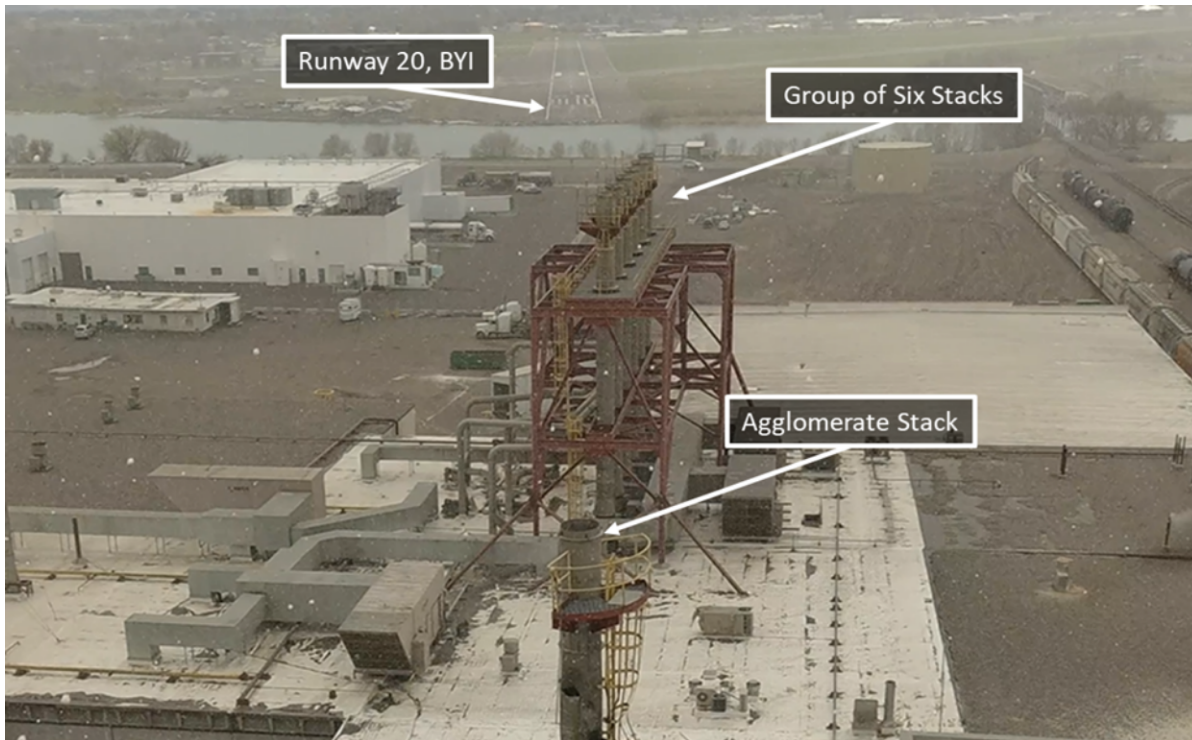
Figure 9. Image of the Gem State Processing plant roof top. The agglomerate stack and the group of six stacks are in view. Photo courtesy of the Hayburn Police Department.

The NTSB asked for clarification as to whether the stacks in question were required to be both marked and lighted in accordance with FAA Advisory Circular 70/7460-1. The FAA confirmed that “as a condition of the No Hazard Determination, dated February 2, 2017, the stacks were required to be painted with white and aviation orange paint, and lit with red obstruction lights, per FAA Advisory Circular 70/7460-1.” The NTSB noted during the investigation that neither the agglomerate stack nor the six drum dryer stacks were painted with white and orange aviation paint. Each stack in the group of six stacks had a red aircraft warning light.
