Crash During Approach to Landing
Empire Airlines Flight 8284
Avions de Transport Régional
Aérospatiale Alenia ATR 42-320, N902FX
Lubbock, Texas
January 27, 2009

**NTSB/AAR-11/02
PB2011-910402**

NTSB/AAR-11/02
PB2011-910402
Notation 8093A
Adopted April 26, 2011

Aircraft Accident Report

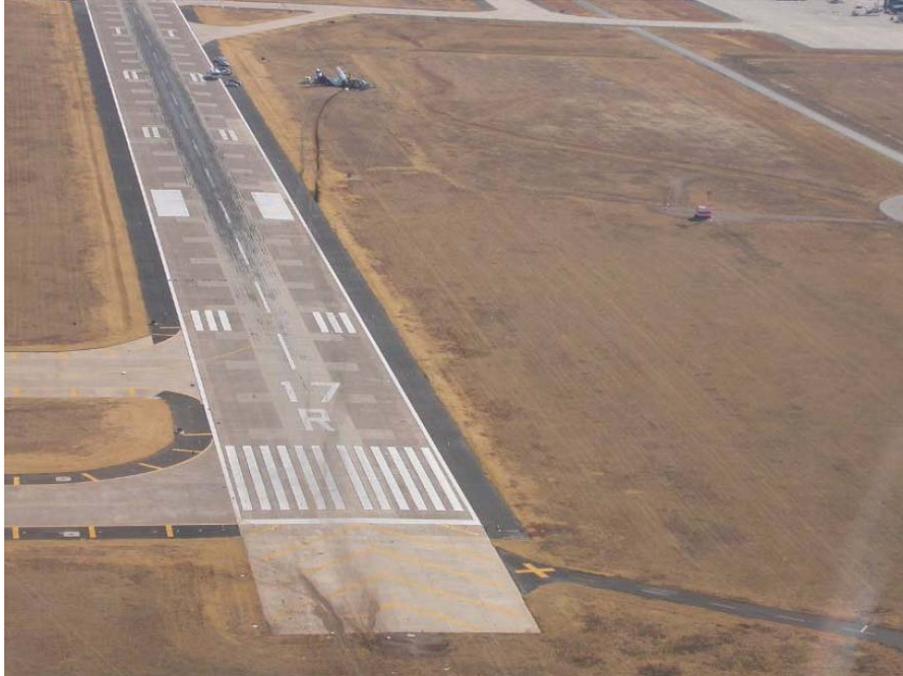
The airplane came to rest next to the right side of the runway (about 200 feet west of the runway centerline), north of taxiway S. Figure 1 is an aerial view of the approach end of runway 17R and the location of the wreckage. The ARFF units, which were on the accident scene within about 4 minutes, were the first responders to arrive. The ARFF response was joined by Lubbock Fire Department units, one of which could not enter at the designated airport access gate because the gate would not open; the unit was diverted to a different gate to enter the airport.¹²

Figure 1. Aerial view of approach end of runway 17R and location of wreckage.

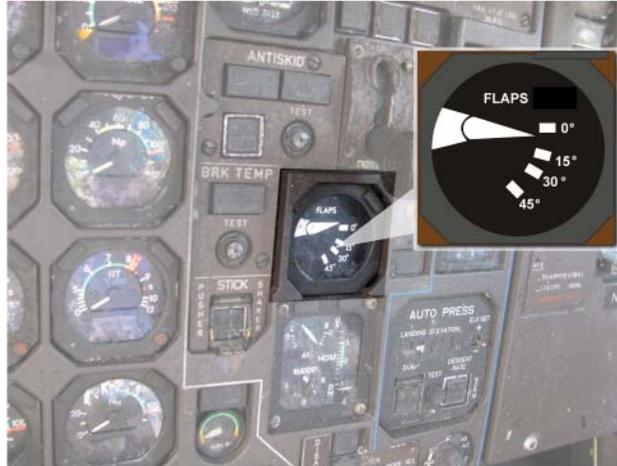
A flap position indicator in the cockpit has an index marked with the four flap positions (shown as 0°, 15°, 30°, and 45°), and a needle pointer indicates the flap position on the index. If a flap asymmetry occurs, the flap indicator needle in the cockpit will point to the index value that corresponds with the average position of the flaps. Figure 2 shows the flap position indicator, and the inset depicts the likely needle pointer position during the flap asymmetry.

Figure 2. Flap position indicator. Inset shows the likely needle pointer position during the flap asymmetry.

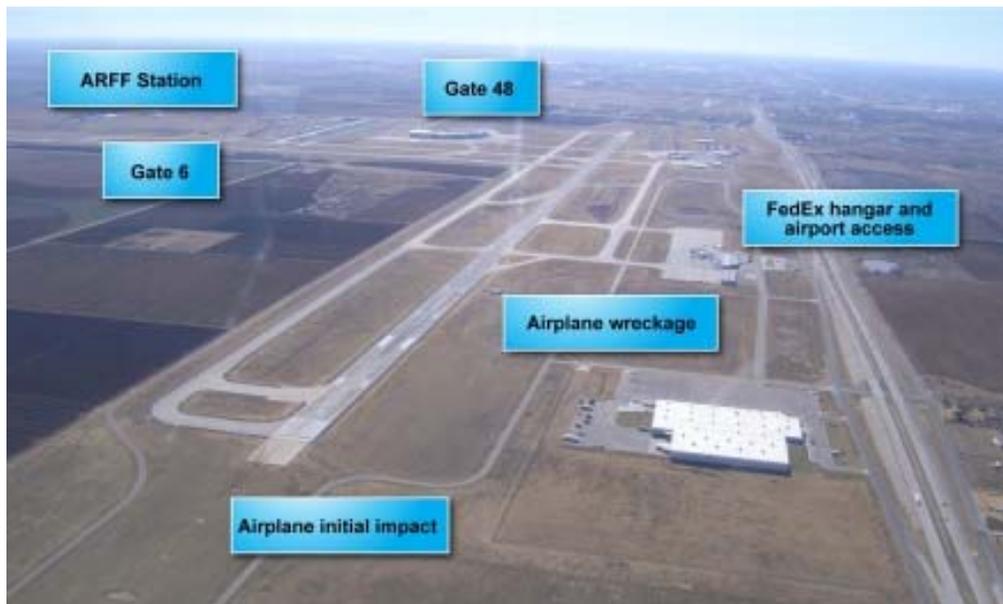
As directed, one engine from Station 2 responded to Gate 48, which is an electronically controlled gate operated by a drive chain. The engine team was unable to enter the airport property at Gate 48 because the gate had ice in its operating mechanism and would not open. The Station 2 engine then drove to the ARFF station to proceed from that point. All other responding Lubbock Fire Department units were informed that the wreckage was closest to the FedEx hangar and were rerouted to respond to that site. A FedEx employee who opened the gate near the FedEx hangar for the Station 2 team, Station 5 engine, and emergency medical service (EMS) personnel informed them that the pilots were at the hangar; the EMS units proceeded to the hangar. Figure 5 is a view of the airport showing the relative locations of airport access gates and the accident site.

Figure 5. View of airport showing relative locations of airport access gates and accident site.

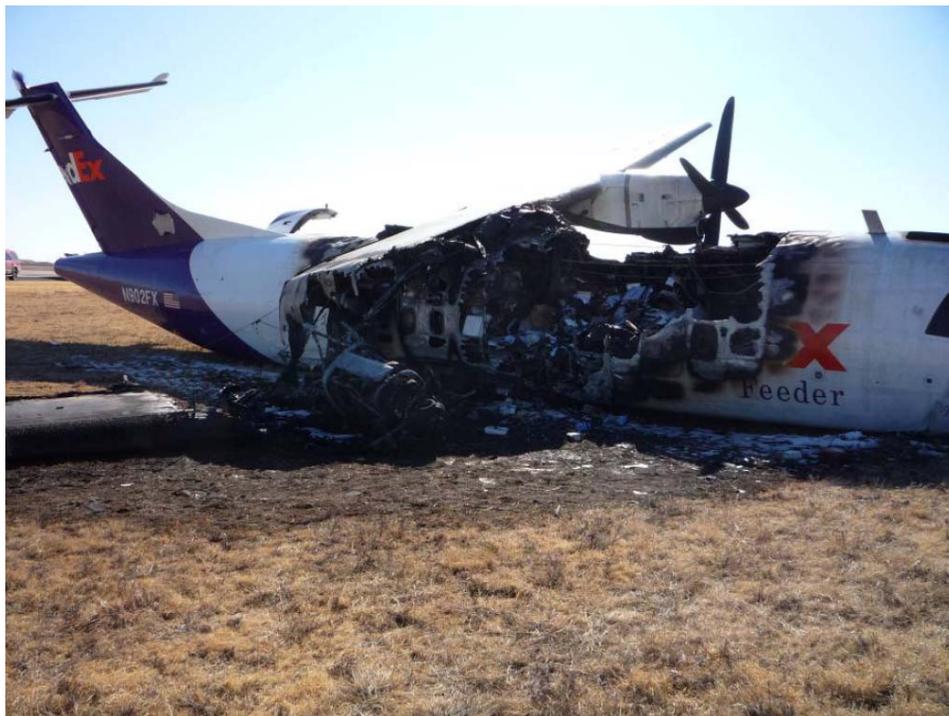
The cockpit flap control lever was found in the 15° position. Examination of the flap system components at the accident site found that the left wing and flap components were intact and covered with soot. The right inboard and outboard flaps and the right inboard flap actuator were extensively damaged by impact and fire. Figure 6 is the right side of the fuselage, showing extensive fire damage to the right wing and flap components. The right outboard flap actuator was found in the retracted position on the ground under the right wing. Damage to the right flaps limited the extent to which preimpact system integrity could be determined. Examination of the available components revealed no evidence of mechanical restriction of movement of the right flaps.

Figure 6. Right side of fuselage showing extensive fire damage to right wing and flap components.

Under normal circumstances, hydraulic pressure holds the flaps in the selected position. The accident airplane's hydraulic system was damaged by impact and fire, and much of the hydraulic fluid routed to the flap actuators was lost because of the damage. Testing of fluid samples obtained from all actuators (either from the actuator itself or the line leading to the actuator) found that the liquid was consistent with hydraulic fluid.

X-ray examinations of all four flap actuators showed that their internal components were in place. The left inboard and left outboard flap actuators functioned when tested on the test bench at the manufacturer's facility. Subsequent disassembly and examination of the left inboard and outboard flap actuators revealed no anomalies. Several of the seals for the right inboard and right outboard flap actuators were damaged from fire exposure, and the damage prevented the
