ACCIDENT INVESTIGATION COORDINATING COMMITTEE

**ACCIDENT REPORT ON
8Q-MAG (TWIN OTTER) CRASH
At the Reef of Halaveli Resort Lagoon (North Ari Atoll),
Maldives
On 2nd of June 2009**

Operator: Maldivian Air Taxi
Manufacturer: De Havilland (Canadian)
Model: DHC-6-200 (Floatplane)

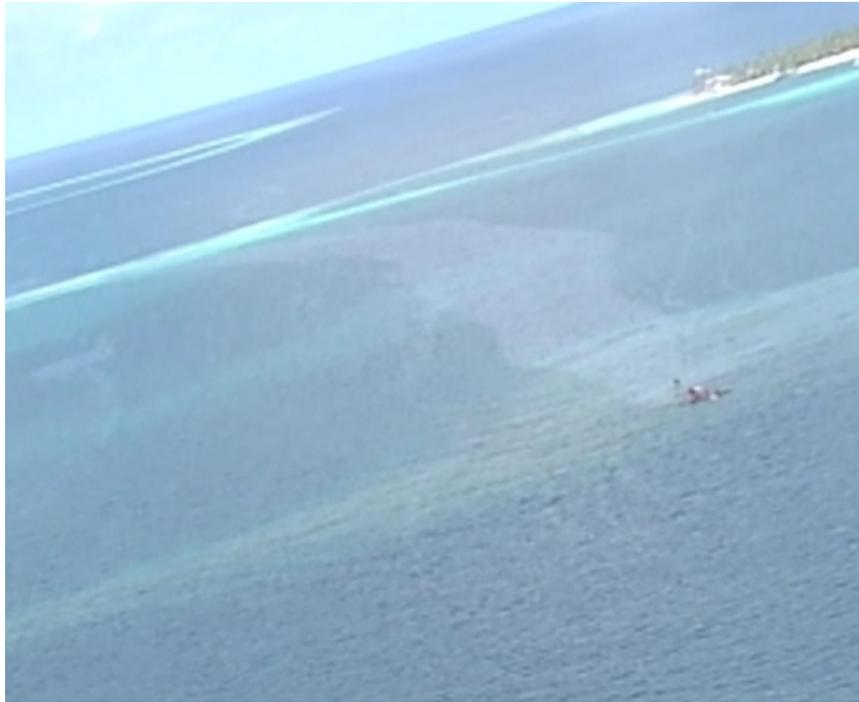
Appendix 2

The aircraft took off westbound. After levelling the aircraft the co-pilot gave his seat to the cameraman, one of the passengers. The co-pilot remained at third row left seat from thereon until the aircraft met the accident. According to the crew and passengers the aircraft made few orbits (right bank) around the island at the initial levelled height and, then descended lower heights and made few more orbits around the lagoon for photography. The passenger seated at the cabin wearing the headset informed the PIC that they got all the shots they wanted and now he could land. PIC started a descending turn (right bank) while keeping the passenger at the co-pilot seat in order to give a different view to him. Before the PIC could complete the turn, the right wing and/or float hit the water. The PIC tried to level the aircraft but he lost control of the aircraft and the aircraft skid on water (appendix 2). Left float was detached

Aerial view of aircraft with Halaveli in the view

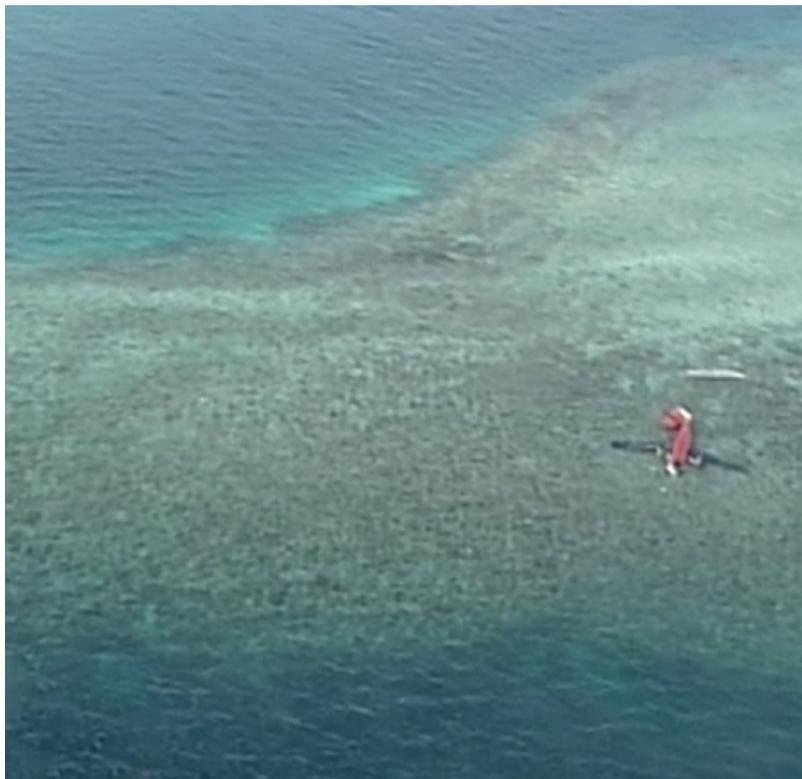
Aircraft on the reef

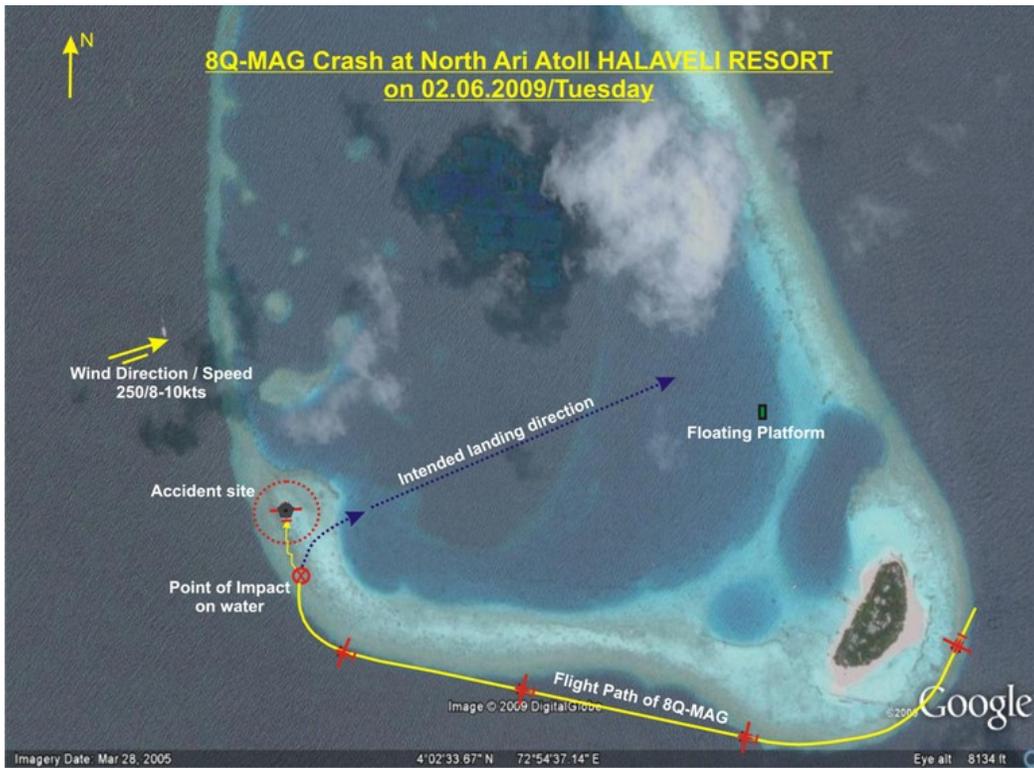
Aircraft flight path

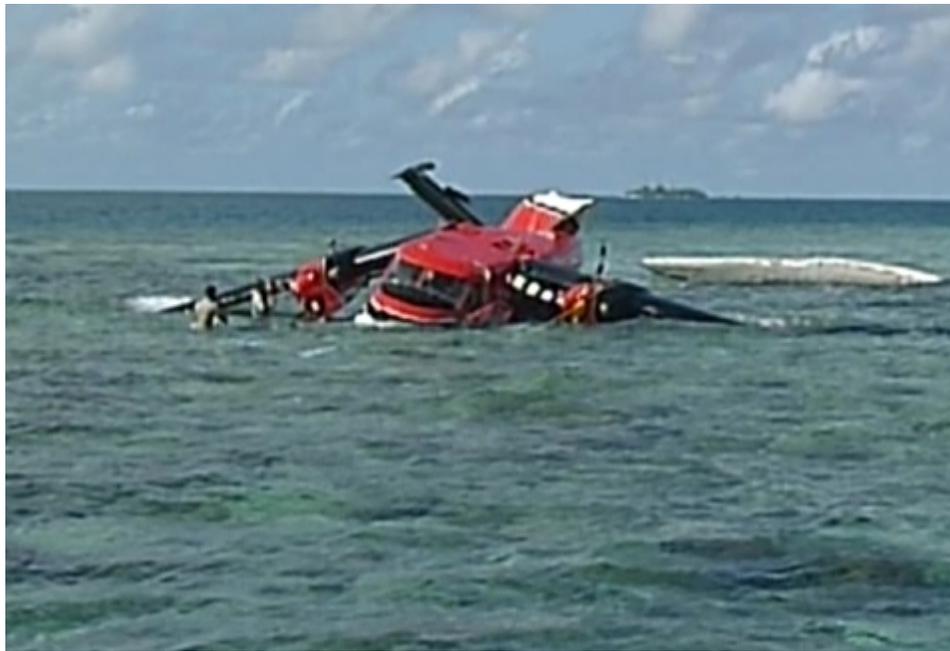
Appendix 3

(appendix 3) and right float got stuck between the engine and the fuselage blocking the co-pilot exit. Empennage (appendix 4) was twisted upside down. All the passengers and crew escaped through the exits safely. The depth of water at the wreckage site was about 1 metre. The passengers and crew was transferred to speedboat using a dinghy.

Left float behind the aircraft

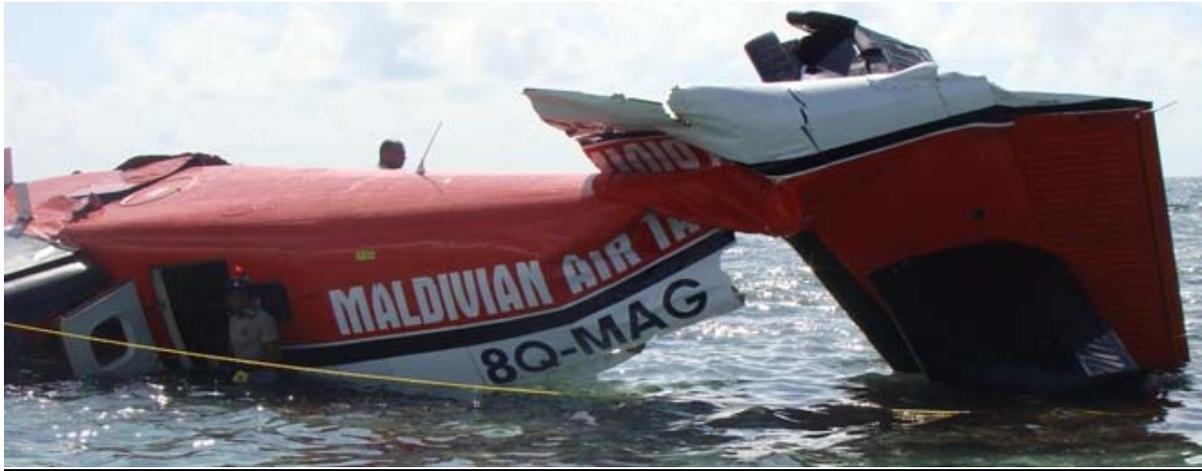
Appendix 4

Aircraft tail twisted

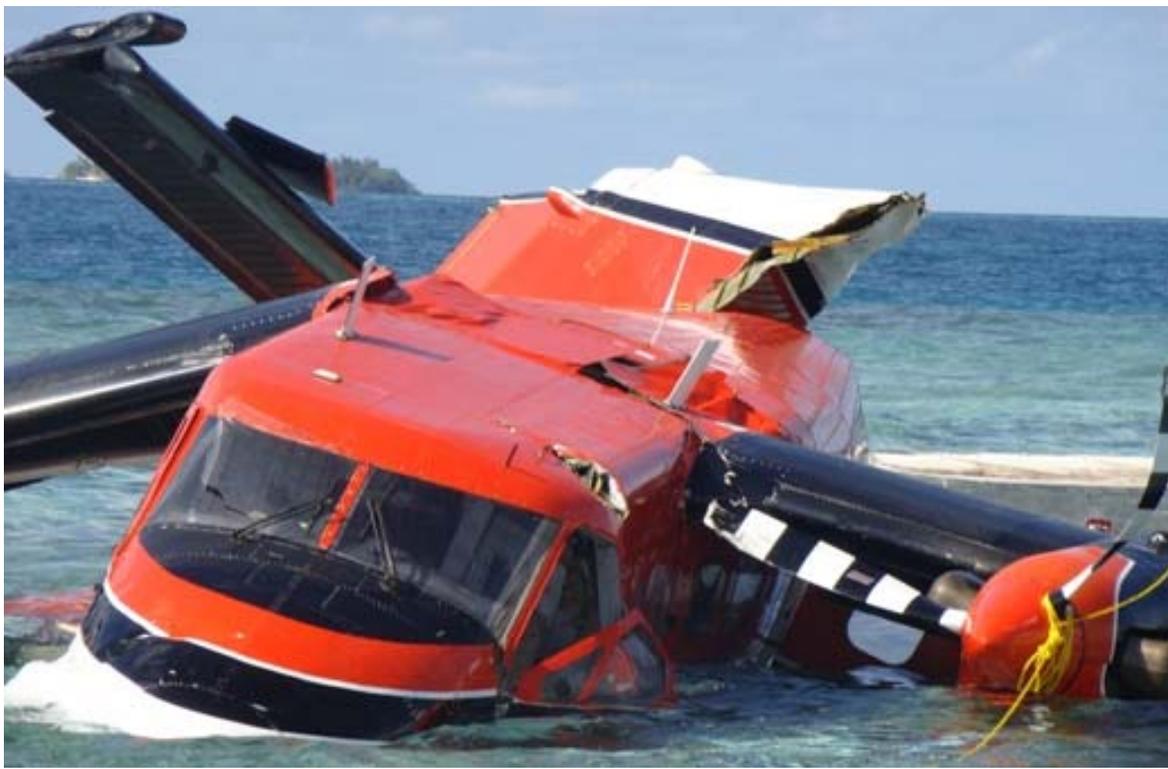
Appendix 5

RH float was broken close to forward end and got stuck on the co-pilot door. LH float was detached from the aircraft. Both wings were broken at the roots (appendix 5). Empennage was twisted anticlockwise upside down. Both propeller blades twisted. A large cut made by the propeller right behind the captain's seat (appendix 6). Co-pilot's wind screen broken into two halves and almost detached (appendix 7). Right hand side passenger window damaged. The aircraft was badly crushed near aircraft nose (appendix 8). Aircraft was on the shallow reef after the accident. Aircraft stopped heading north-north easterly direction.

Wings broken at the roots

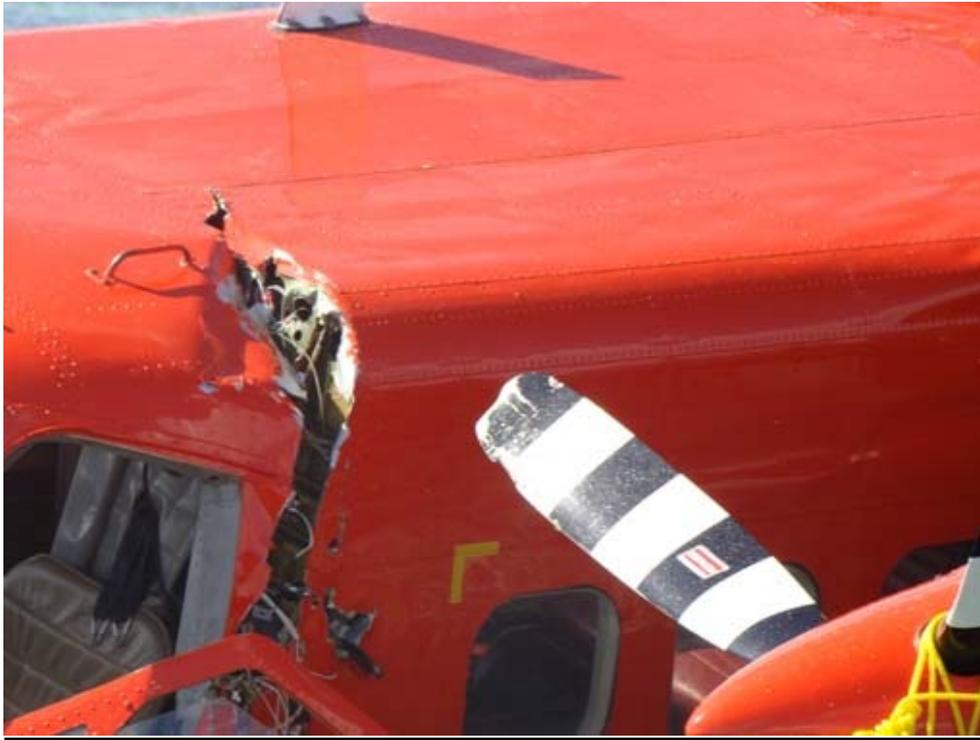
Appendix 6

Fuselage cut made by propeller close to captain's seat

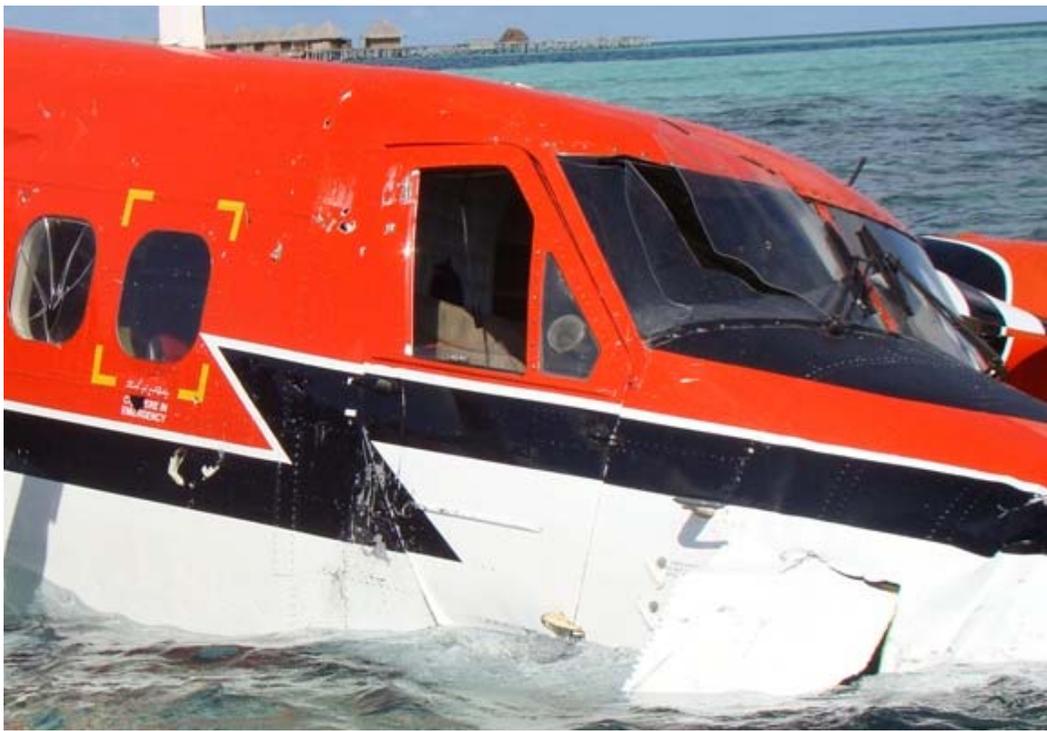
Appendix 7

Co-pilot's windscreen broken

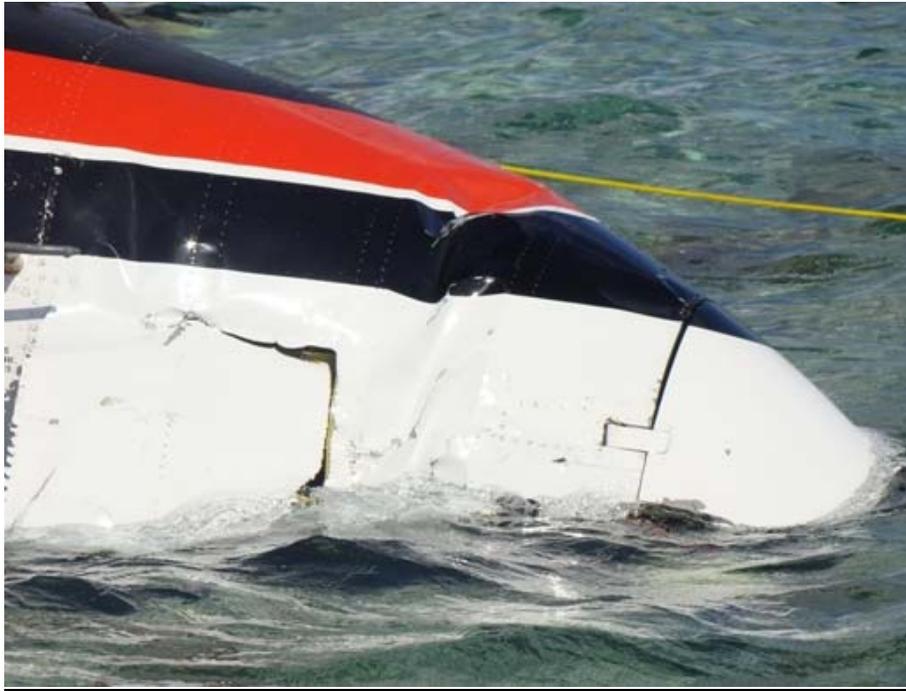
Appendix 8

Fuselage area close to aircraft nose crushed

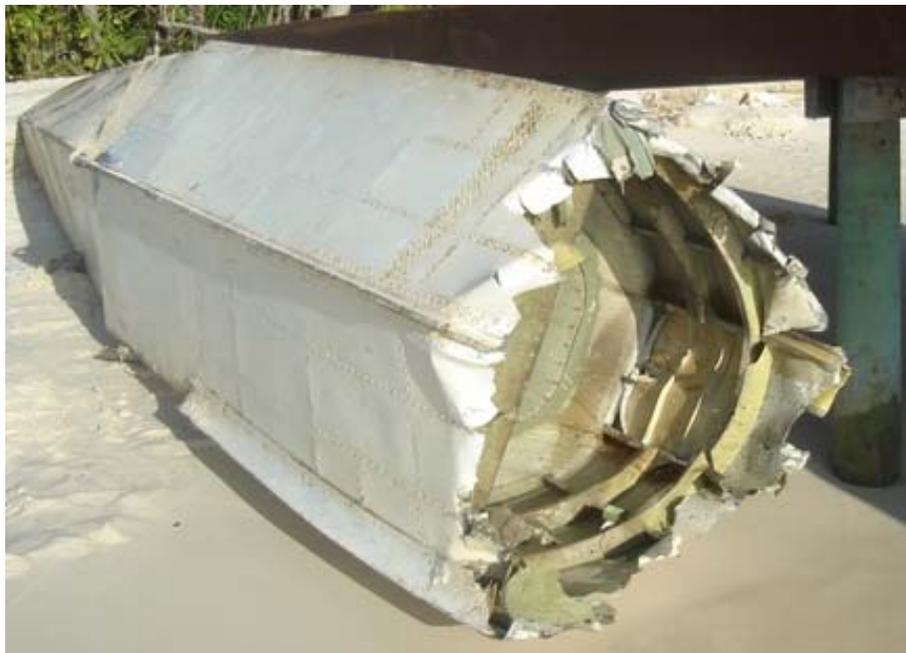
Appendix 9

At the time of site visit the RH float was located on the beach of Halaveli (appendix 9). PIC accounted that the float was stuck on the co-pilot door.

Right hand float on Halaveli beach

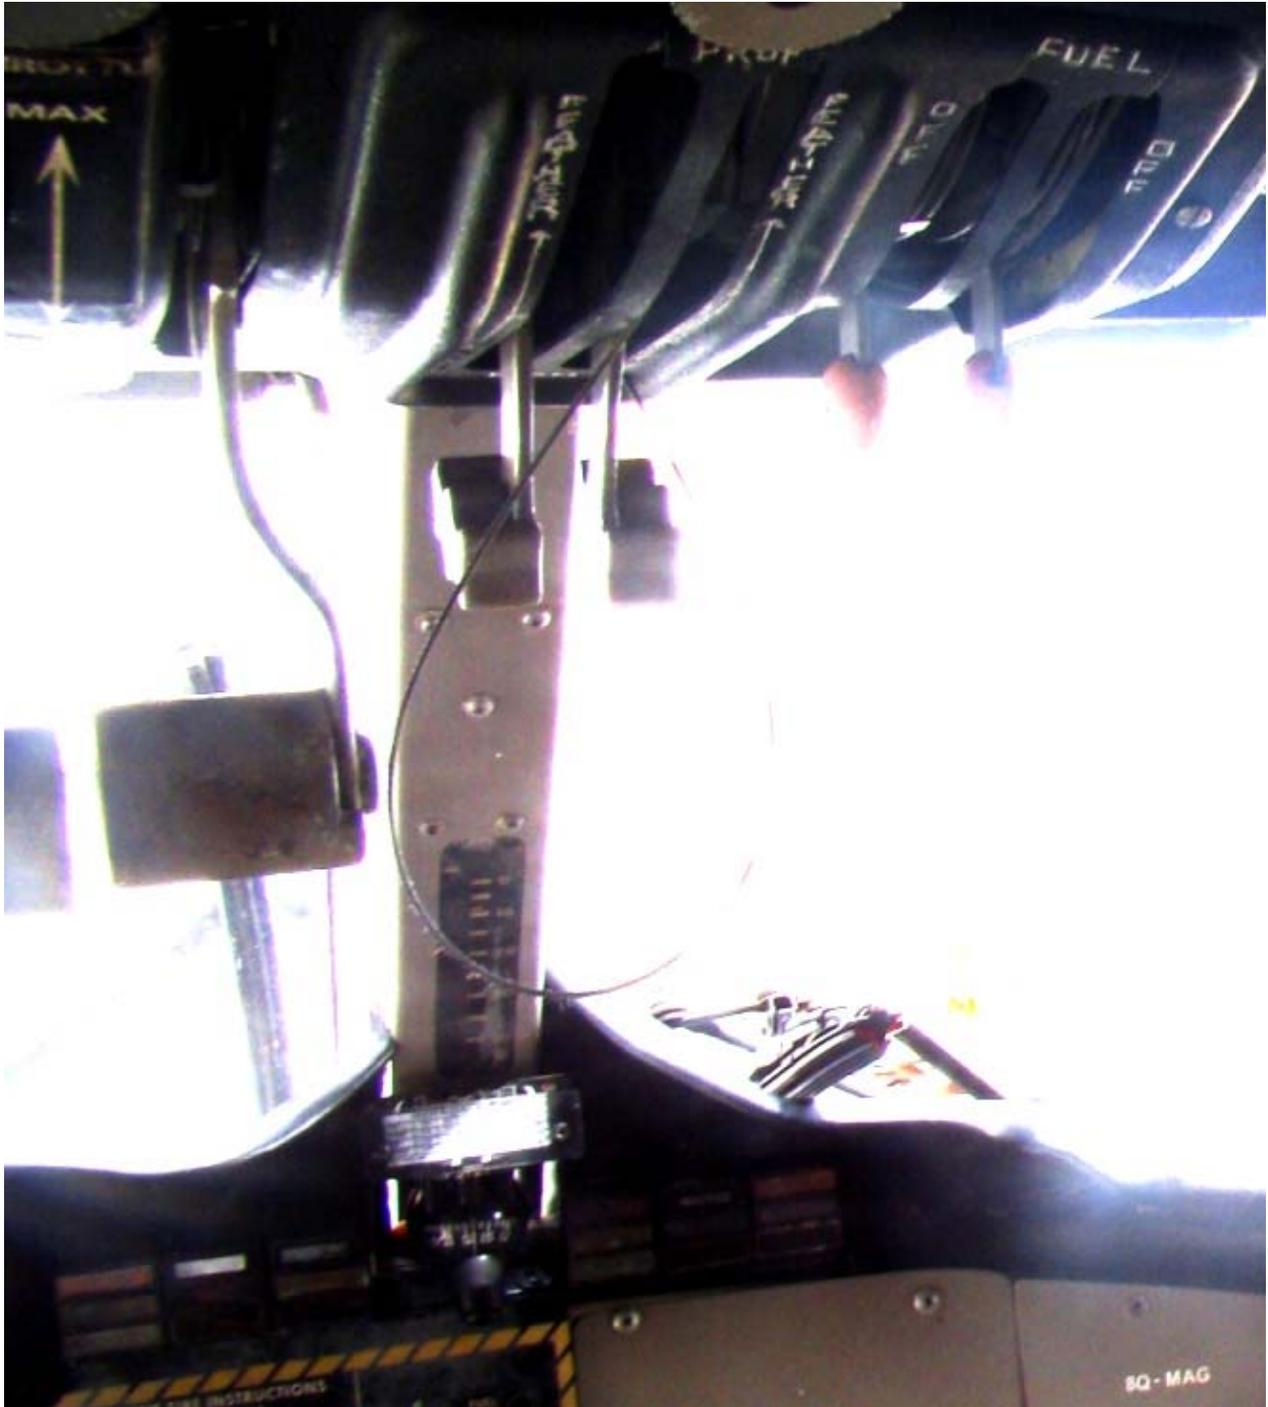
Appendix 10

- A passenger was occupying the co-pilot seat at the time of accident.
- The preparing of the cabin for landing was not performed on the flight of accident.
- As per the wreckage pictures, the flap selector was set to zero flaps and the flap angle indicator indicates zero flaps (appendix 10) and the aircraft was heading north-north easterly direction (wind direction from westerly direction) prior contact with water, giving the impression that aircraft was not on final for a landing.
- The PIC was conducting flying activities below an altitude allowed by CAD regulations and Company Operations Manual.
- During investigation it was revealed that the crew were not aware of amendments to the regulations, although all amendments to the regulations were published on the CAD website and sent to the operators via email.

Flap angle indicator
