Investigation Report

Type of Occurrence:	Accident
Date:	2 February 2010
Location:	Munich
Aircraft:	Airplane
Manufacturer / Model:	Cessna / Cessna 425
Injuries to Persons:	None
Damage:	Aircraft severely damaged
Other Damage:	None
Information Source:	Investigation by BFU
State File Number:	BFU 3X004-10

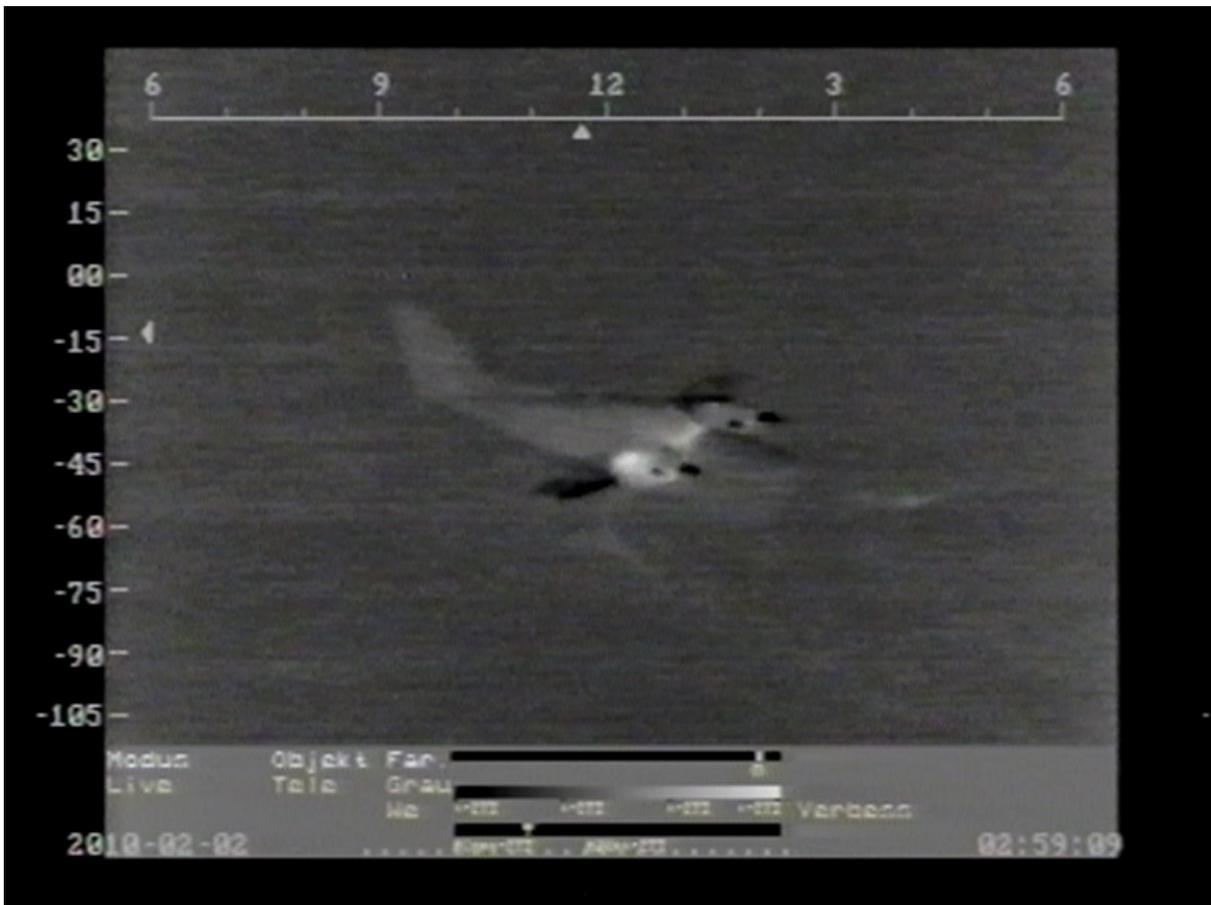
Thermal images of the airplane - different heat emission of the engines

The left engine cowl had external traces of oil. An oil film was also found on the left horizontal tailplane.

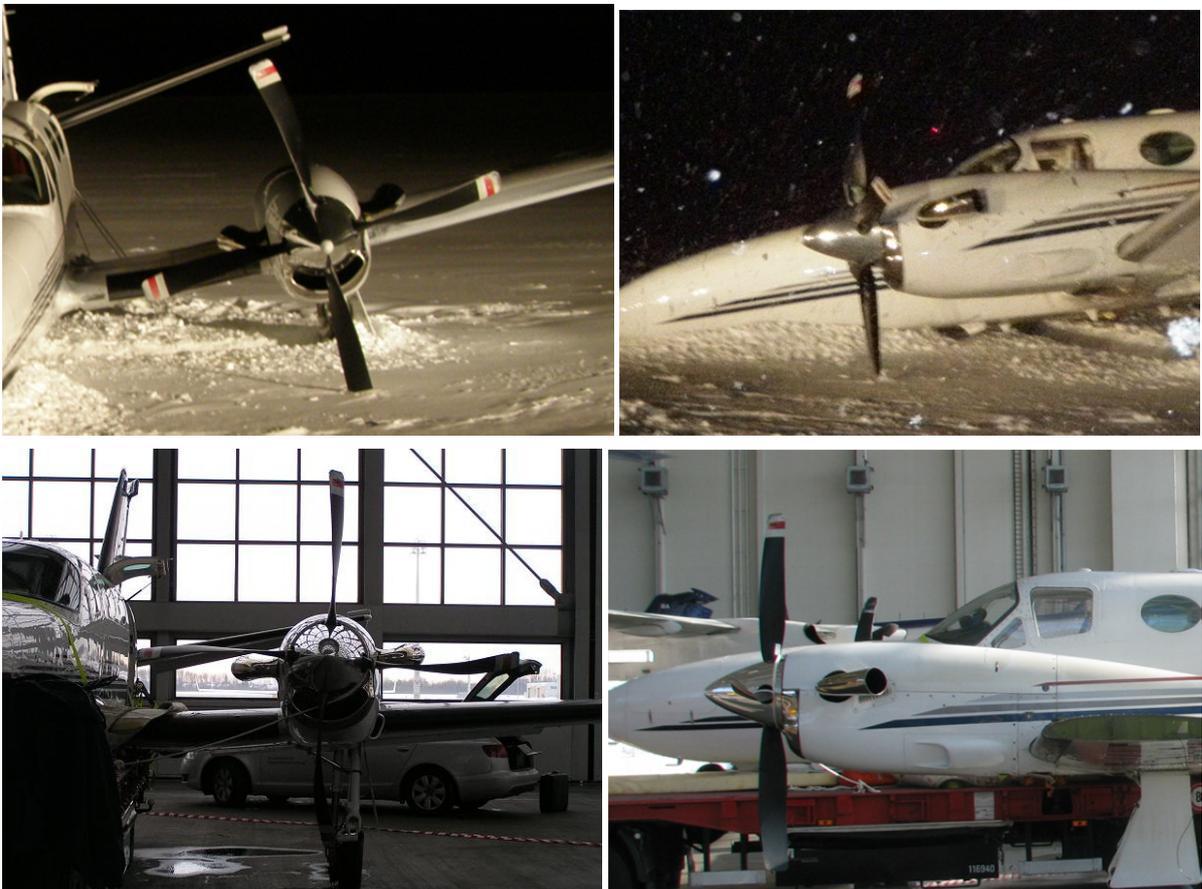
Position and deformation of the propeller blades of the left engine at the accident site and after the salvage operation and the transport to a hangar

On the left engine, all four propeller blade tips were deformed and the leading edges were damaged. Examination of the left engine determined that both the compressor and power turbine were free to rotate. The exhaust casing was slightly deformed. The oil filter was filled with clear oil, and no metal particles were visible. The fuel filter was clean and filled with fuel. A small quantity of oil was found in the exhaust duct. The oil level was 2.25 US-Quarts (2.13 litres) below the maximum.

The fact that all four propeller blades showed the same damages on their tips indicates that the propeller windmilled at the time of ground impact, i.e. the propeller was not in the feathered position. The traces found on the ground which were caused by several rotations of the propeller also point in the same direction. The photographs taken shortly after the accident document unambiguously that the propeller was not in feather at that time. If the propeller of the shut-off engine was not in feather during the flight it had to be driven by the air stream (windmilling). The traces the propeller left in the snow were about 0.80 to 1.00 m apart from each other. On the one hand the traces can clearly be attributed to the left engine and on the other hand they clearly show that the propeller turned. Based on a ground speed of the airplane of 60 kt after the initial impact and given the distance of the propeller traces of 0.80 - 1.00 m a propeller rpm of 579 and 463 min^{-1} was calculated. At a speed of 70 kt the rpm would have been between 675 - 540 min^{-1} and at 30 kt between 289 - 232 min^{-1} . Had the propeller been in feather such revolutions per minute would not have been reached.

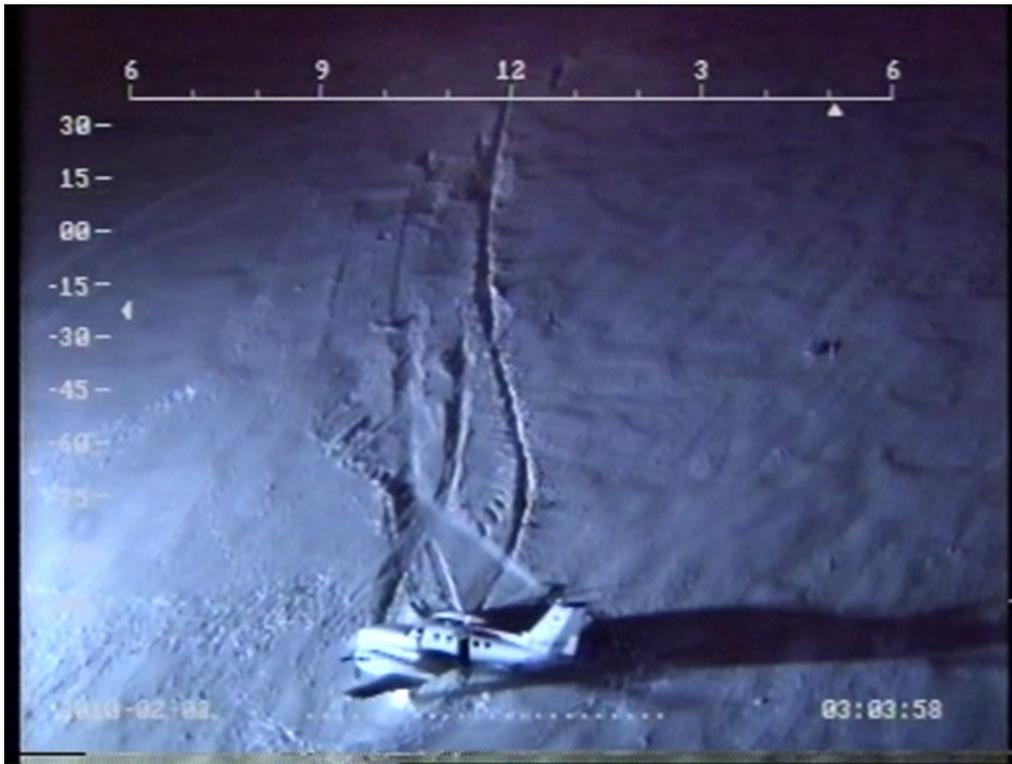
Accident tracks and final aircraft position (Photo: Police)

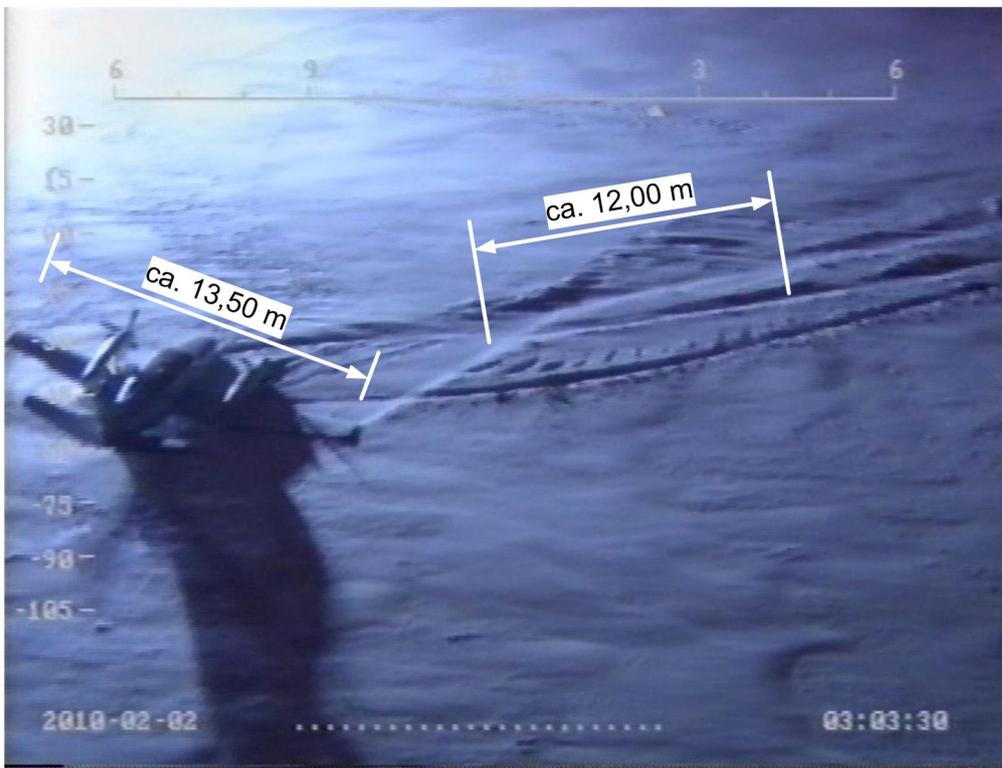
Propeller tracks at the accident site on a length of more than 12 meters
