Papua New Guinea

Runway overrun
Misima Airport, Papua New Guinea
31 August 2010
P2-TAA
Cessna Aircraft Company Citation C550

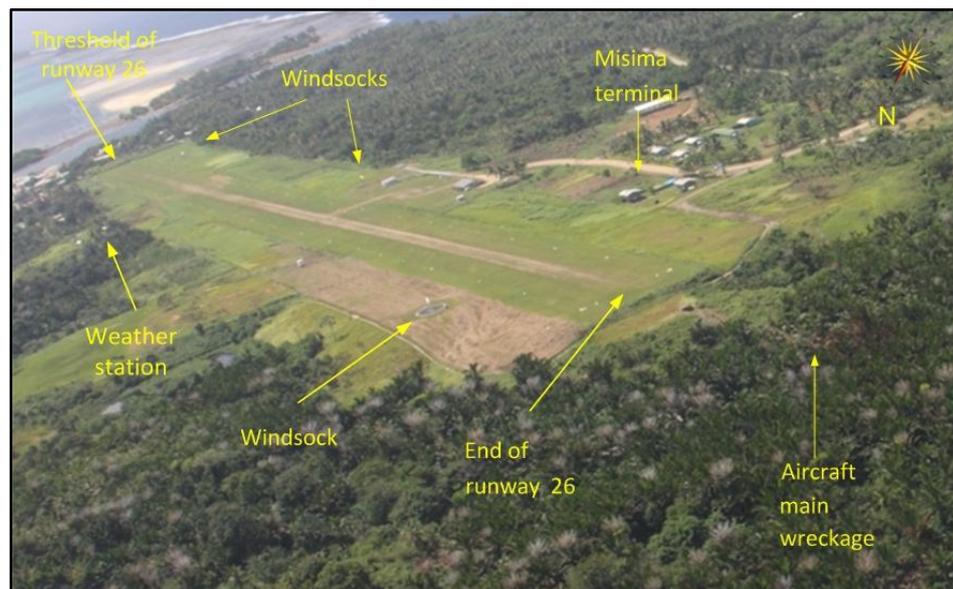
Figure 4: Weather station and other aerodrome features

During the on-site investigation, it was noted that the weather station anemometer was recording a wind speed of 4 kts from the east. This was inconsistent with the actual conditions at the time. A portable anemometer was taken onto the runway at the point where the aircraft touched down prior to the accident and the wind speed was noted to be 15 kts from the east. The windsocks were inspected and appeared to be operating normally at that time.

An examination of the weather station revealed that, in certain wind directions, the anemometer was shielded by nearby trees and a knoll to the east. The serviceability

of the anemometer was not assessed at the time of the on-site investigation. A subsequent examination was conducted and found that the measuring mechanism had malfunctioned.

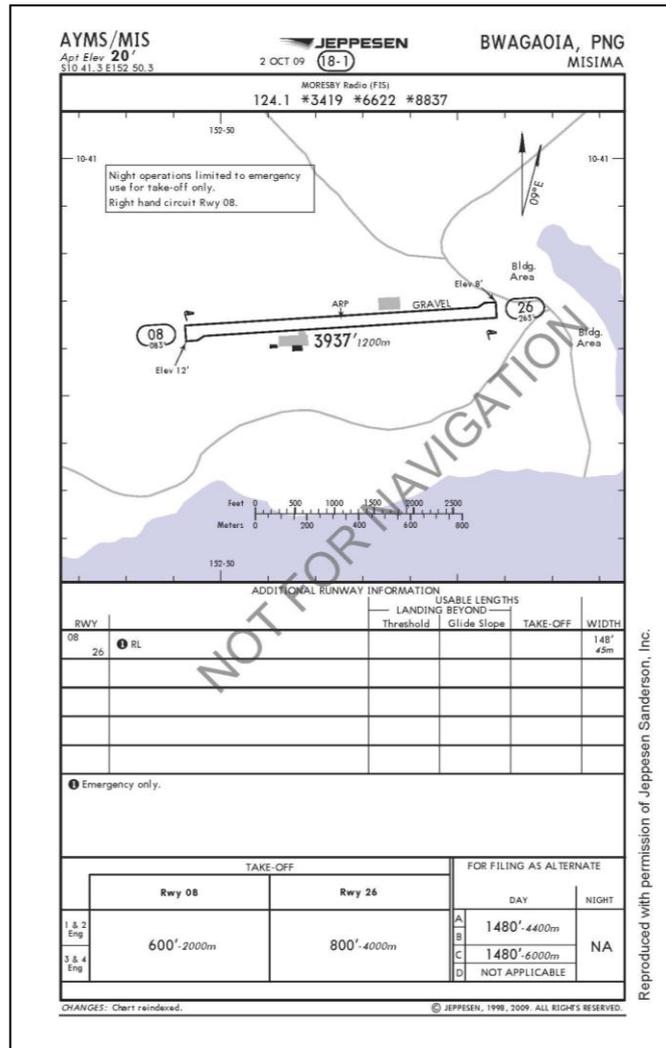
Figure 5: Misima Island runway chart

The runway chart described the runway as having a gravel surface. The investigation determined that the surface was a combination of crushed coral aggregate, which in normal conditions could be expected to provide aircraft tyres with a high coefficient of friction (important for aircraft braking). However, fine dust and soil particles had become embedded between the pieces of coral aggregate, and in places, grass had grown to about 15 to 20 cm high. Advice from the Australian Tropical Herbarium in Cairns was ‘...that it was not possible [from the evidence provided] to positively identify the vegetable material on the runway but it was most likely a moss, green algal mat or a lichen.’

The drainage of any surface water from the runway surface would be affected by the embedded particulate matter and the vegetable material.

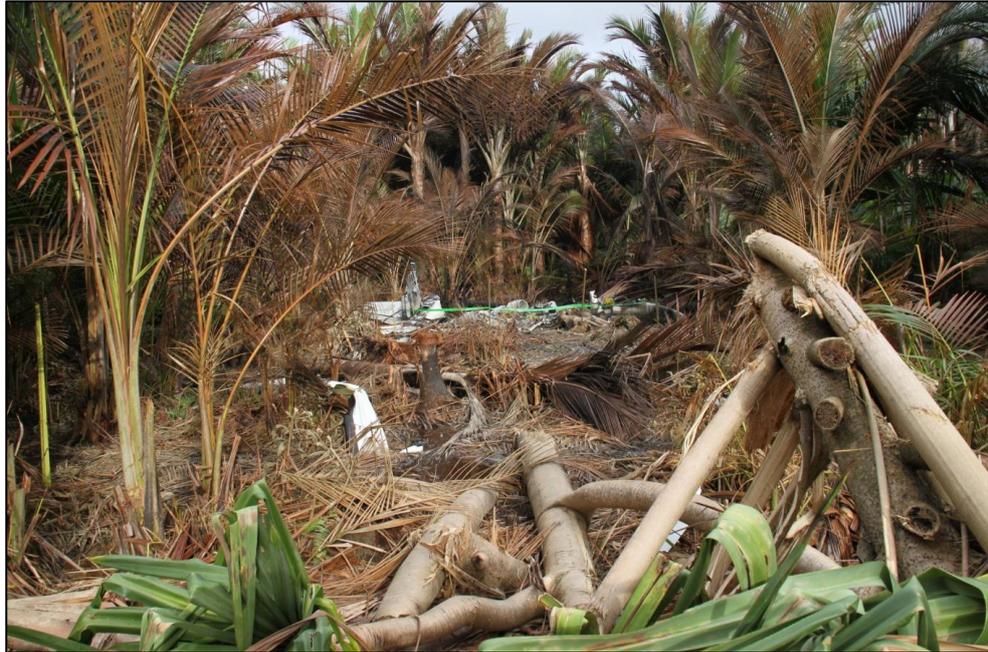
Figure 6: Main wreckage

More significant collisions with additional sago palms were noted about 100 m from the end of the runway and the main wreckage was located on wet, swampy ground within in a large stand of sago palms about 160 m from the end of the runway (Figure 6). The aircraft's average trajectory from overhead the end of the runway to the initial tree contact was 4° down.

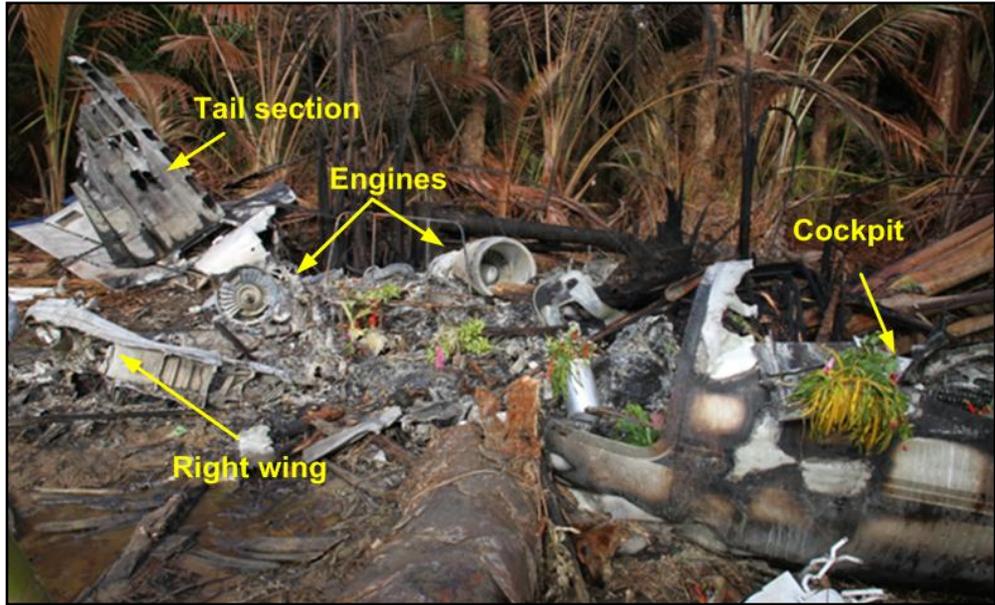
Figure 7: Damage to the aircraft

The extent of the damage precluded a detailed examination of some of the aircraft's components and systems. However, there was inwards bending of the left side of the fuselage in the area of the cabin door and damage to the door itself, consistent with impact loads from the left just before the aircraft came to rest. The door was also blocked by a large tree. In contrast, little structural damage was apparent in the area of the emergency exit on the right side of the fuselage.

All of the aircraft's primary structures and flight controls were accounted for at the accident site and there was no evidence of any pre-impact structural failure. Where possible, flight control continuity was established and no pre-impact defects were identified. Figure 7 shows the extent of the damage to the aircraft.

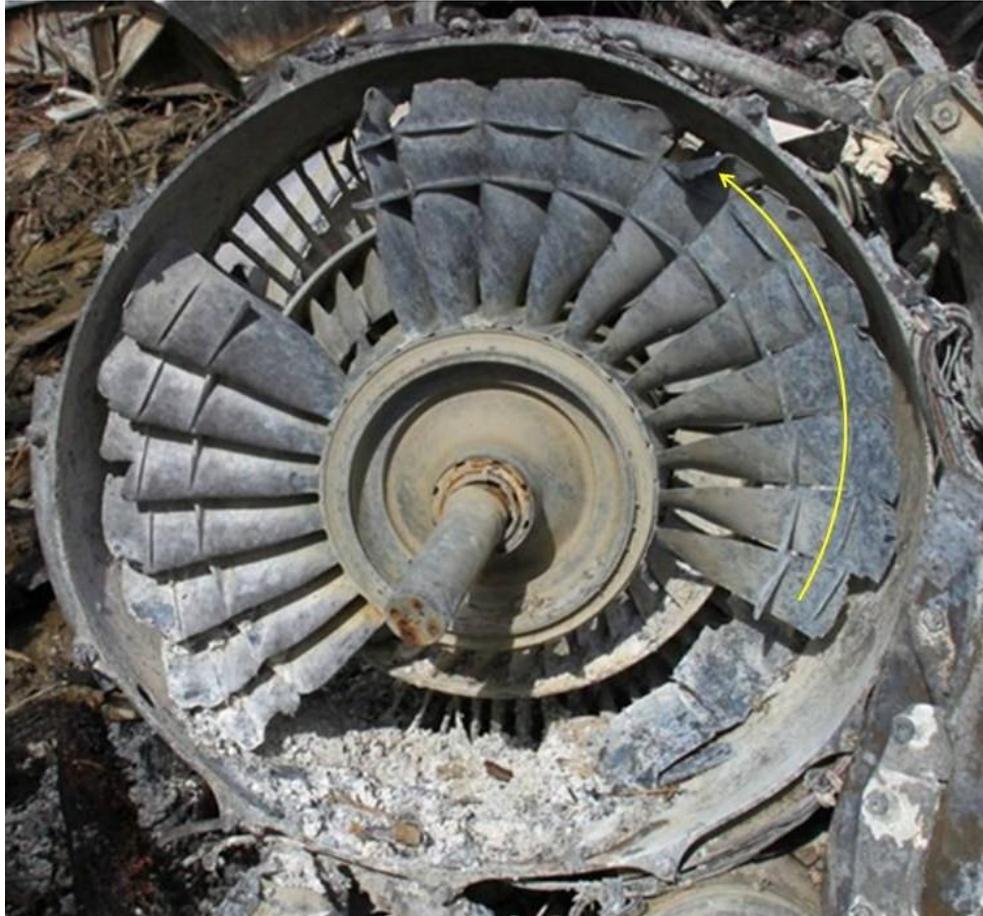
Figure 8: Right engine showing indications of rotational damage

The first stage compressor blades of both engines were bent in the opposite direction to rotation (Figure 8), indicating their operation at significant power at the time of impact with the terrain. The turbine sections of each engine appeared to be in good condition with no pre-accident defects identified.

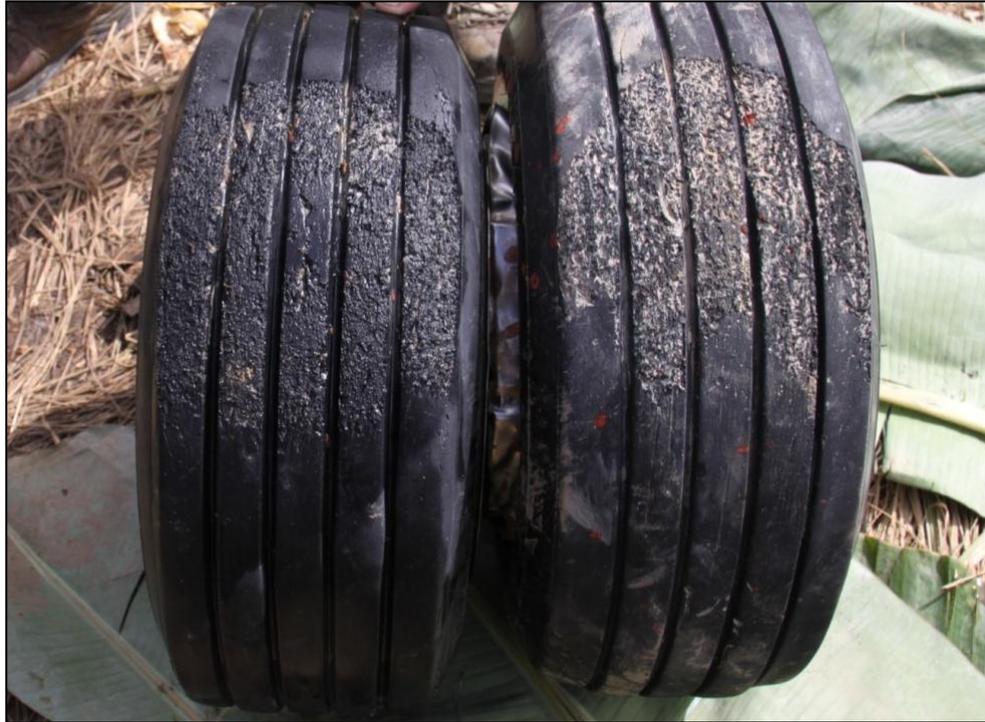
Figure 9: Abrasion damage to the left and right main landing gear tyres

The mainwheel tyres were burnt in areas that were exposed to the post-impact fire; however, the majority of both tyres were in good condition. Localised damage was identified on parts of the mainwheel tyres that had been protected from the fire by the swampy surface water and mud (Figure 9).

The localised damage appeared to be consistent with abrasive wear and included small, sharp gouges to each surface. This damage was consistent with contact with the rock/coral runway surface by non-rotating tyres. A number of longer gouge/scrape marks were evident on the surface of each tyre and were oriented in the circumferential direction.

The shape of each localised area of damage was consistent with the tyres' footprint. That was consistent with the wheels not rotating until about 400 m after touchdown, resulting in severe localised abrasion.

No evidence of melting or reverted rubber¹⁹ was observed on either of the damaged tyres.

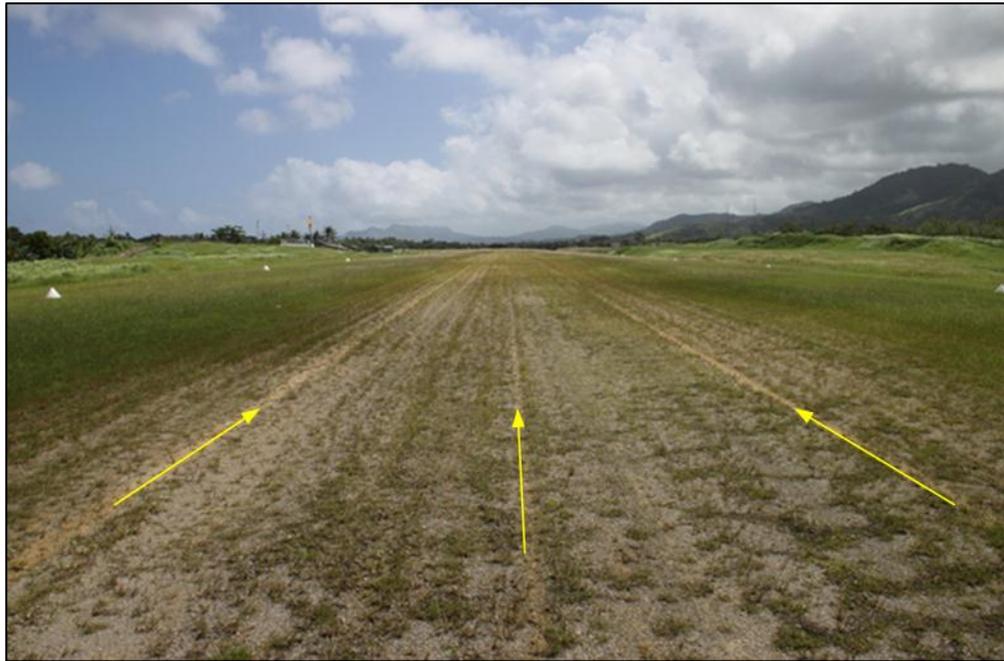
Figure 10: Runway 26 showing the initial touchdown point

Inspection of the runway showed recent, distinctive wheel tracks of similar dimensions to the aircraft's landing gear dimensions. Other recent track marks were consistent with the main landing gear of a de Havilland Dash-8-type aircraft.²⁰

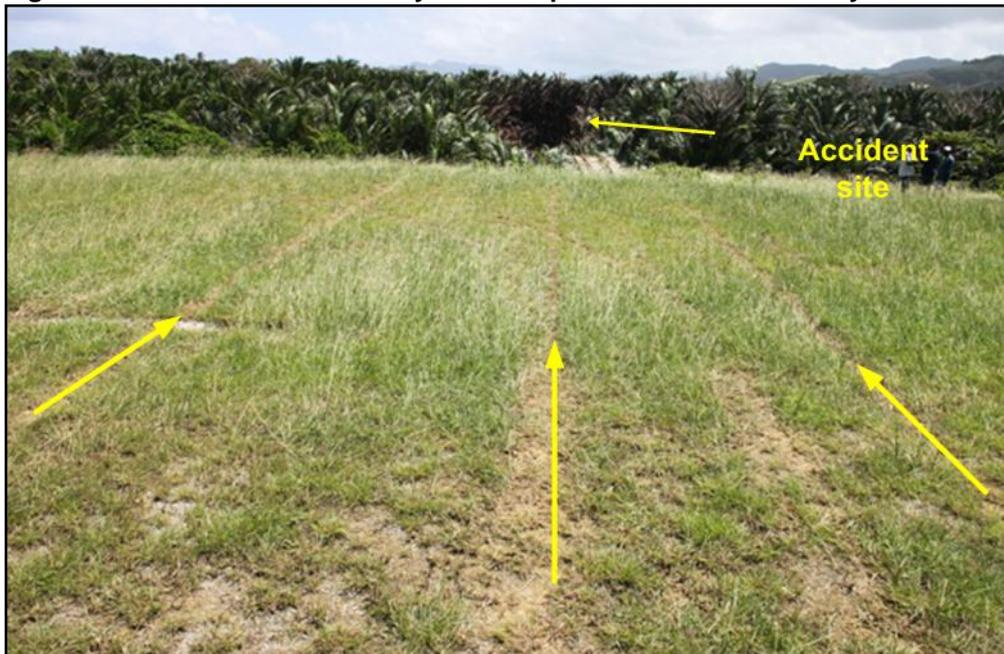
Figure 11: Wheel track marks beyond the upwind end of the runway

Measurement of the track marks at the upwind end of the runway showed that the nosewheel track marks were to the right of centre. That equated to about 10° of right yaw²¹ when the aircraft left the runway.

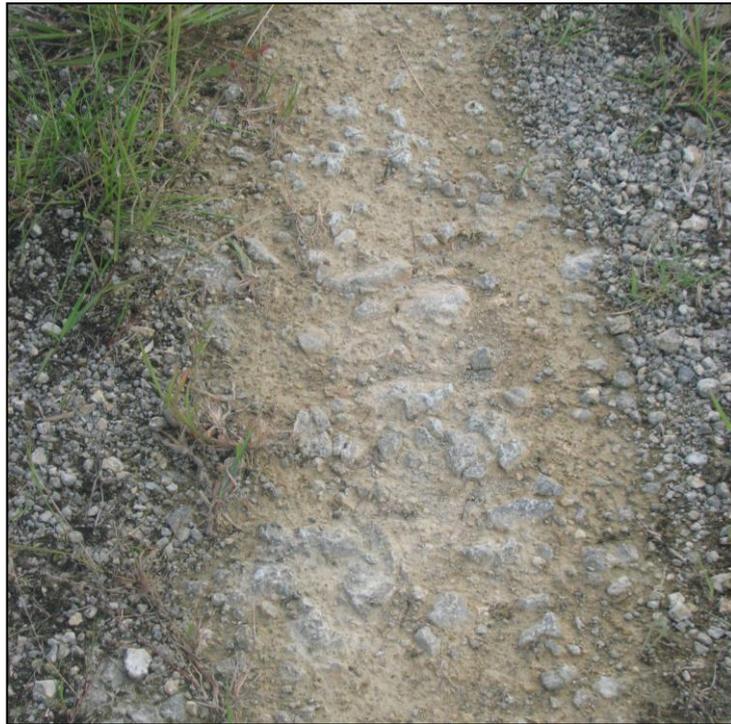
Figure 12: Removal of the small stones and dust from the landing tyre tracks

The centre of each tyre mark was virtually clear of small stones and dust for the initial 490 m. For that distance, all of the small stones and dust were deposited outside the tyre track prints, leaving only the embedded rocks and crushed coral in the soil under each tyre track. This was consistent with the tyres forcing surface water to the sides of the respective tracks (Figure 12). This scouring effect was typical of dynamic aquaplaning (see section 1.18.2 titled *Aquaplaning*).

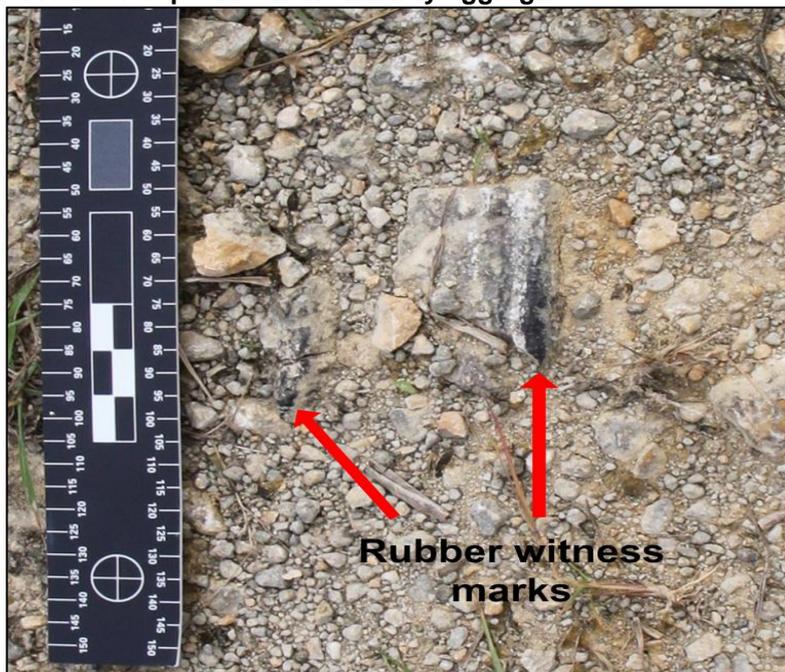
Figure 13: Rubber deposits on the runway aggregate

After the scouring marks ended, the track marks indicated contact between the tyres and the runway surface, with rubber deposits and witness marks on the coral aggregate (Figure 13). The transfer marks were consistent with damage caused to a non-rotating tyre as it skidded on the runway.

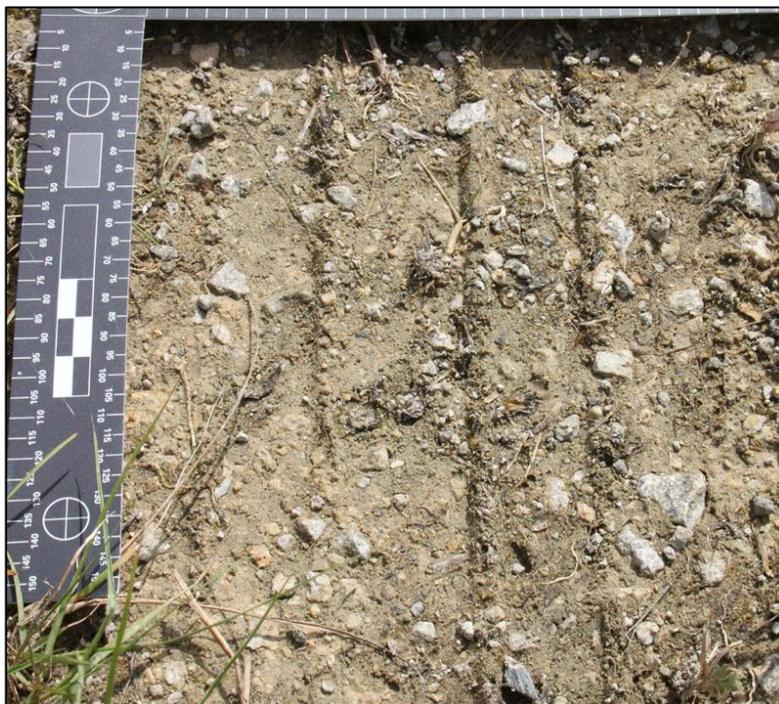
Figure 14: Indications of normal wheel roll

Indications of normal wheel roll were observed after the witness marks with no evidence of scouring in between the crushed coral aggregate. That was consistent with there no longer being any aquaplaning (Figure 14). Recorded data indicated that this point coincided with the commencement of the baulked landing.

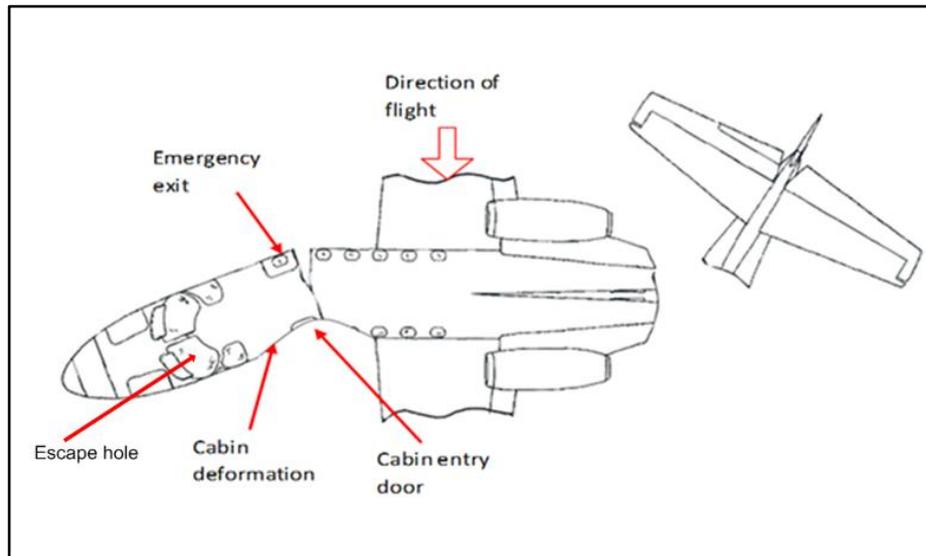
Figure 16: Fuselage damage

The inwards movement of the left of the fuselage near the cabin door compromised the liveable cabin space (Figure 6). The deceleration forces causing that deformation would have also acted on the aircraft occupants, tending to move them towards the left side of the cabin.

The copilot stated that the aircraft's galley was forced to the right, blocking access to the cabin door and emergency exit. He reported escaping the aircraft by enlarging a pre-existing hole above the PIC's windscreen and then crawling out through that hole. He attempted to extricate the PIC from the aircraft but without success.

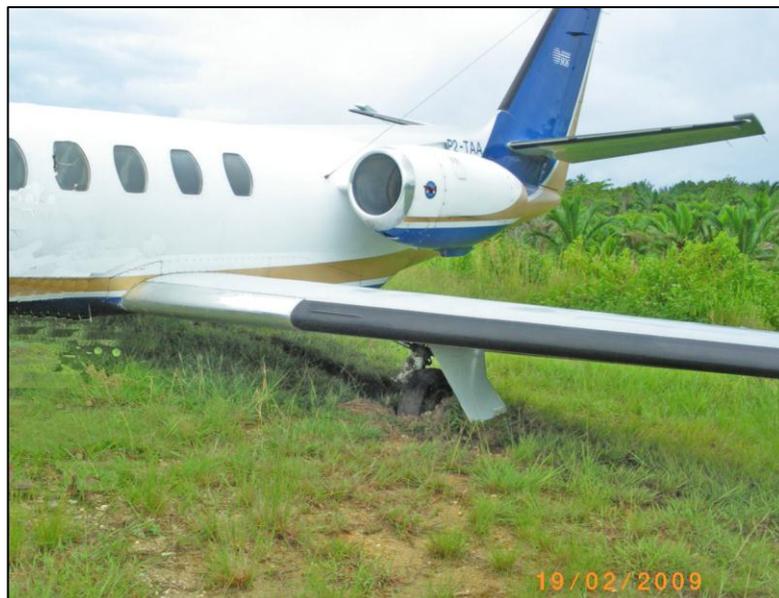
Figure 17: Left main landing gear bogged

The copilot applied maximum right brake and full right rudder in an attempt to stop the aircraft running off the end of the runway. The aircraft yawed right, and skidded sideways, coming to rest heading about 120° right of the landing direction with the left mainwheel about 4 m from the end of the runway overrun (Figure 17).
