**AVIATION INVESTIGATION REPORT
A12C0005**

LOSS OF CONTROL AND COLLISION WITH TERRAIN

**KEYSTONE AIR SERVICE LIMITED
PIPER PA31-350 NAVAJO CHIEFTAIN, C-GOSU
NORTH SPIRIT LAKE, ONTARIO
10 JANUARY 2012**

Report Number A12C0005

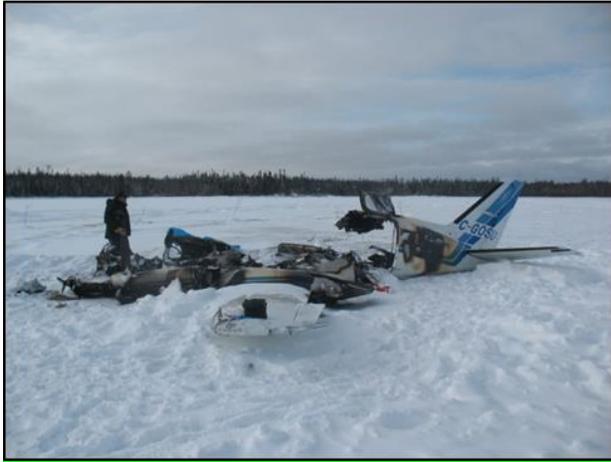
TSB investigators arrived on scene approximately 26 hours after the accident. The aircraft struck the frozen surface of the lake in a right-wing-low attitude at both a high rate of descent and forward speed. Contents of the aircraft, such as baggage and cargo, were found strewn halfway up the wreckage trail, indicating an early breakup of the cockpit and cabin area. The wreckage trail was generally aligned with the extended centreline of the runway. It was approximately 380 feet long, and the aircraft had come to a rest in an upright position, facing a southeasterly direction (Photo 1). Damage to the propellers suggests that the engines were producing power at the time of the impact. A post-impact fire consumed a majority of the aircraft.

Photo 1. Wreckage on site

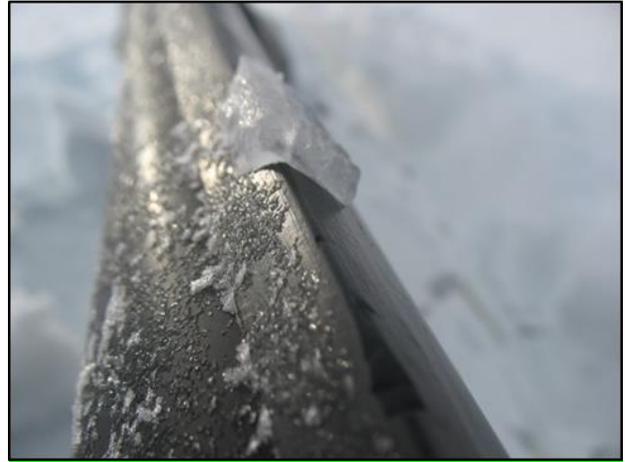
An approximate 4-foot section of the right-wing leading edge containing the stall warning vane was torn off and found approximately halfway down the wreckage trail. This section of leading edge was not affected by the fire, and exhibited some clear and mixed ice that was approximately 3/8 inch thick (Photo 2). The stall warning vane was not heated, and exhibited hard packed ice inside the stall warning housing, trapping the vane in a downward position (Photo 3). The left horizontal-stabilizer leading edge was also not affected by the fire, and exhibited ice accumulation (Photo 4).

Photo 2. Leading edge ice

The remaining ice found on the 4-foot section of the right-wing leading edge and on the left horizontal-stabilizer leading edge indicates that a significant amount of ice accumulated on the aircraft's critical surfaces in flight. The investigation was not able to assess the serviceability of the de-ice system because of extensive impact and fire damage.

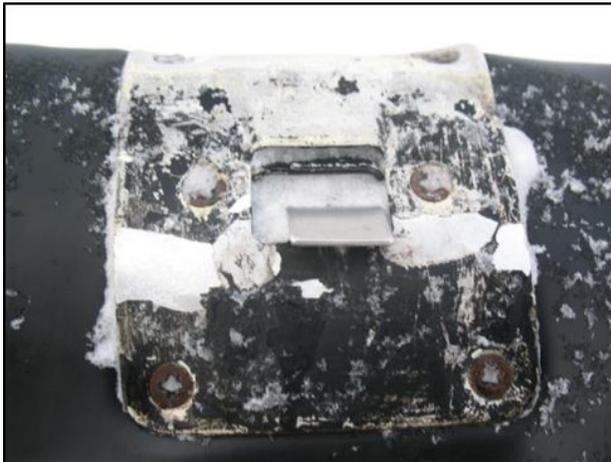
Photo 3. Stall warning vane

It is likely that once the runway was cleared, the pilot extended the landing gear and set approach flaps before turning onto final approach. With the stall warning vane trapped in a downward position, the stall warning system would have been inoperative and would have provided no warning to the pilot of a stall condition. The accumulation of ice and the change in aircraft configuration resulted in an increased stall speed and an increase in drag.

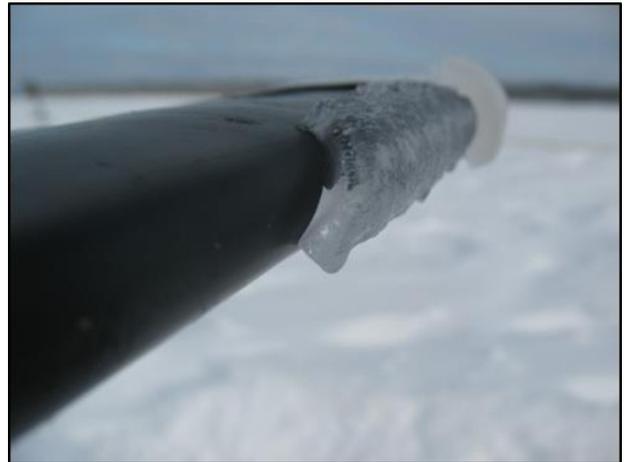
Photo 4. Ice on the horizontal stabilizer leading edge
