Collision with water – Aero Commander 500S VH-WZU

26 km north-north-west of Horn Island, Queensland | 24 February 2011

ATSB Transport Safety Report
Aviation Occurrence Investigation
AO-2011-033
Final

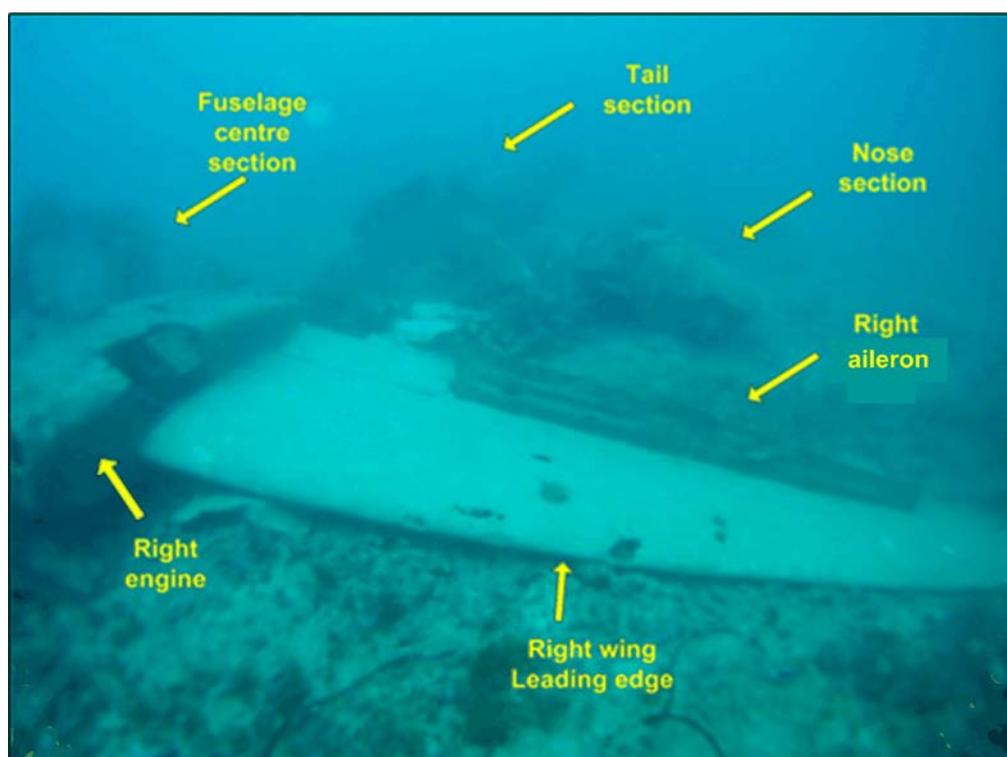
Figure 5: Right wing

The wing sections were found inverted with the engines still attached. The majority of the nose, cabin and tail sections had all separated from the wing section but were still attached by the aircraft control cables. Overall, the aircraft had broken into large sections, which was consistent with impact at a relatively low speed.

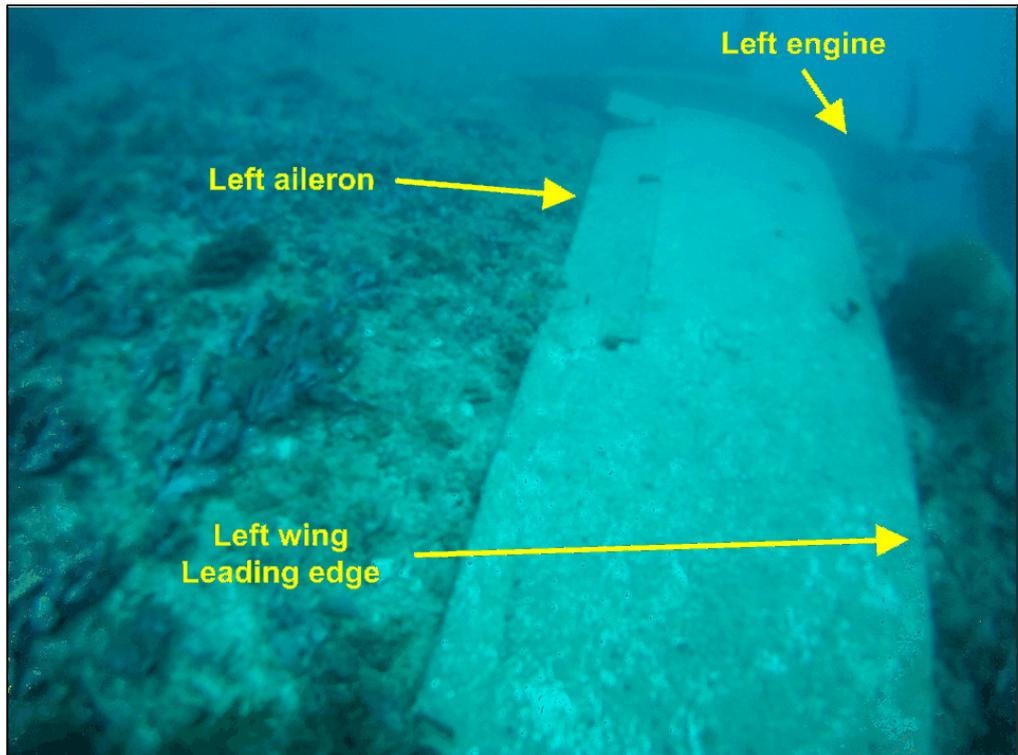
Figure 6: Left wing

Both wings displayed similar impact damage. There was no major crushing damage to the leading edges, and there was no significant impact damage to the undersides of the wings. Both propeller spinners and most of the engine cowls, which consisted of light fibreglass and aluminium, also displayed minimal damage. This pattern of evidence indicated that the aircraft impacted the water in a near wings-level attitude.

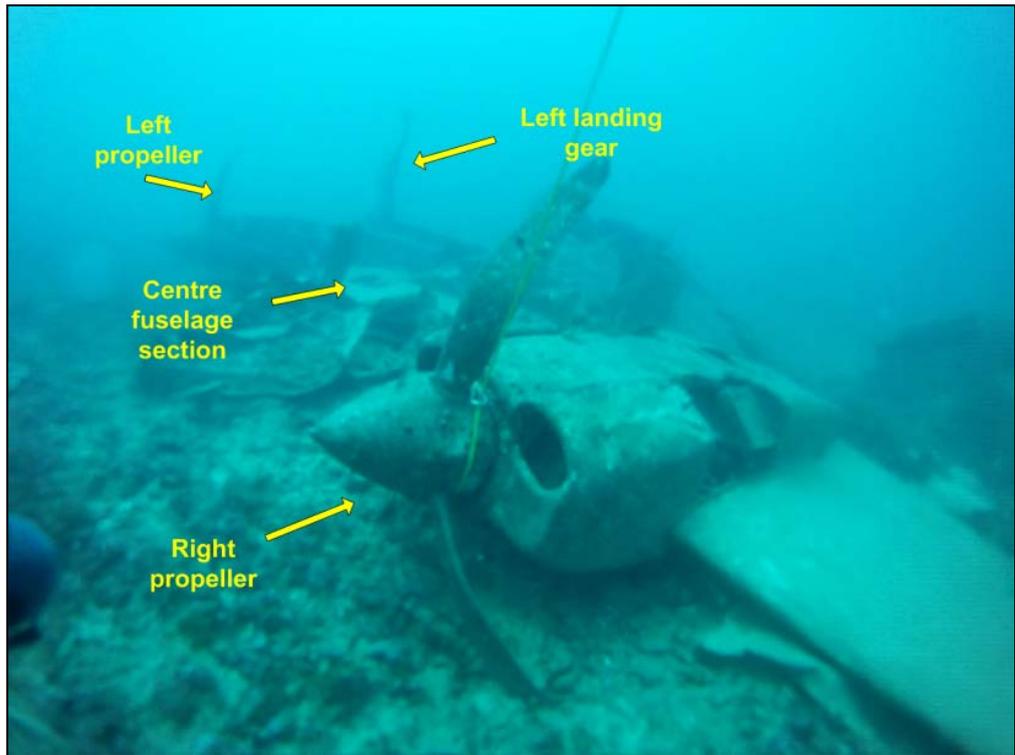
Figure 7: Right wing section, propellers and left landing gear

The left main landing gear was found in the extended position (Figure 7), and the right main landing gear was retracted but the gear doors were partially open. It could not be ascertained whether the flaps were retracted or were extended to the first stage. Loss of hydraulic pressure or impact damage may have allowed the landing gear and flaps to extend after impact. There was no significant impact damage to any of the main landing gear doors or the outboard wing flaps, as would be expected if the gear and flaps had been extended prior to impact. Overall, there was insufficient evidence to conclude whether the gear or flaps were extended at impact.

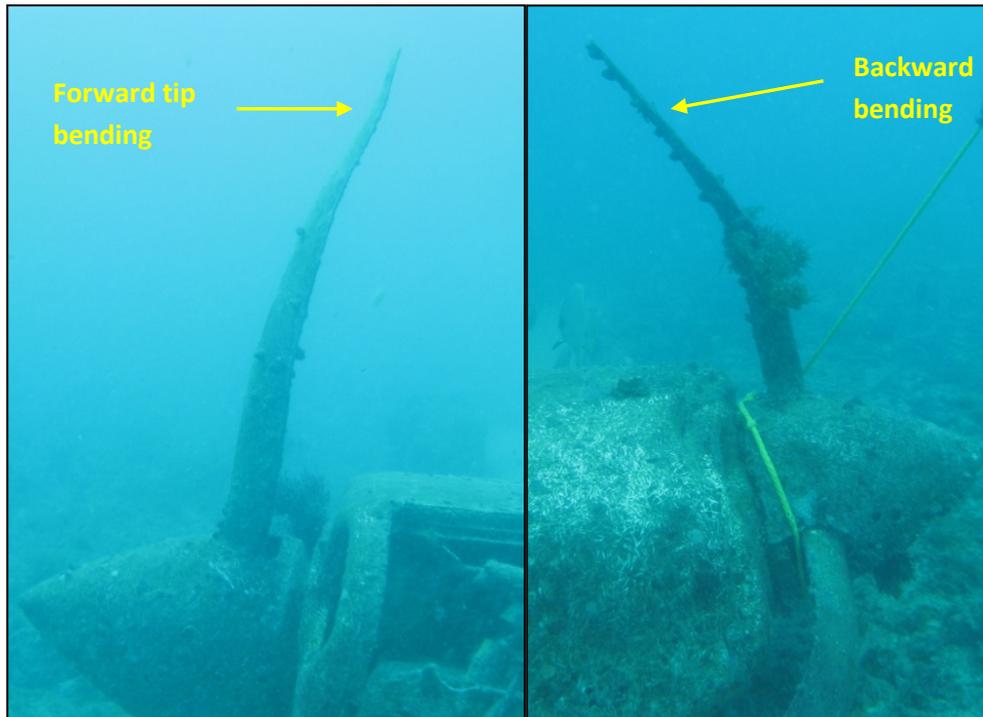
Figure 8: Left propeller blade (a) and right propeller blade (b)

Two of the blades of the left propeller showed clear evidence of double bending (Figure 8a) and the tip of the third blade was obscured from view. The presence of double bending showed that the left engine was delivering significant power on initial impact with the water.²³

There was a difference in the damage signatures of the two propellers, with the left propeller showing clear evidence of it being under power at impact and the right propeller only showing that it was rotating at impact. However, this difference did not mean there was a problem with the right engine as the same pattern of evidence could have been produced with both engines under power.

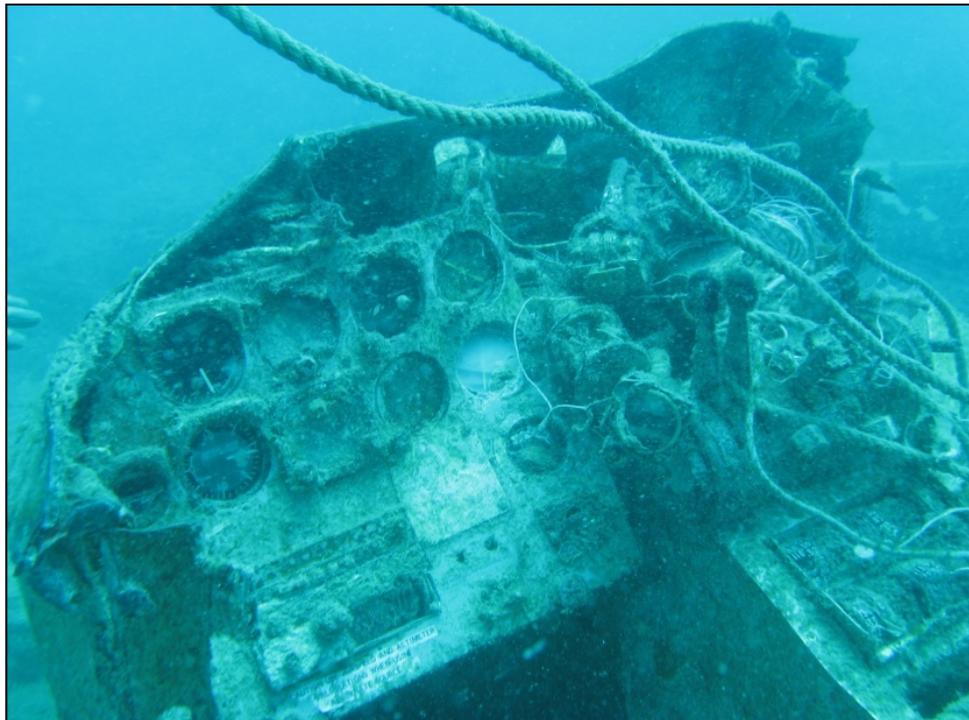
Figure 9: Instrument panel

Due to the extent of damage to the cockpit area (Figure 9), no conclusions could be drawn as to the pre-impact position of any of the controls, switches or instruments.

Due to the extent of damage to the cockpit area, it is very unlikely that the accident was survivable.
