File No. 1008-12

Docket No. SA-65

REPORT OF THE CIVIL AERONAUTICS BOARD

Of the investigation of an accident involving aircraft of United States registry NC 18146 which occurred near Salt Lake City, Utah, on May 1, 1942.

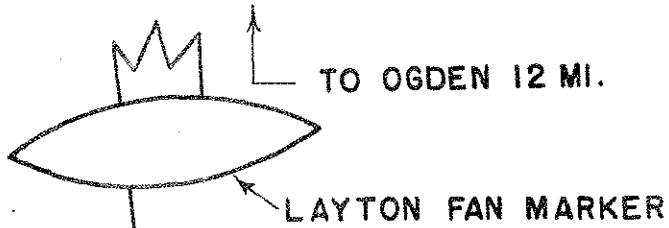
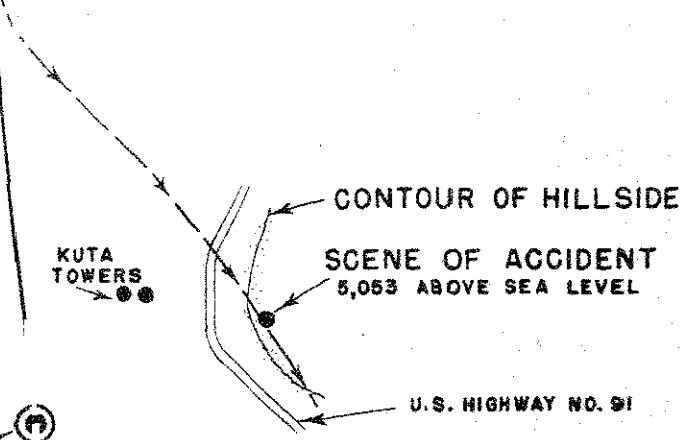
MAP SHOWING PROBABLE APPROXIMATE FLIGHT PATH OF THE AIRPLANE

It is possible that Captain Brown confused the lights of the towers of radio station KUTA with those of the Salt Lake Range Station. These towers are about 1.4 miles northwest of the scene of the accident and 1.9 miles northeast of the Salt Lake Range Station. (See map opposite page 6.)

8. The trip reported at 10:56 p.m. that it had become contact 6,000 feet above sea level about 10 miles north of the field. The actual position of the airplane was probably about 7 or 8 miles north of the field at the time. At 10:57 p.m., Trip 4 contacted the control tower and reported that it was five miles north, approaching the range station, and received landing instructions in code. About one or two minutes later the airplane crashed into the side of a hill about three miles east-northeast of the range station and 3.8 miles northeast of the airport.

10. The north leg of the Salt Lake Radio Range, on which Trip 4 had been proceeding, has a magnetic bearing of 150 degrees toward the station. The marks on the ground at the scene of the accident showed that the airplane was following a course of about 124 degrees magnetic at the time.
