Accident Report

7th October 2012
V.C, Bird International Airport, Antigua (TAPA)
Britten-Norman BN2A-26
Registration VP-MON
Montserrat Airways Limited doing business as
Fly Montserrat

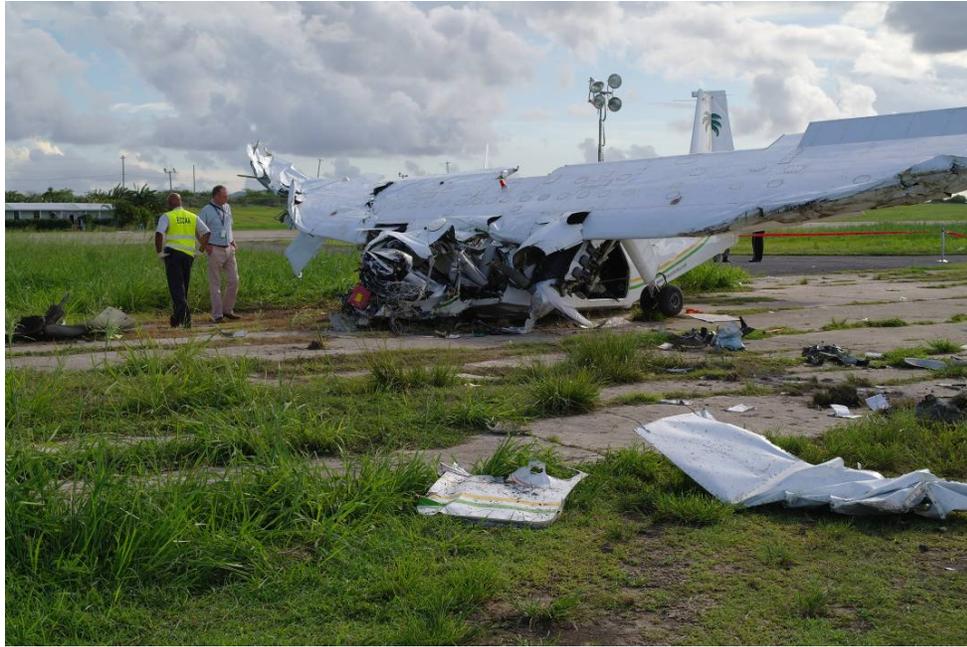
The aircraft was destroyed as a result of severe damage sustained by the forward fuselage and wing tips during the impact. Figure 1 shows the aircraft as it was found.

Figure 2
View of the aircraft as found after the accident

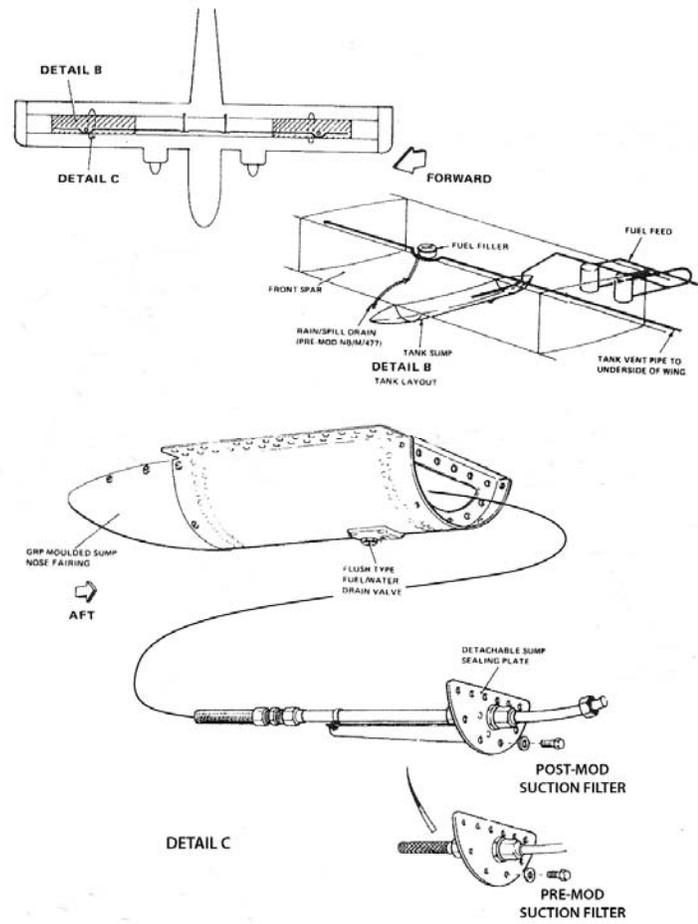
An illustration of the aircraft fuel tank installation is shown at Figure 3, where it can be seen that the fuel off-take, via the suction filter, is the subject of Modification No NB/M/350.

Figure 3
 Fuel tank sump installation, showing pre- and post-modification NB/M/350 suction filters

It is recommended that the European Aviation Safety Agency take the appropriate measures to ensure that all Britten-Norman Islander and Trislander series of aircraft are equipped with the latest standard of fuel suction filters.

It is further recommended that all authorities with Britten-Norman Islander and Trislander series of aircraft on their register take appropriate measures to ensure that all these aircraft are equipped with the latest standard of fuel suction filters.

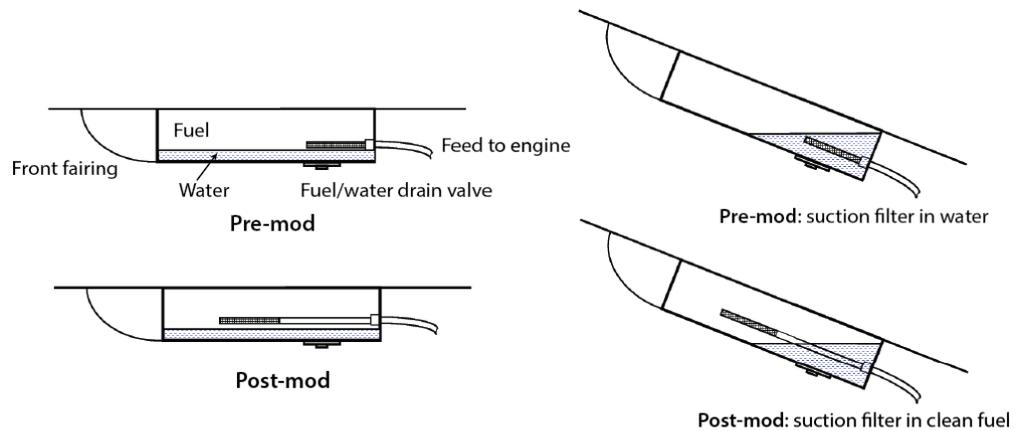
NB/M/350 mounted the suction filter 8.5 in forward of the sealing plate, on the end of a tube. This also had the effect of raising the filter from 1.05 in to 2.25 in above the bottom of the sump. The purpose of the modification, which was issued in 1968, was to provide increased protection from water contamination of the fuel. Any water would collect at the bottom of the sump and would tend to move aft during takeoff and, with the filter attached directly to the sealing plate, be fed directly into the fuel line to the engine. However, the post-modification configuration is more likely to place the filter in the uncontaminated fuel above the water level, as illustrated in Figure 4.

Figure 4
Fuel behaviour with pre- and post-mod suction filters

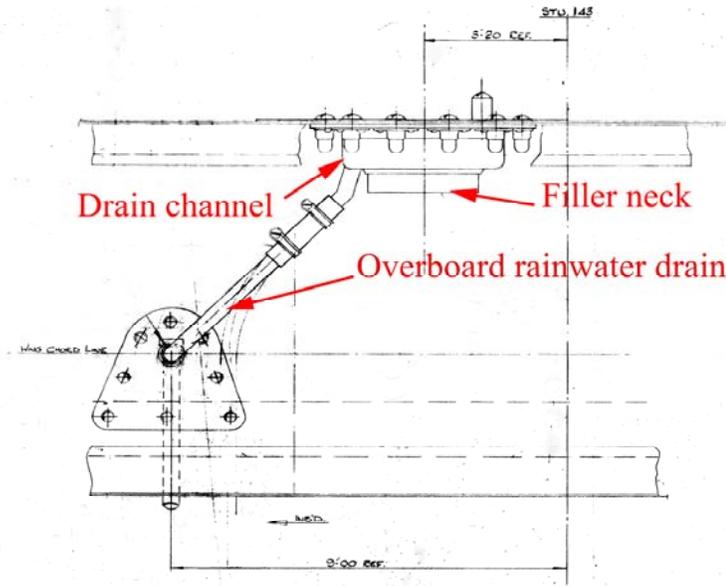
Figure 5

position by two pegs that engaged with cam profiles in the filler neck), the inner rim sealed against the lower face of the cap. This ensured that any rainwater that leaked past the top of the cap was guided into the channel and thence overboard. A drawing showing the filler neck is shown at Figure 5.

Drawing of fuel tank section showing rainwater drain details

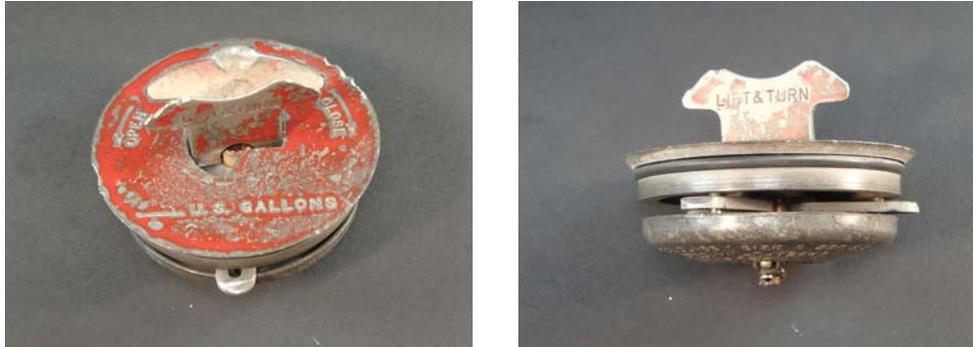
Figure 8

Examination of the wreckage of VP-MON revealed that both filler caps were the Shaw Aero Devices component (see the example shown in Figure 8), although the filler necks were of the pre-modification standard. This is covered in more detail on page 24 of this report.

Example of post-modification NB/M/477 fuel filler cap as found on VP-MON

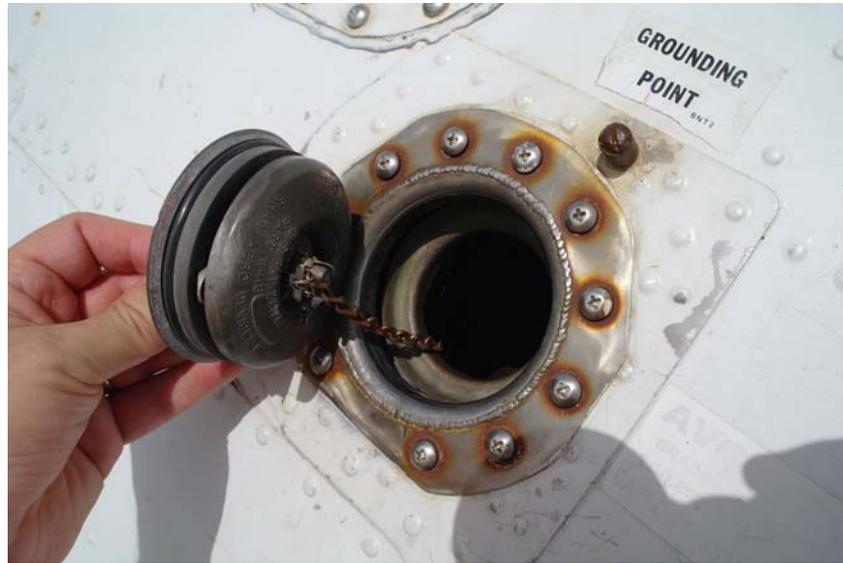
Figure 9
Left fuel tank filler neck, showing stainless steel fitting

When the same experiment was repeated on the left tank filler cap, no water leakage past the seal was observed; it was clear that the smooth surface of the stainless steel formed an effective seal against the 'O' ring on the cap.

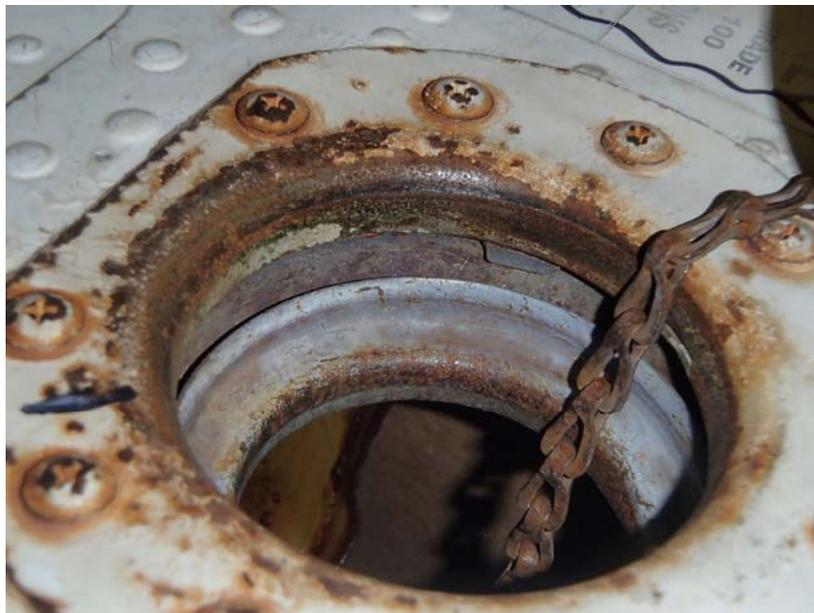
It can be seen in Figure 10 that the right tank filler neck displayed evidence of corrosion.

Figure 10
Right fuel tank filler neck showing corrosion and drain channel

In a simple experiment to discover if this had adversely affected the seal between the neck and the cap, water was poured onto the top of the wing around

the filler cap. After gaining access to the filler cap underside via an adjacent access panel, water droplets could be observed dripping from the central spigot of the cap and falling into the body of the tank; they were not being directed into the rainwater drain channel. The experiment was repeated a number of times, each time removing and then reseating the filler cap. Leakage, at variable rates, was observed in most cases, although it was sometimes possible to achieve an effective seal.

A sample from the refuelling bowser was found to be free from water contamination; furthermore there were no reports of problems occurring on other piston engine aircraft operating out of Antigua. It is thus reasonable to conclude that the water entered the fuel tank during the period the aircraft was parked in heavy rain. However, such conditions are not unusual in the Caribbean, where, in addition, high humidity levels can generate condensation within the fuel tanks, further contributing to water contamination. In the case of VP-MON, the variable efficacy of the fuel right tank fuel cap seal would have led to water periodically entering the tank, although it is likely that this could have been removed by the daily water drain checks. The fact that the Technical Log page for the day of the accident did not display a signature for the daily Check 'A' (which would have included the water drain check) raises the possibility of the check being omitted. However, the aircraft flew without problem from Montserrat to Antigua earlier in the day, indicating that either there was no water or there was insufficient quantity to be drawn into the fuel system. It was therefore concluded that a combination of the heavy rainfall and a relatively high leakage rate past the fuel cap resulted in a significant quantity of water entering the right fuel tank.

Following the accident to VP-MON, Britten-Norman issued Service Bulletin 332 and the EASA issued the associated Airworthiness Directive 2012-0270. This was intended to address the problem of water entering the fuel tanks and will eventually result in the fleet being equipped with the modified fuel caps and receptacles. However, it is worth noting that the original design, although relatively complex to build, acknowledged that rainwater would inevitably leak past the cap itself, and thus provided a drain. Modification NB/M/477 relied on an improved seal between the cap and adaptor plate to keep rainwater out of the fuel tanks. It is possible that whilst this may be effective when the components are new, wear of the 'O' ring seal on the cap and corrosion on the adaptor plate could eventually result in leakage similar to that which actually occurred on VP-MON. (In fact the left filler cap had been replaced in November 2010 due to the discovery of water leakage into the tank; it is probable that this was due to a worn/faulty 'O' ring, as the stainless steel adaptor plate is unlikely to have corroded.) This emphasises the importance of conducting regular and effective checks for water contamination of fuel.
